Report on  
Geotechnical Assessment – Urban Capability

Proposed Subdivision  
Lots 1 – 5 and 7 DP771051, Parkwood, NSW

Prepared for  
The Riverview Group

Project 77356  
February 2014

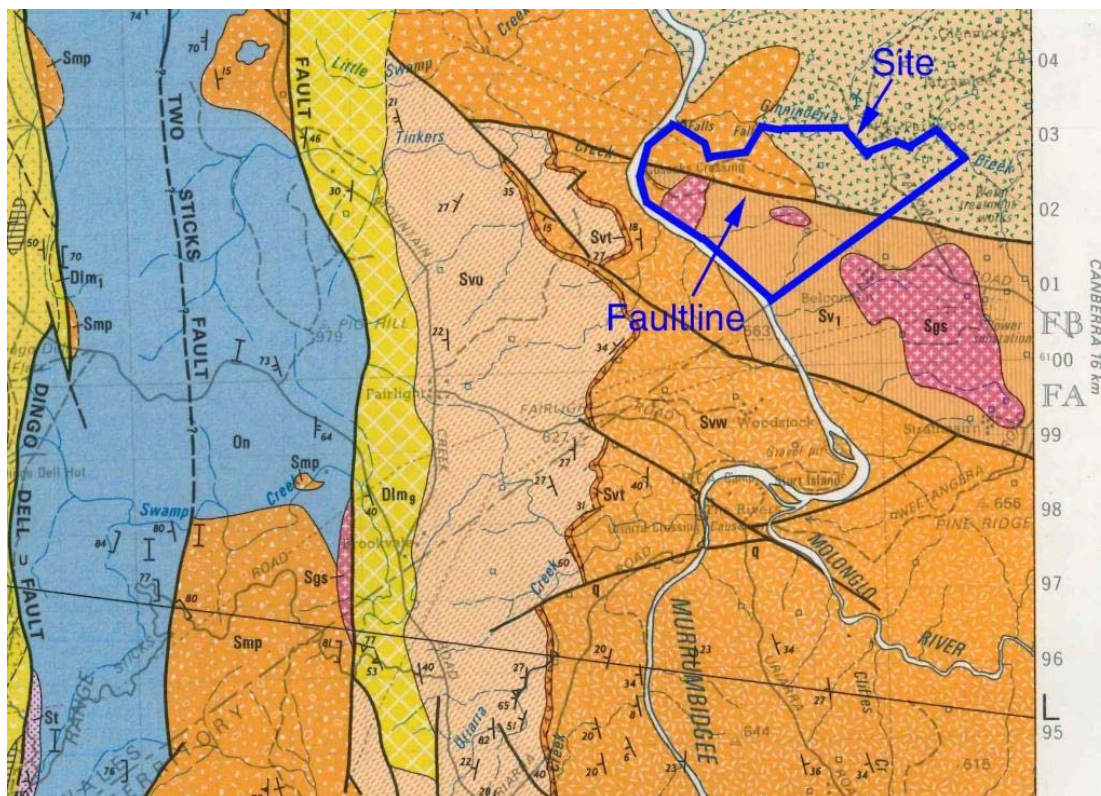
**Figure 1: Extract of Geology Map.**

Reference to the Brindabella Geology Sheet (Ref 1) indicates that the site is underlain by four igneous rock units. Figure 1 below is an extract of the geological map showing the approximate site extent and the contained geological units.

The north western quarter of the site is underlain by the Ginninderra Porphyry member of the late Silurian age which typically comprises red porphyry with quartz, plagioclase and mafic phenocrysts and rare k – feldspar megacrysts.

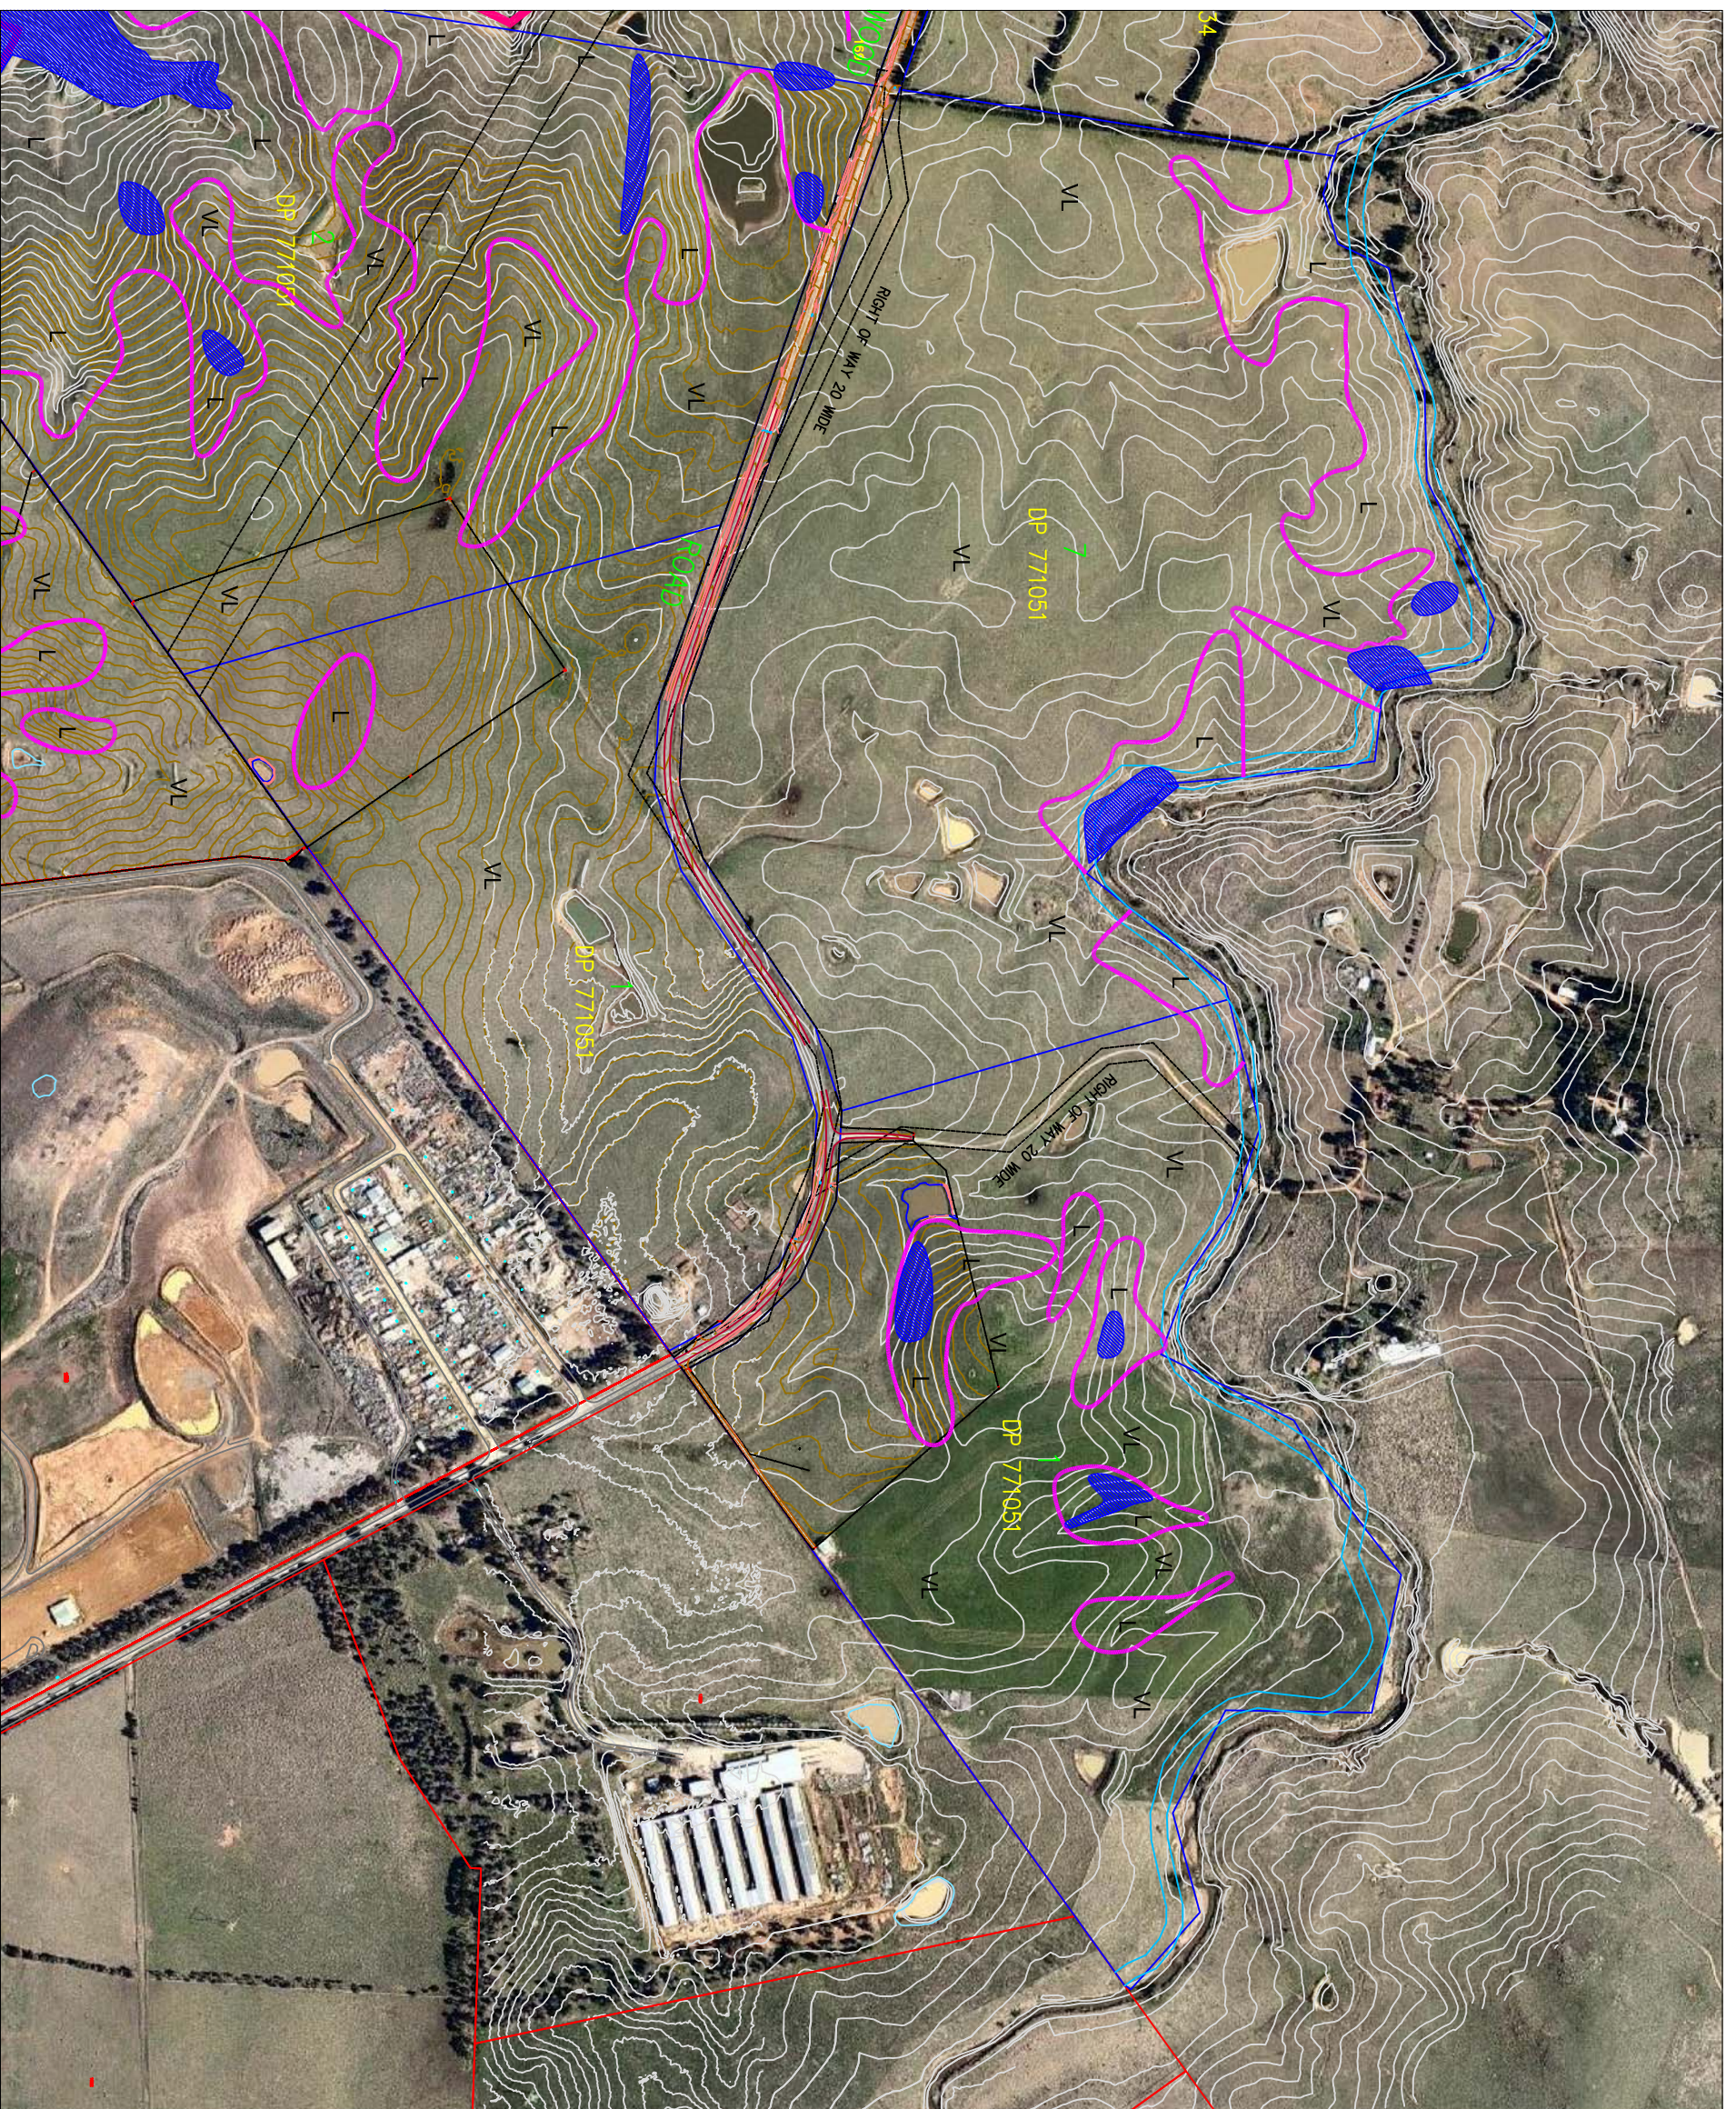
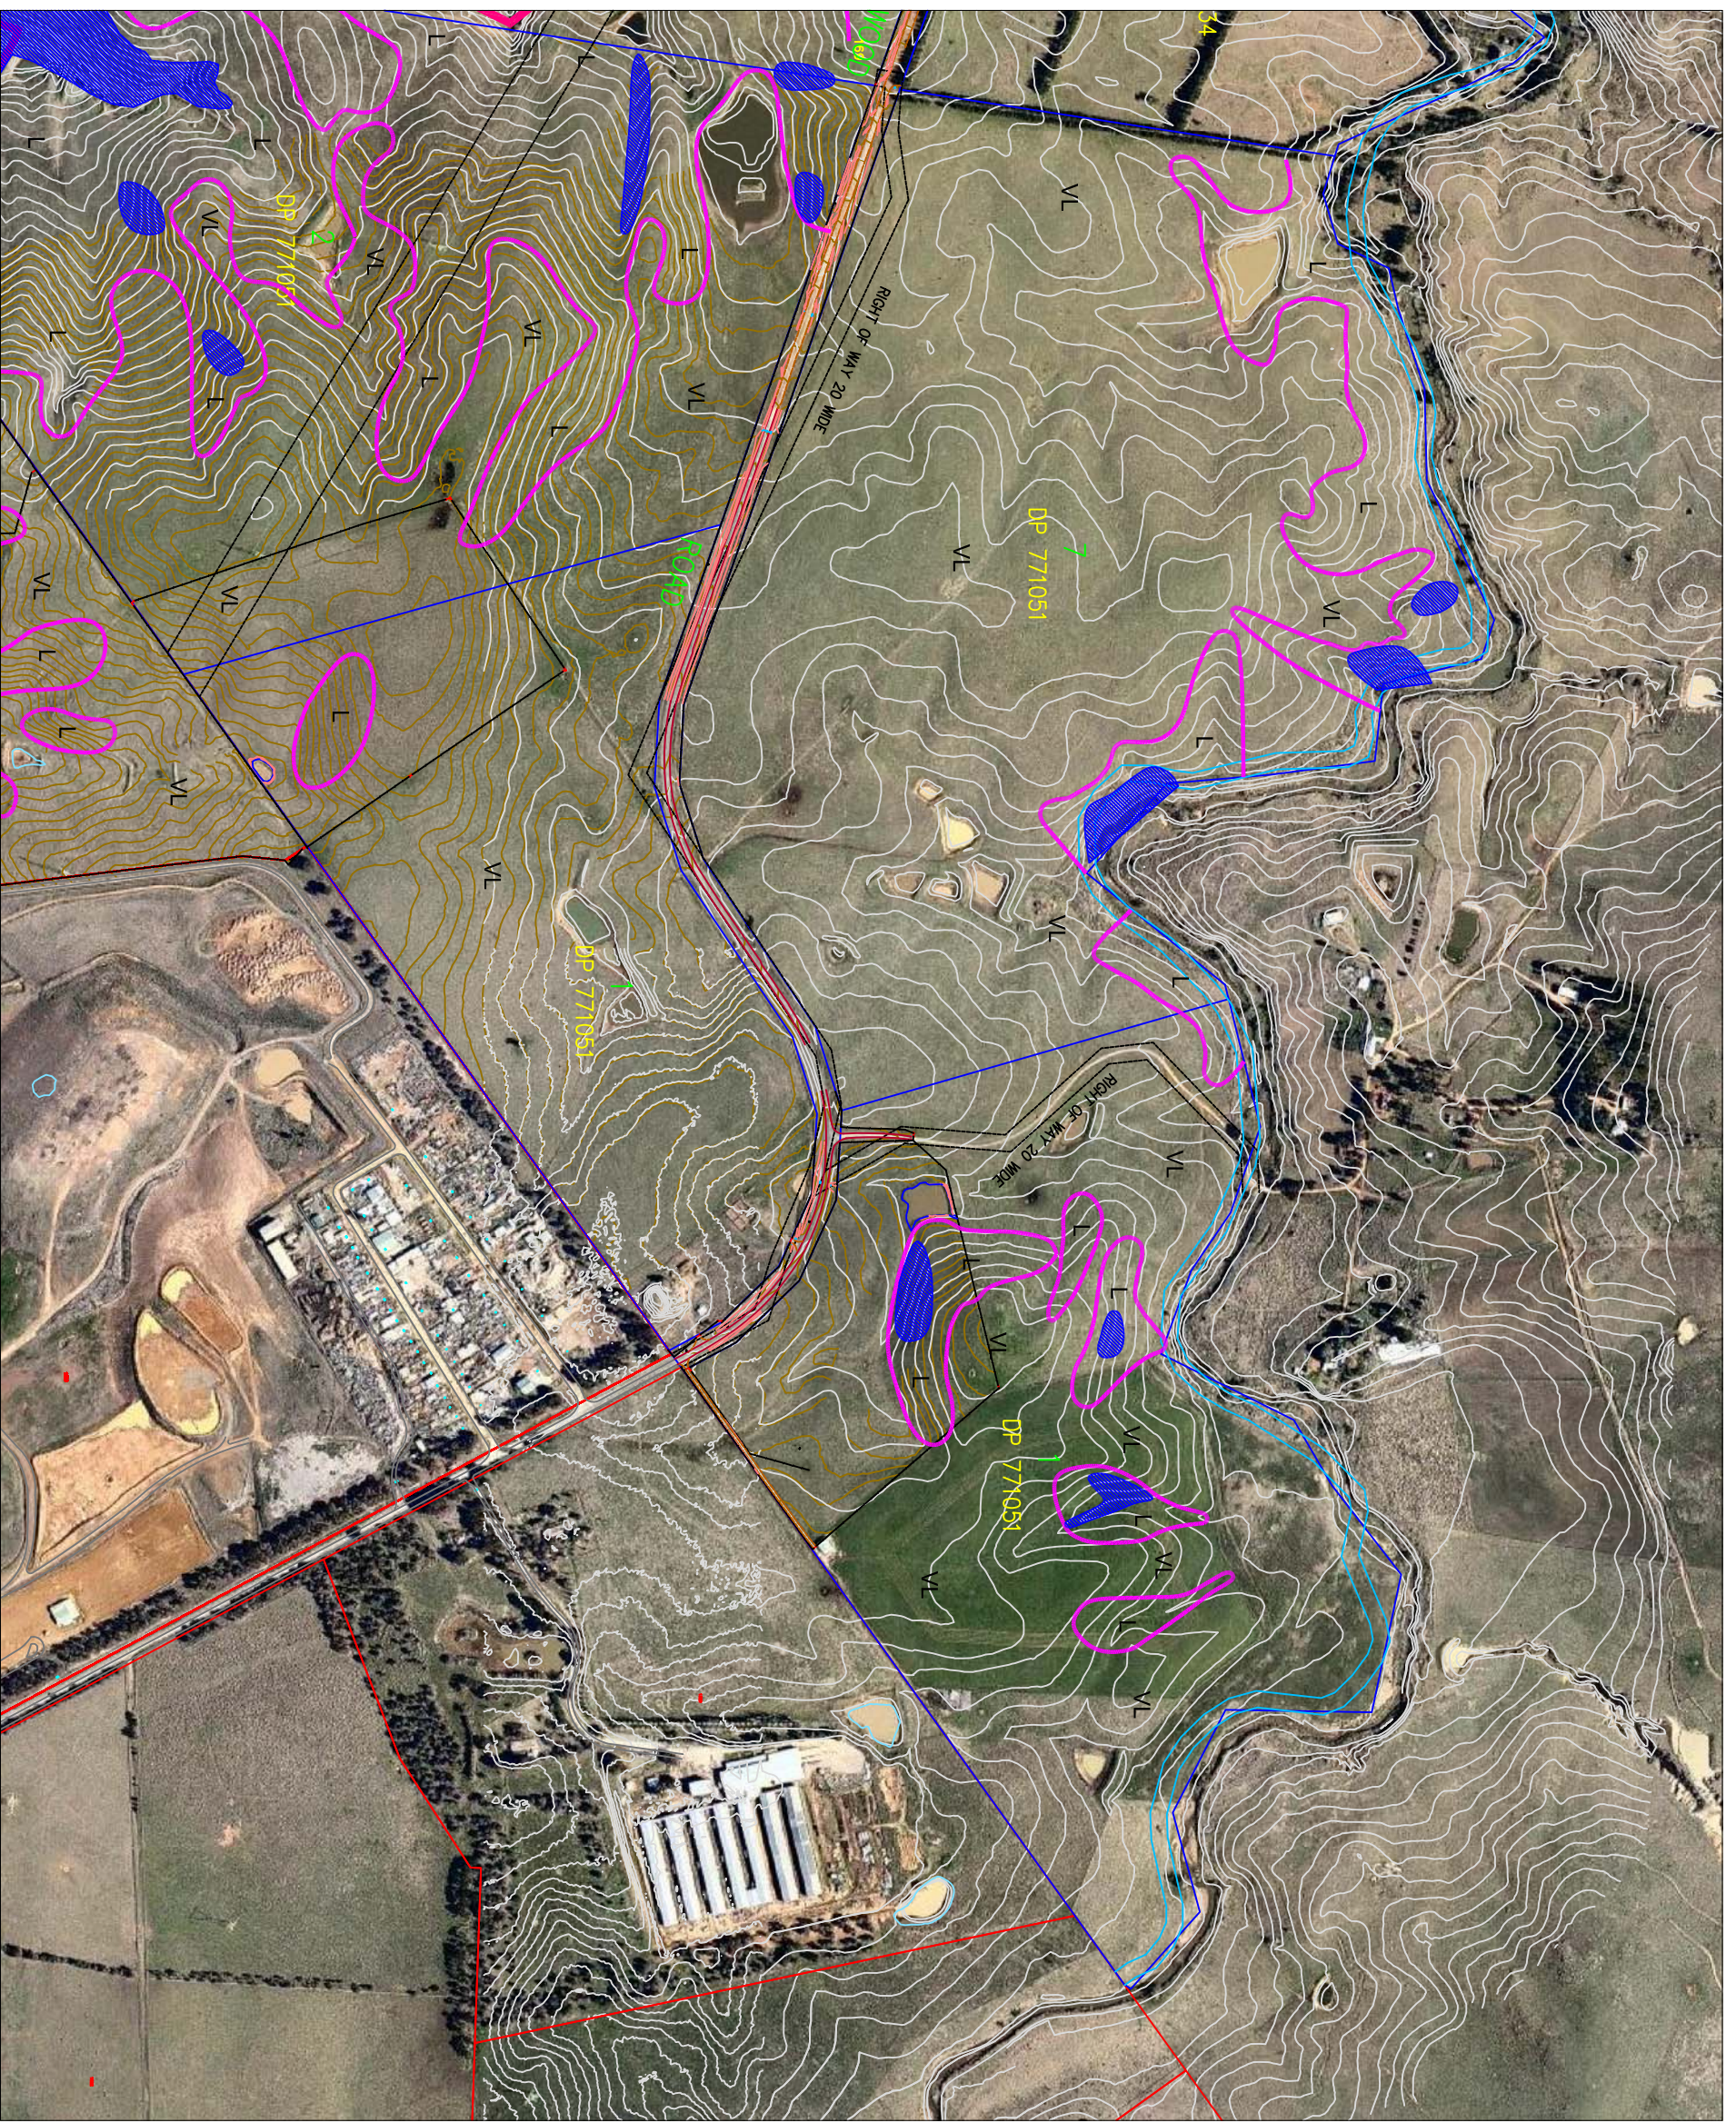
PROJECT No: 77356  
 DRAWING No: 5  
 REVISION: 0

In summary, it is considered that most of the site is classified as very low or low risk of damage to property occurring as a result of slope instability. Several areas are considered of moderate or high risk (refer Drawings 5 and 6) of causing property damage due to the steep ground slopes and possible unsuitable design and construction practice.

**Stability:** Several areas (refer Drawings 5 and 6) have been assessed as having a potential moderate to high risk of damage to property from land instability.

Areas of steeply sloping land (moderate and high risk) are not recommended for residential development at this stage. A detailed site stability assessment including subsurface investigations must be undertaken in these areas to establish an appropriate site model for analysis purposes to assess whether development is feasible in the high risk zones.

At this stage without subsurface investigations, development within the high risk areas are not recommended. A comprehensive site stability assessment will be required if development in those areas are proposed.
