PREPARED FOR RIVERVIEW GROUP
MAY 2015
C13080-01D
ORIGINAL
CIVILWATER&ENVIRONMENT

WEST BELCONNEN DEVELOPMENT Phase 2 – Stream Strategies

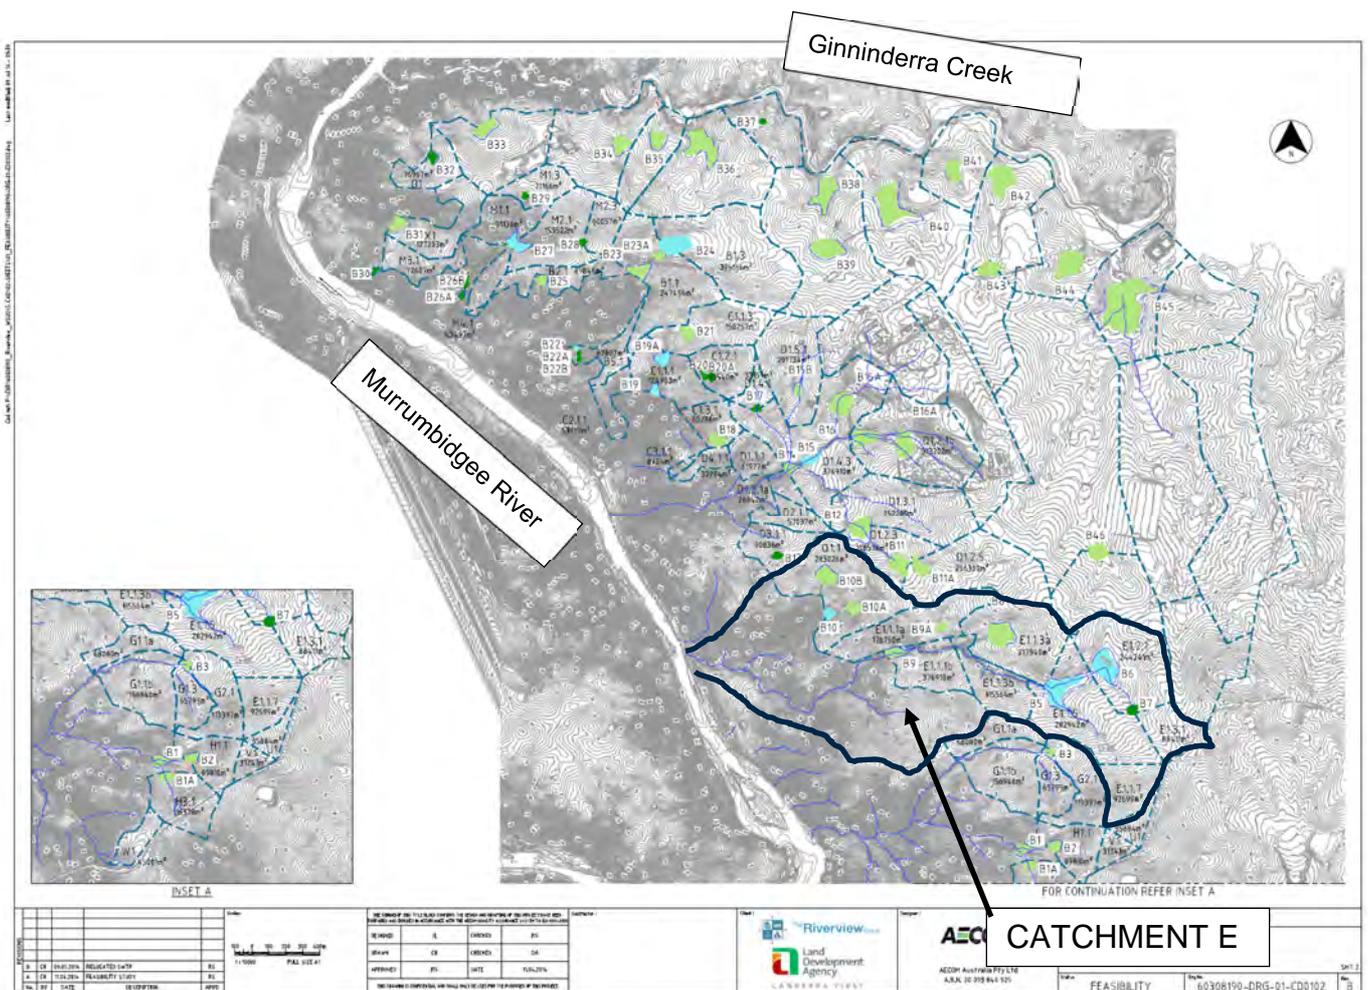
Figure 2-1: Locality Plan

The following plan prepared by AECOM shows the catchments across the West Belconnen development area inclusive of Catchment E. The stream under investigation in this report is the main stream located within Catchment E and has previously been commonly referred to as Stream E and this terminology will be utilised throughout this report to ensure consistency amongst the various reports and investigations undertaken on this stream. Refer to a copy of this plan in **Appendix A**.

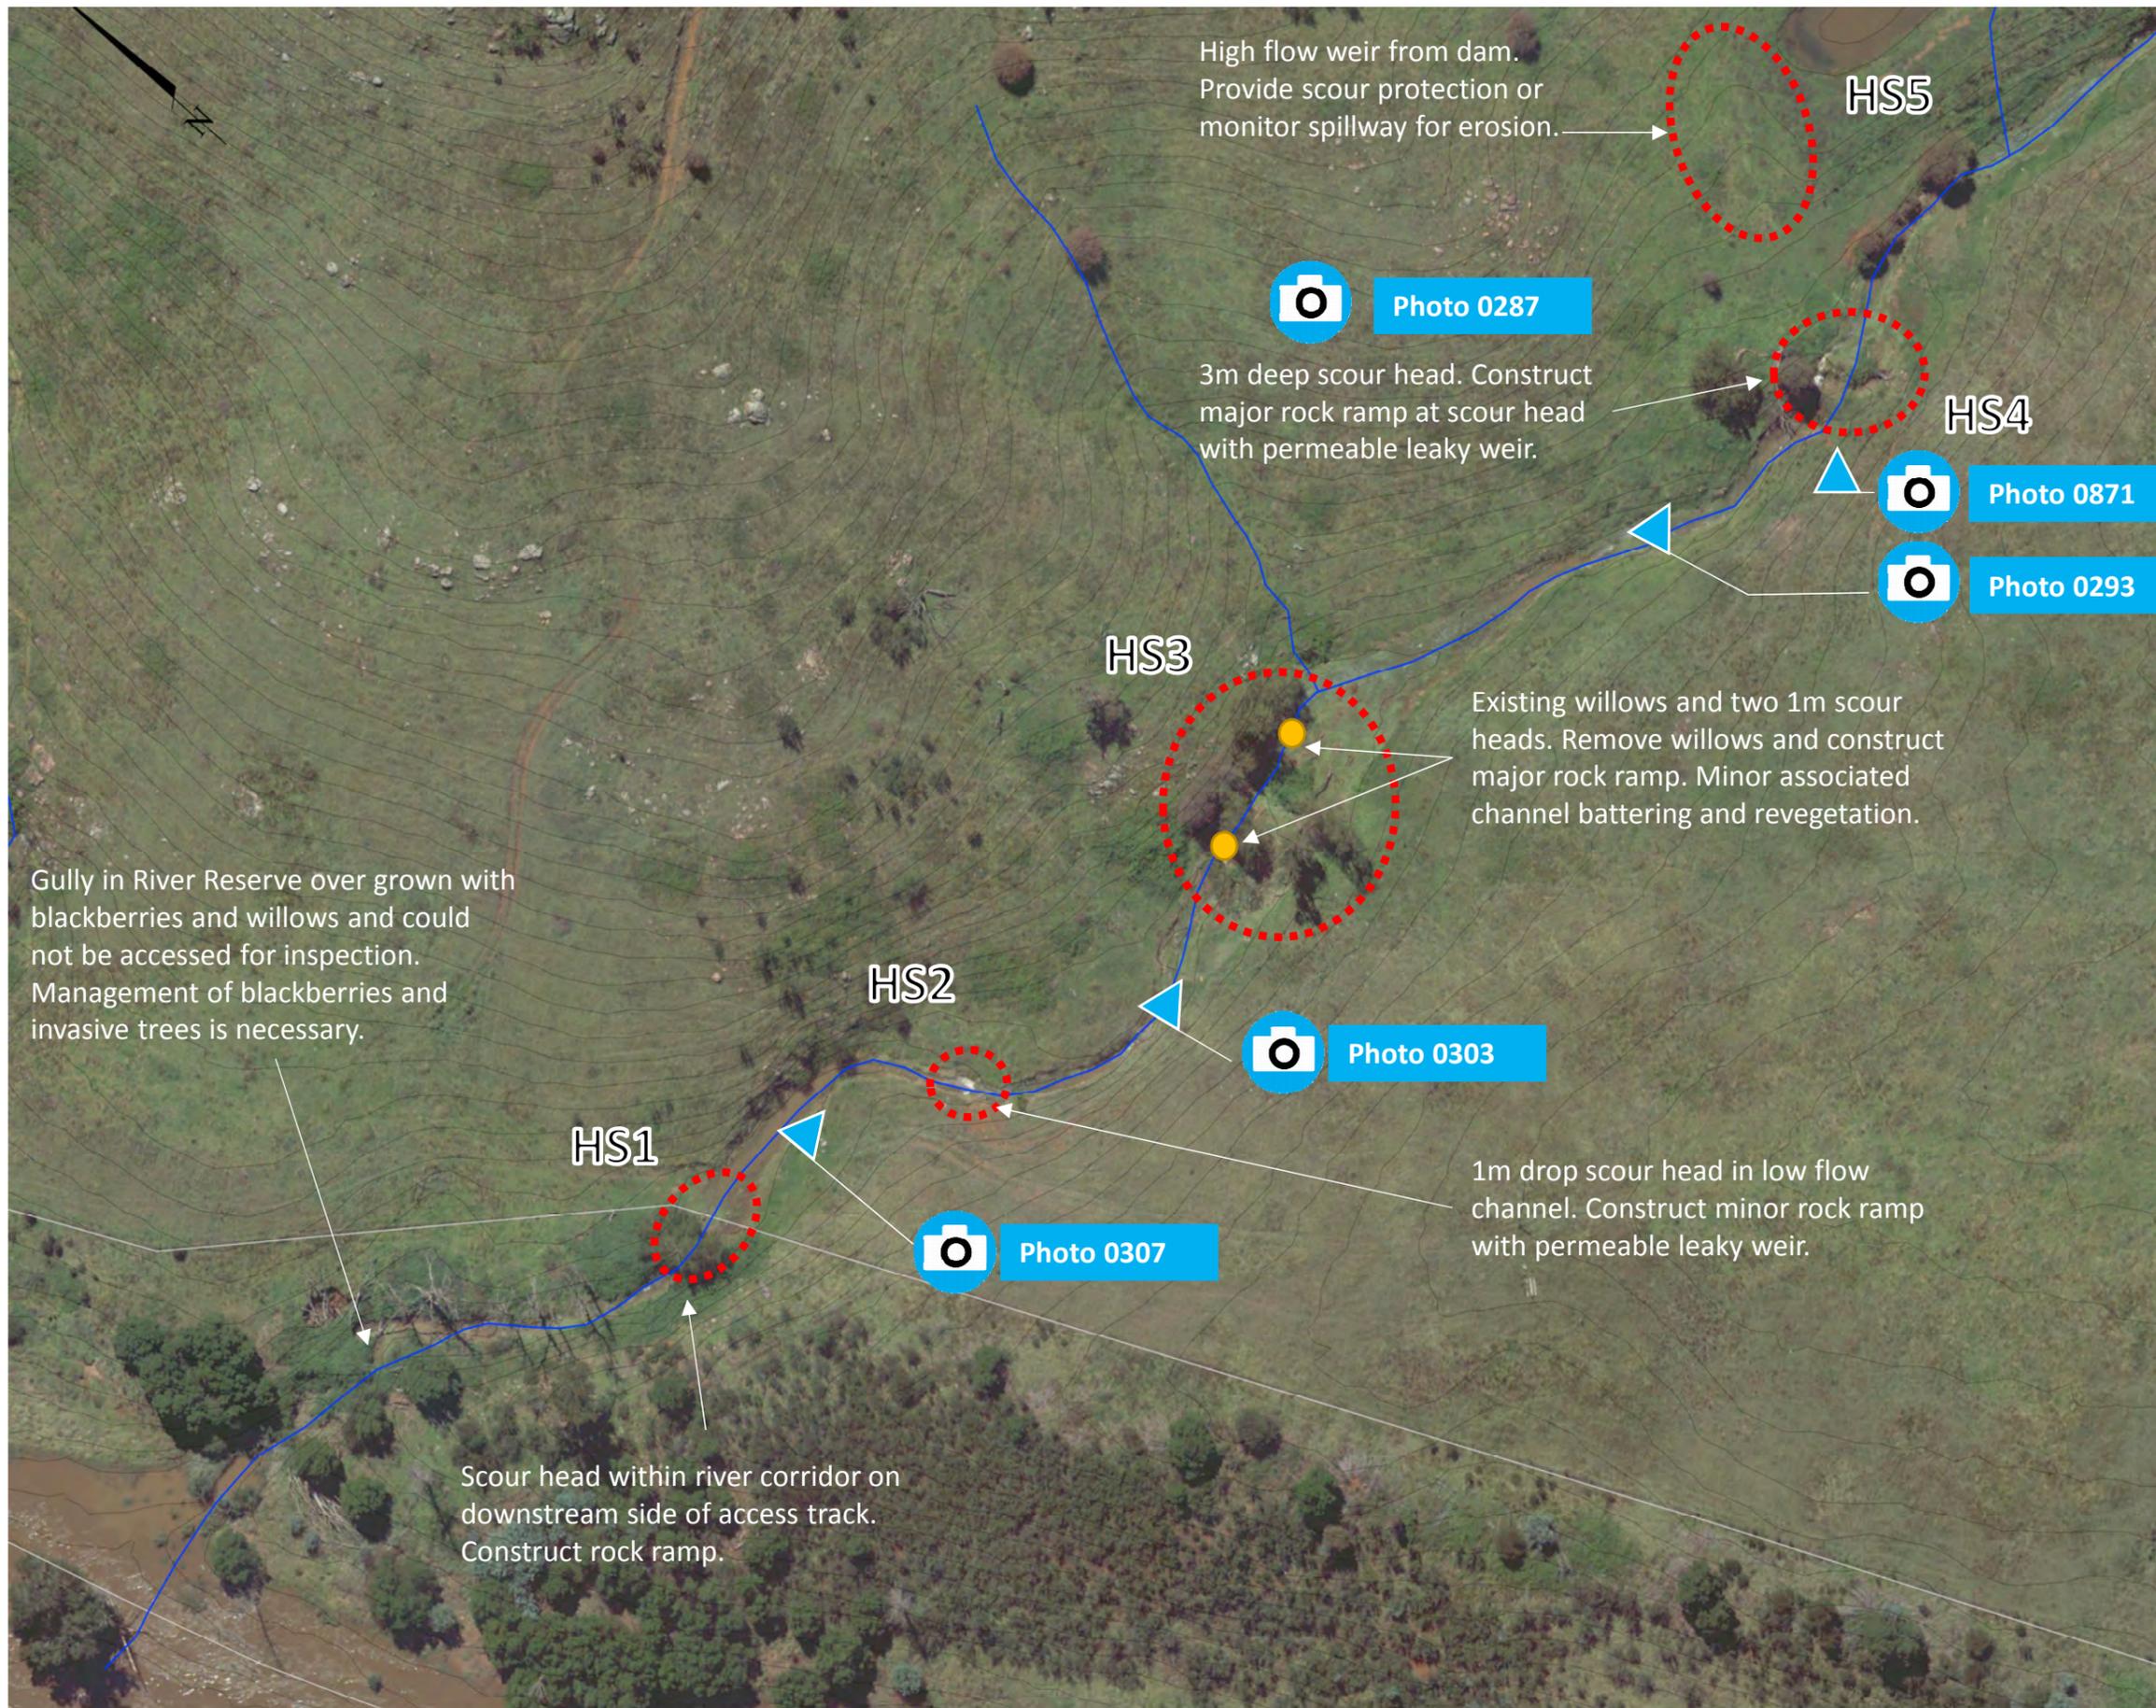
- General Notes for Sheet 1**
- Gully Area:**
1. Gully has stable vegetation (e.g. Photo 0293).
 2. Flat longitudinal grade of channel with long pools.
 3. Non-dispersive soils.
 4. Lots of rock and existing bed control structure (rock)
 5. Scour in gully limited to four hotspots (HS1 to HS4).
 6. Limited gully works proposed for stabilisation.
 7. Minimal intervention recommended.
 8. All works proposed subject to survey and detailed design.

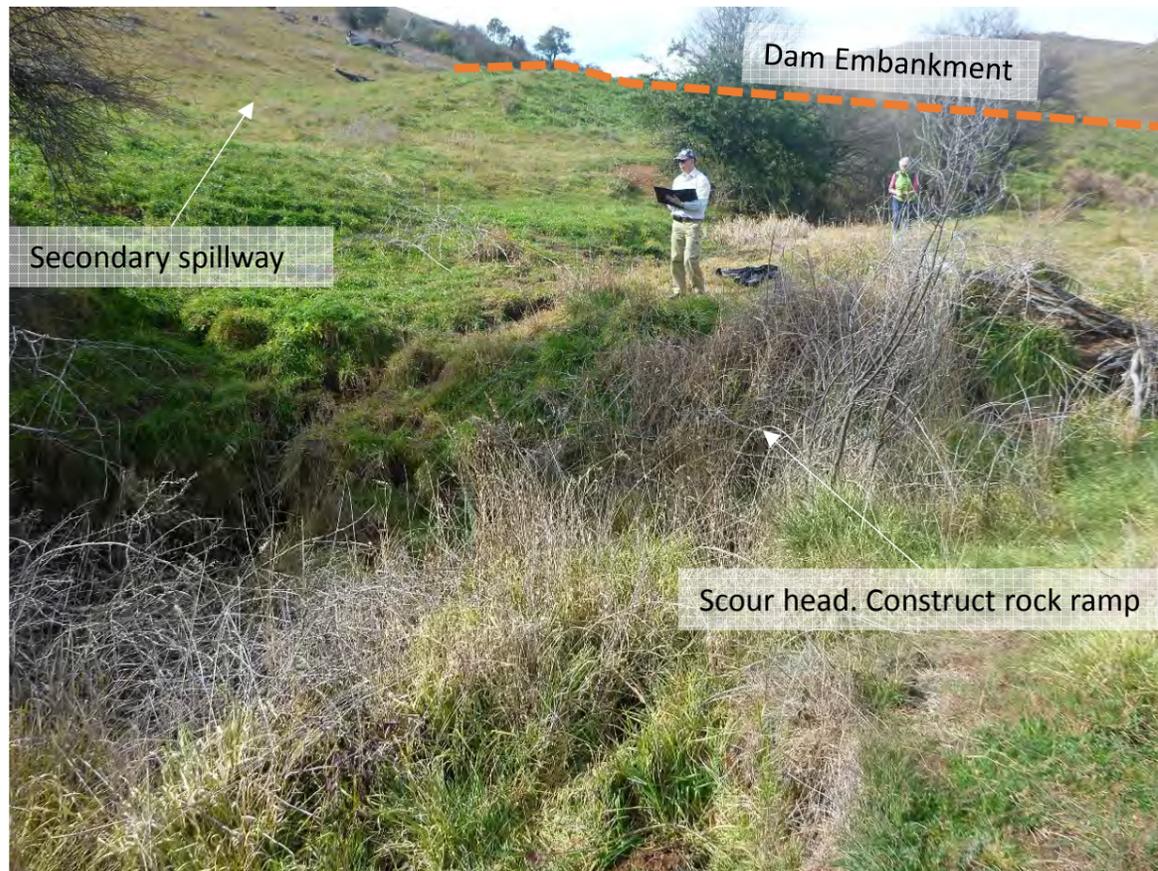
Photo 0871- Dam high flow weir outfall

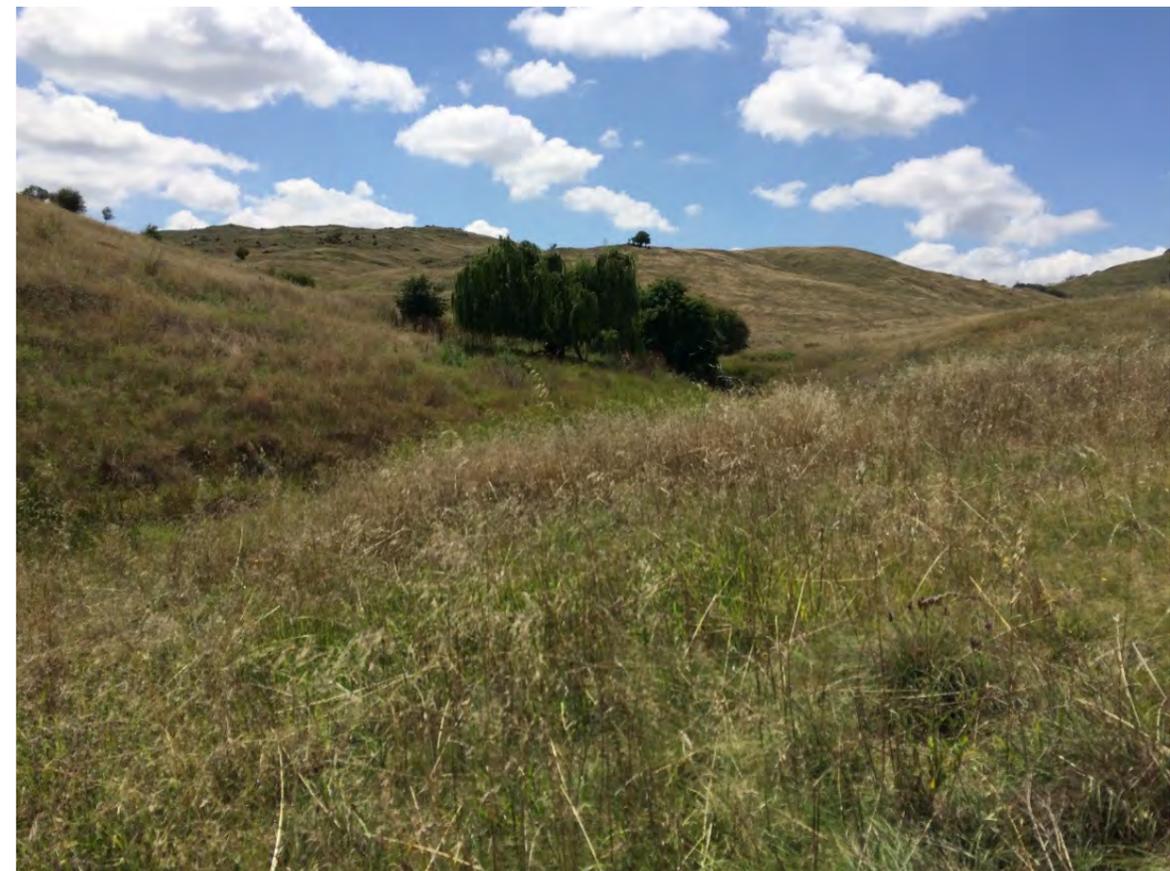
Photo 0293 – Existing stable vegetated gully

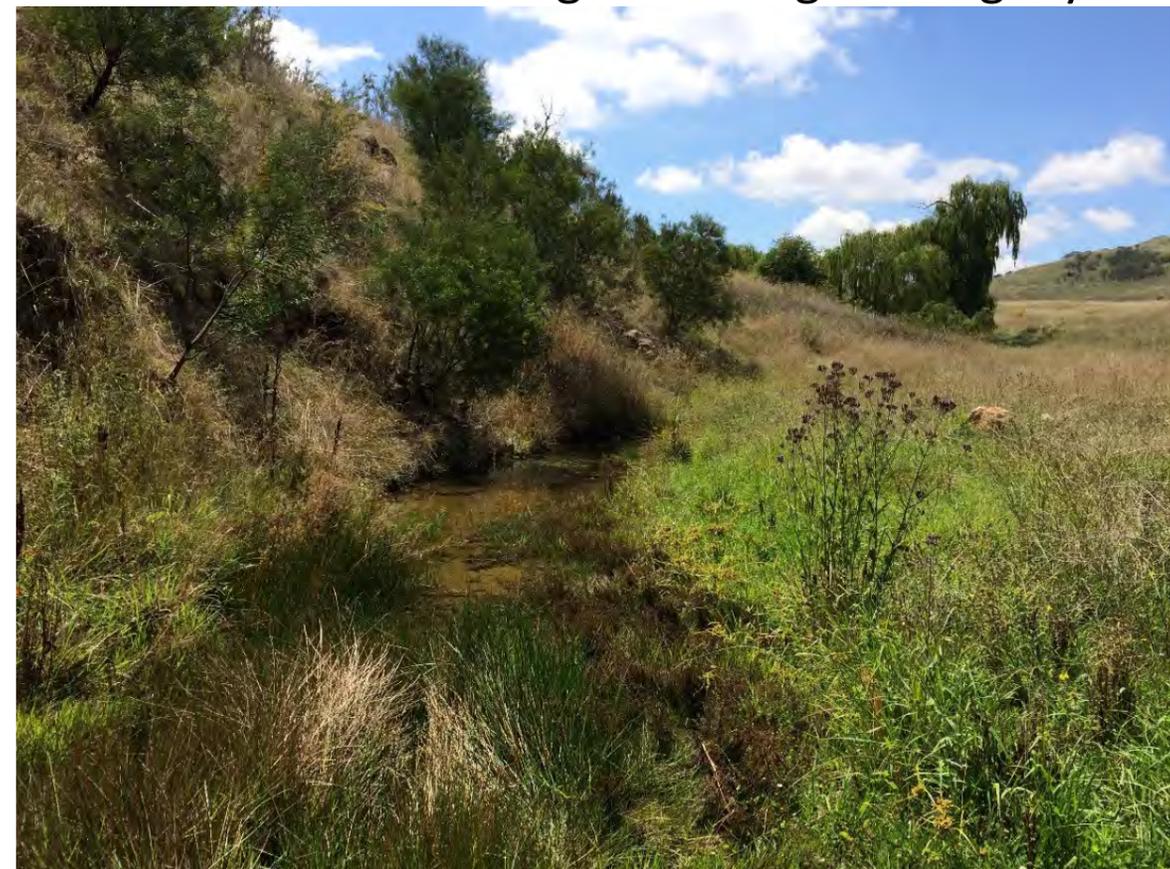
Photo 0307 – Existing pool and stable vegetated gully

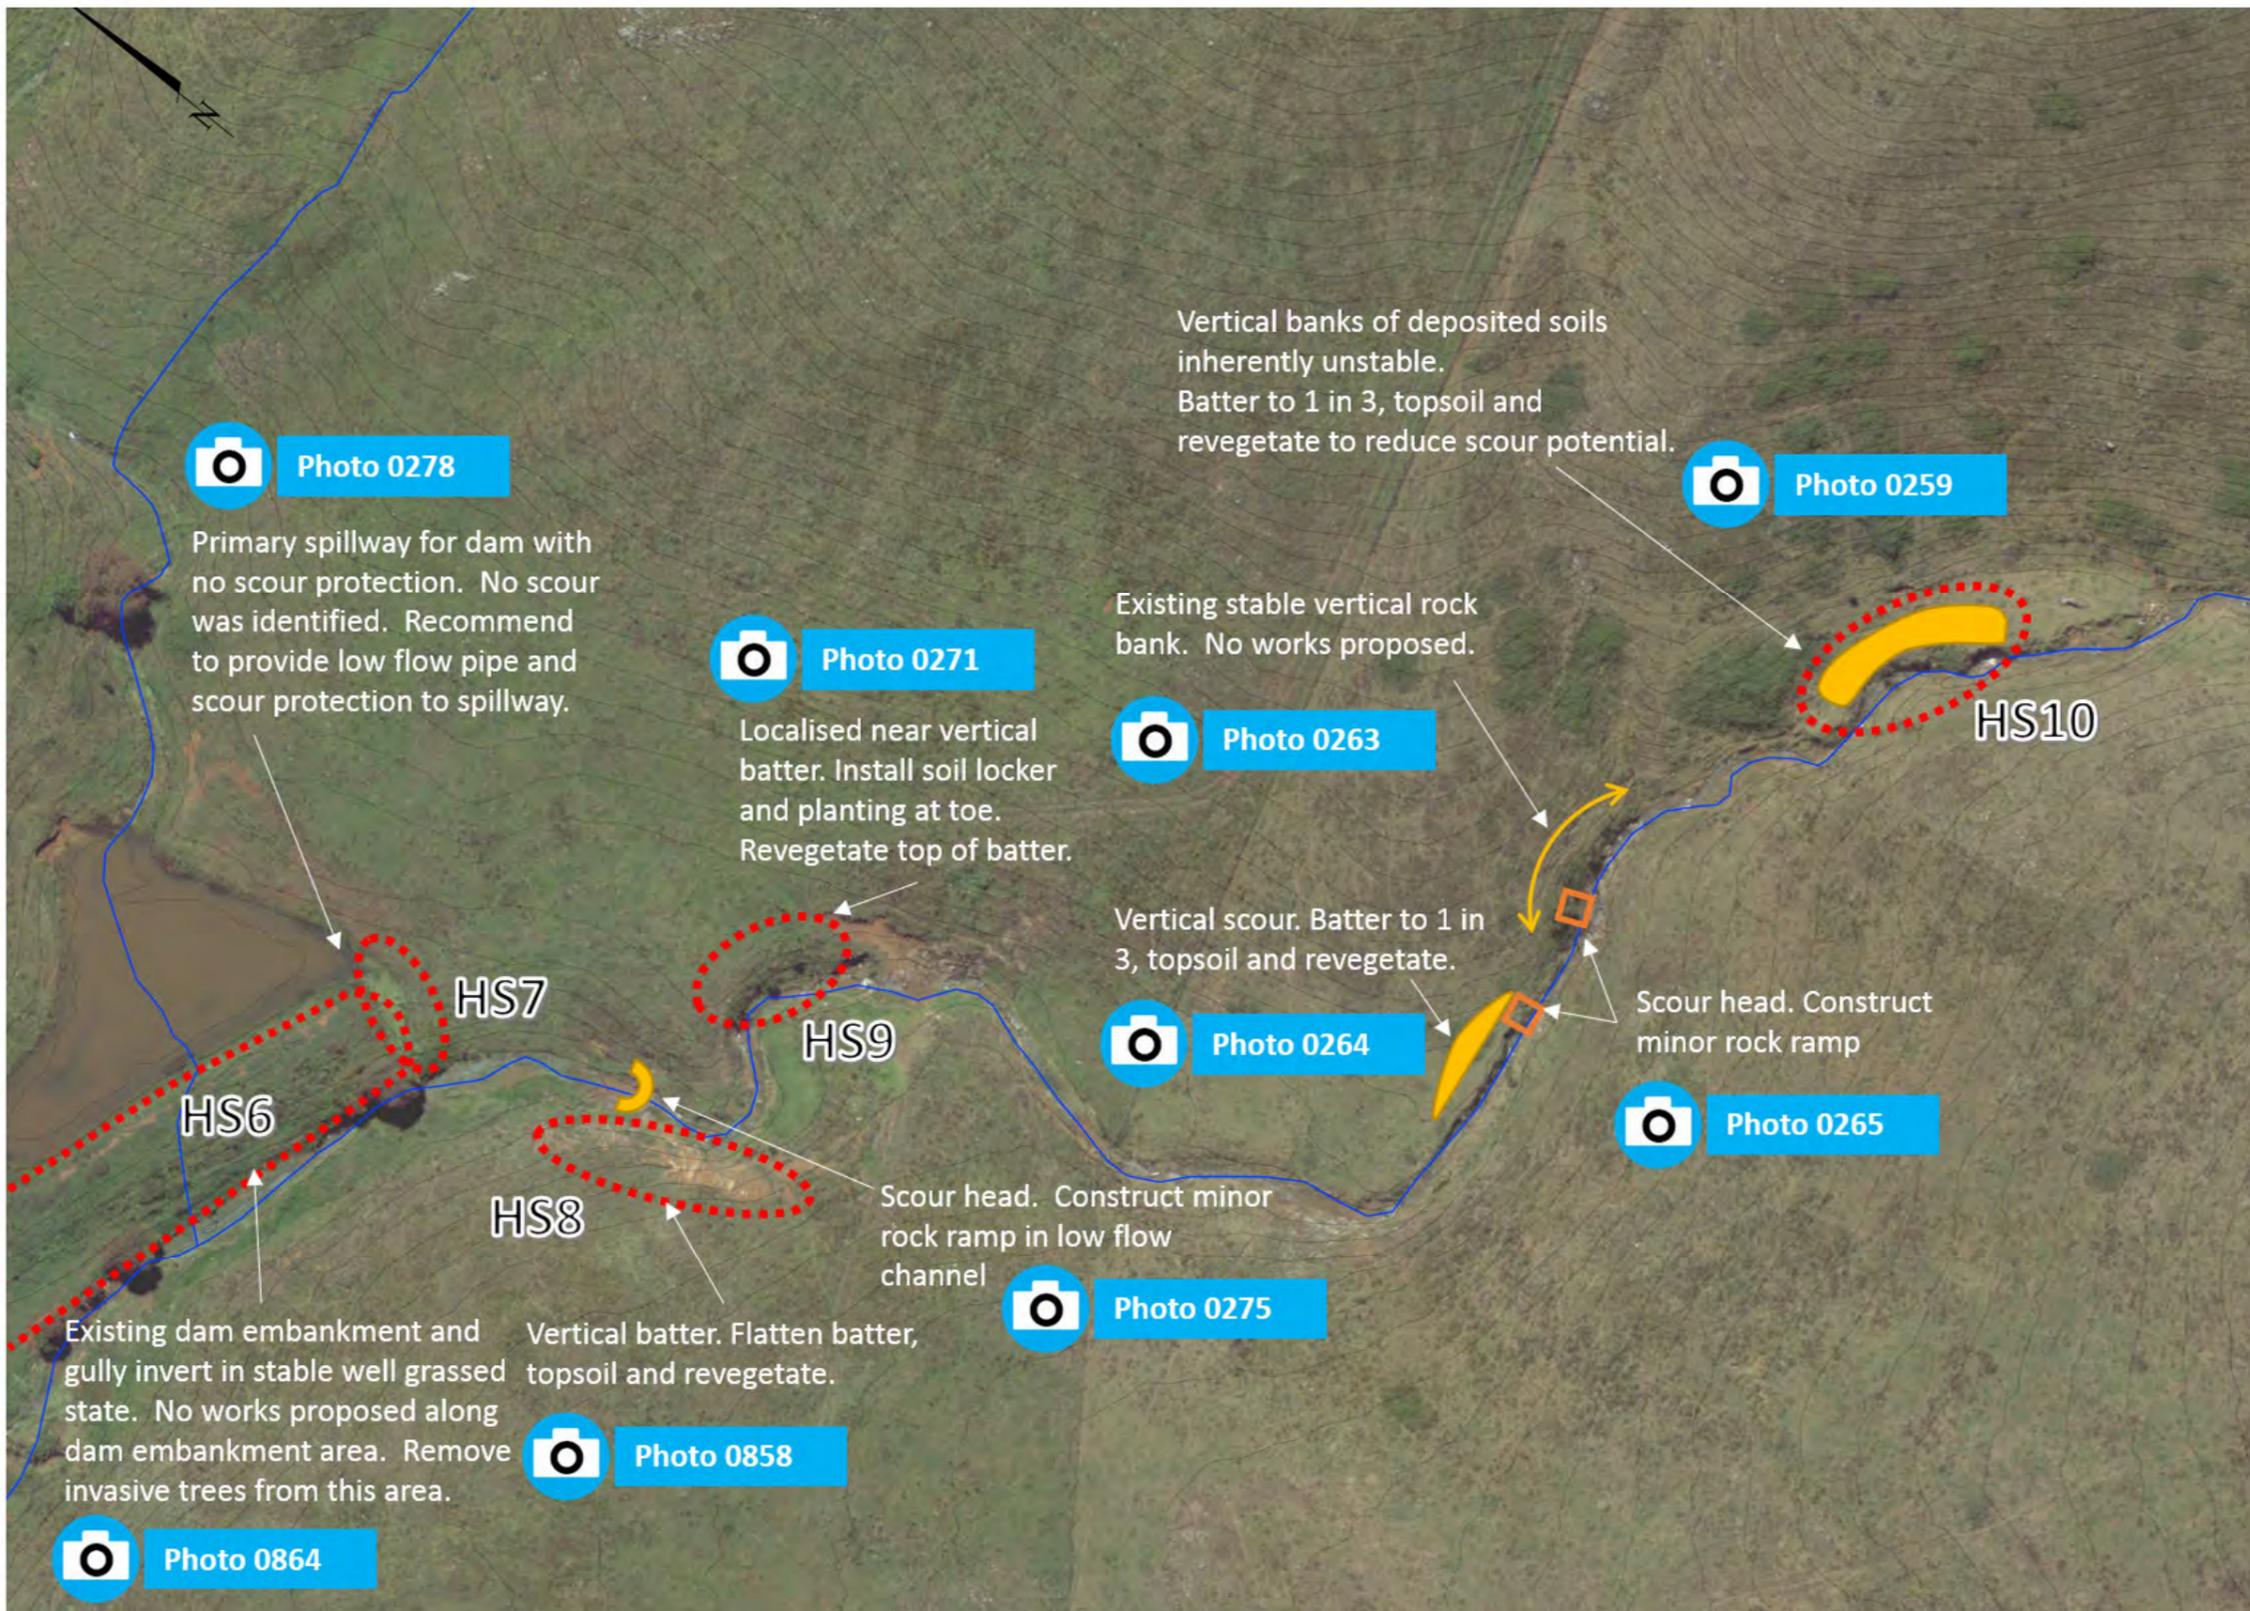
1. Gully has many natural bedrock weirs and invert along this reach.
2. Batters typically stable and well vegetated except where indicated.
3. Non-dispersive soil.
4. Areas of deep sediment deposits which have vertical eroded batters to be stabilised.
5. Flat longitudinal grade of channel with bedrock controlled steps and long pools.
6. Extensive phragmites plants between HS10 and HS13, providing soil stabilisation.
7. All works proposed subject to survey and detailed design.

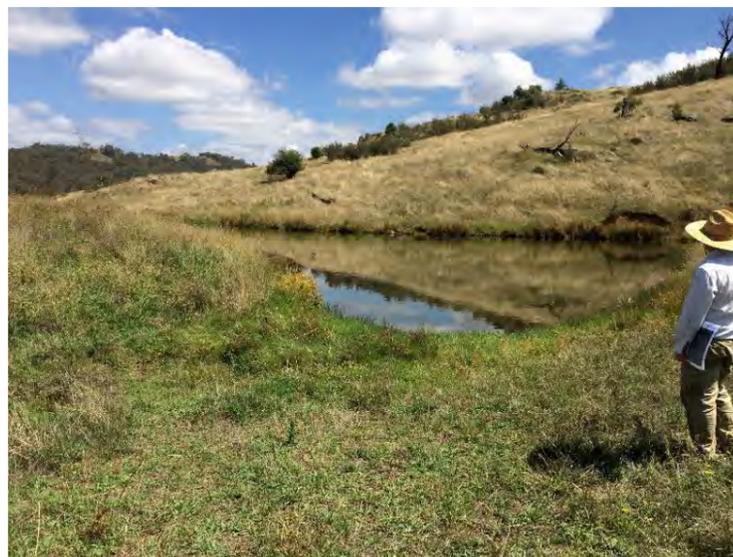
Photo 0278 - Grassed dam spillway

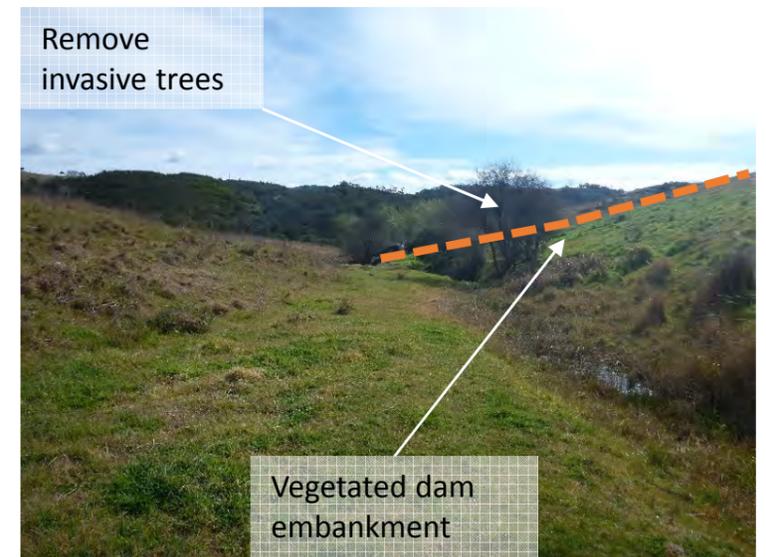
Photo 0864 - Stable vegetated gully adjacent dam

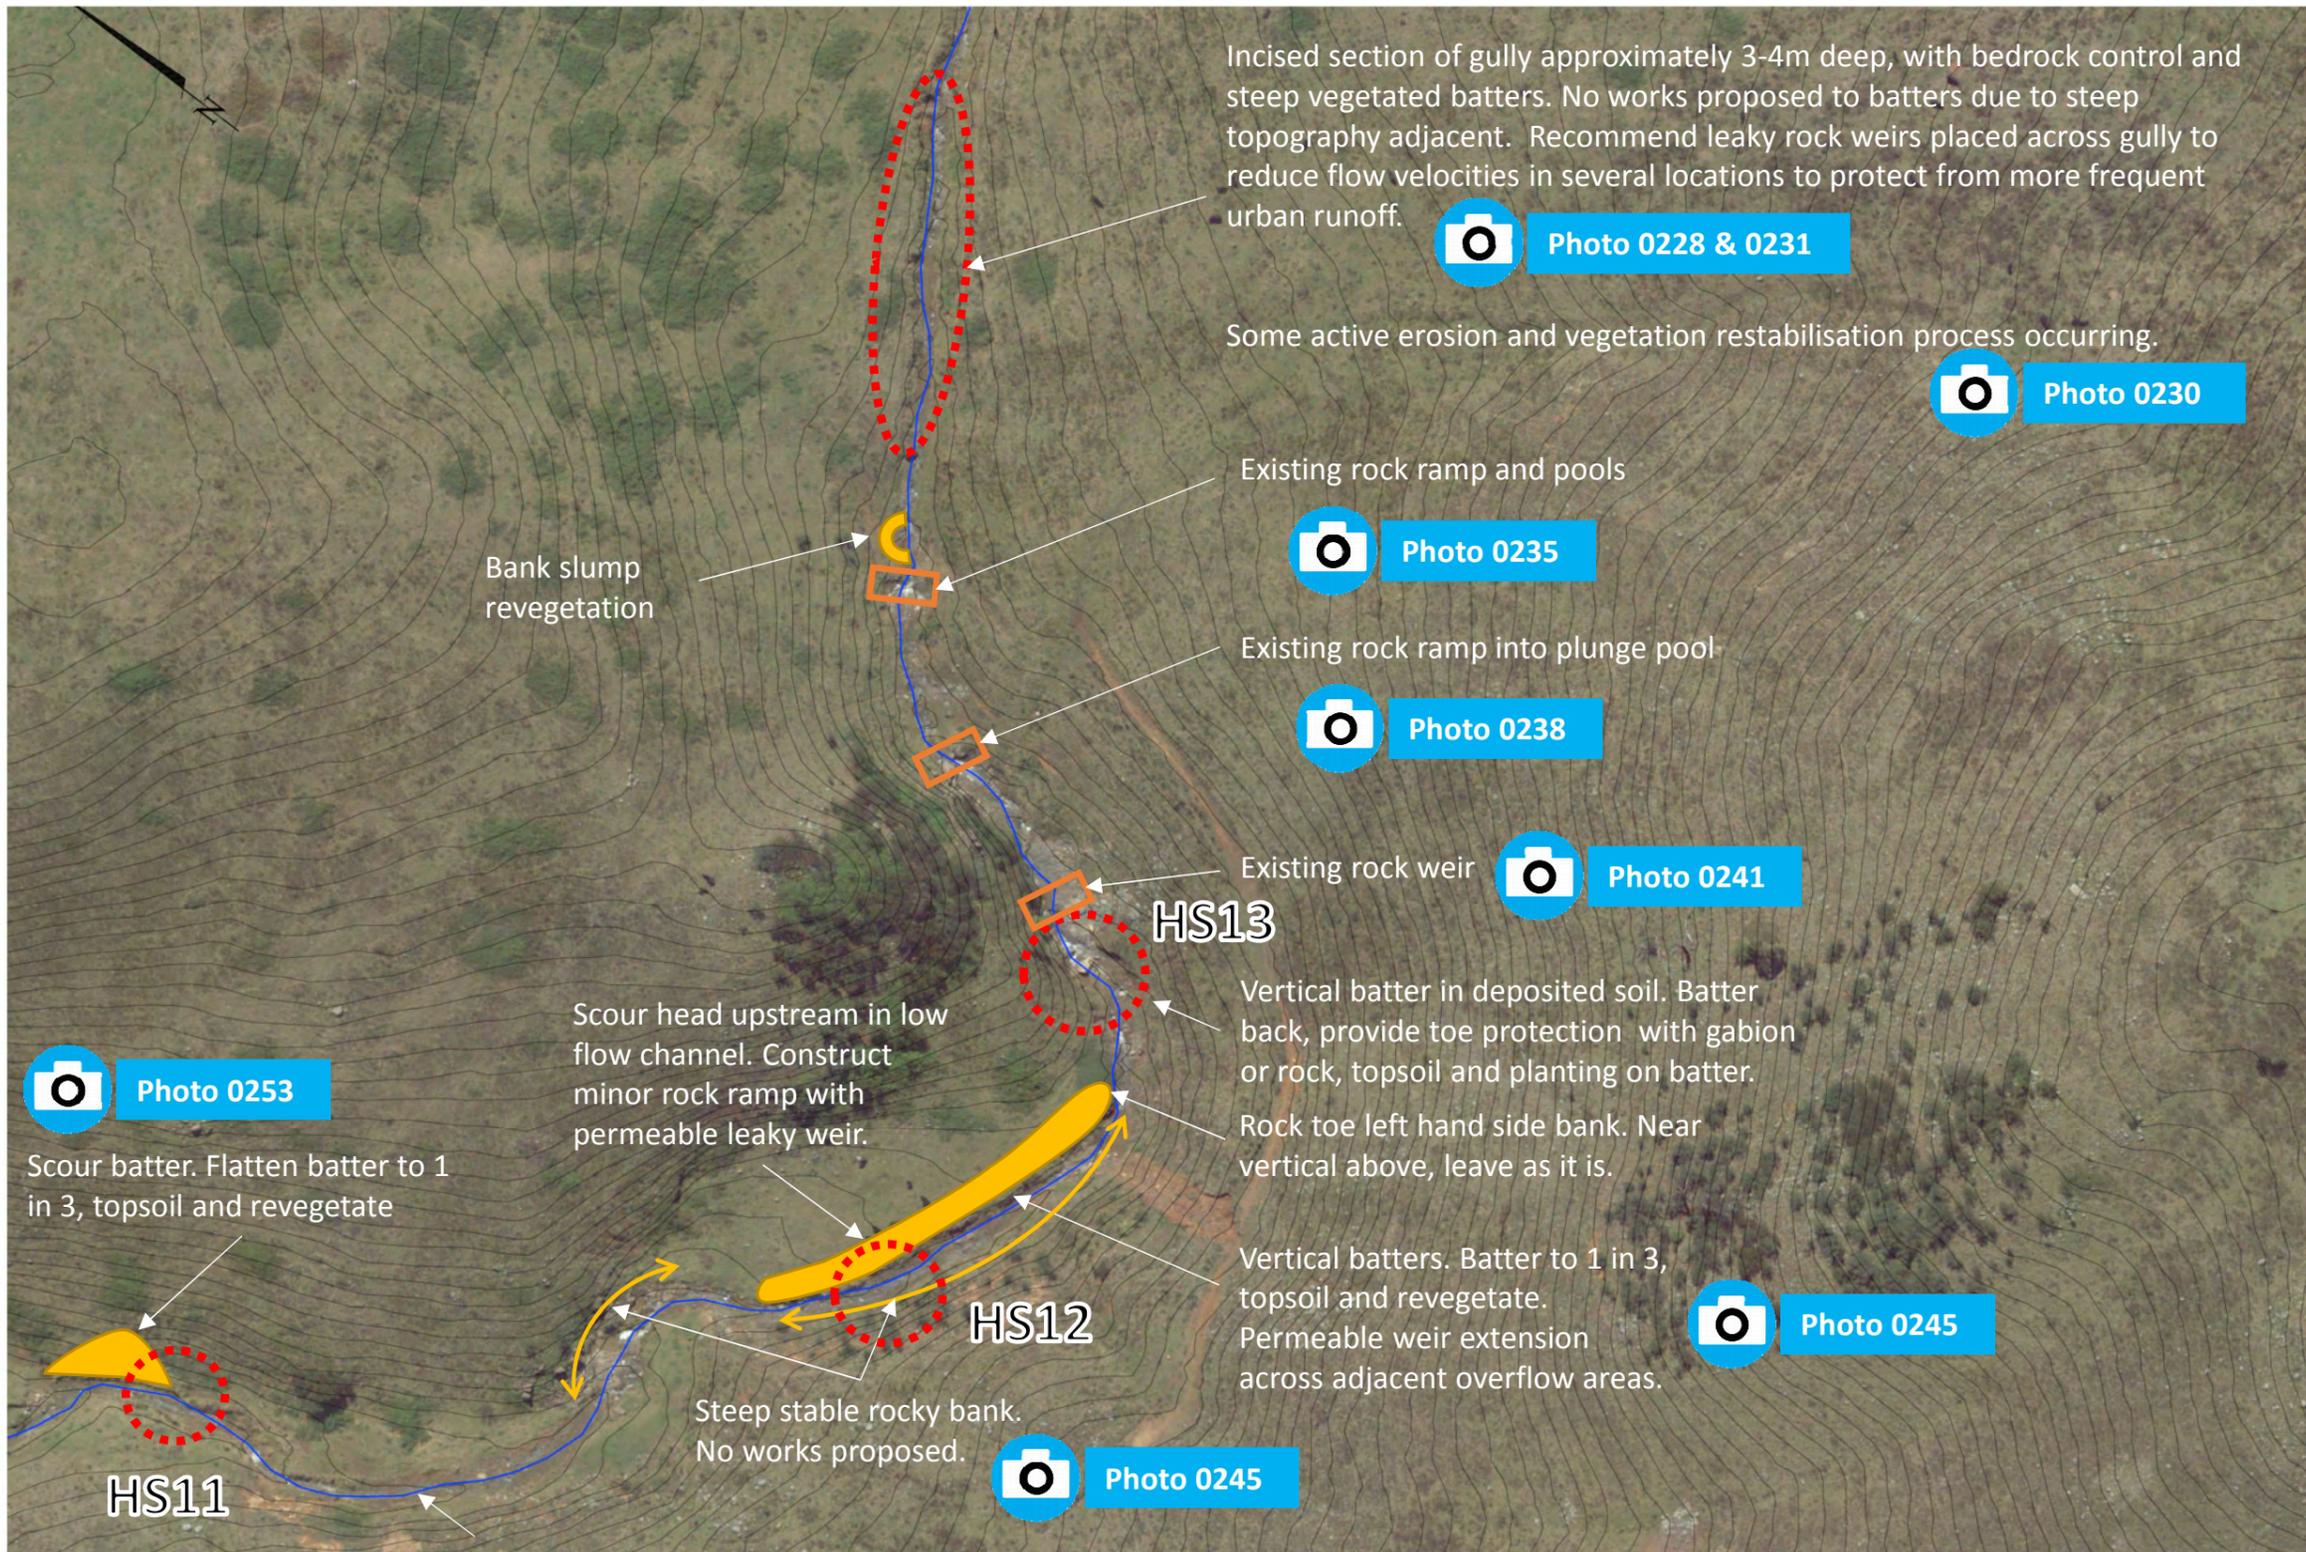
1. Flatter longitudinal grades downstream of HS13 with rock steps and long pools.
2. Batters are typically stable downstream of HS13 except where indicated.
3. Extensive phragmites plants between HS10 to HS13.
4. Steep grade and bedrock controlled upstream of HS13. No protection works proposed except where indicated. Batters have good vegetation cover.
5. All works proposed subject to survey and detailed design.

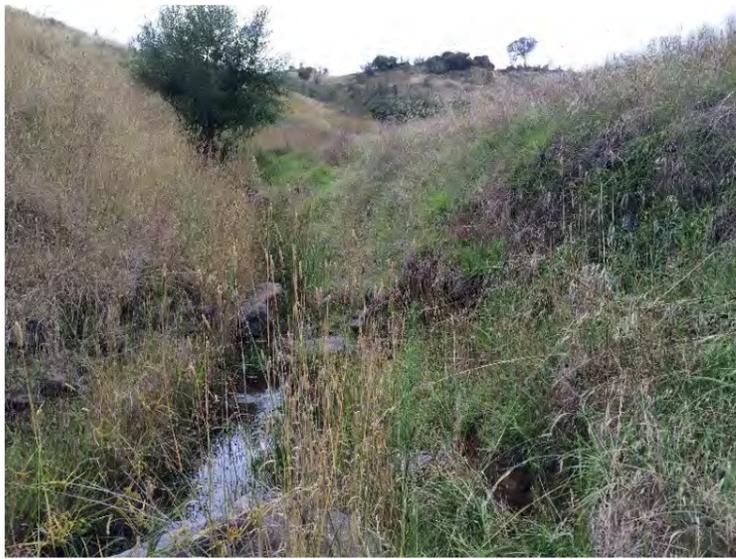
Photo 0228 – Bedrock controlled gully with steep stable batters

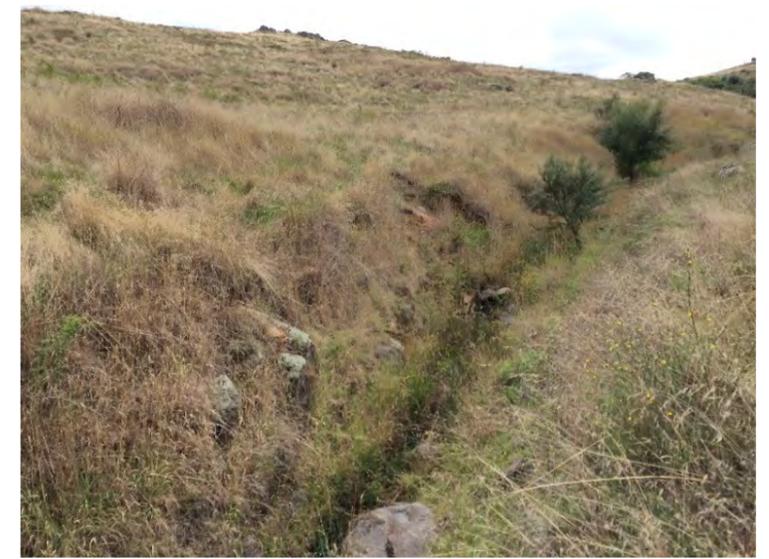
Photo 0231 – Bedrock controlled gully with steep stable batters

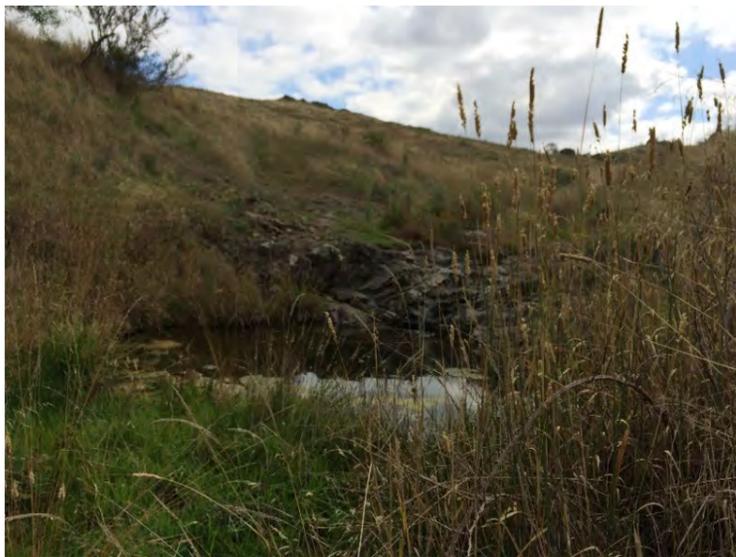
Photo 0235 – Existing rock ramp and pool

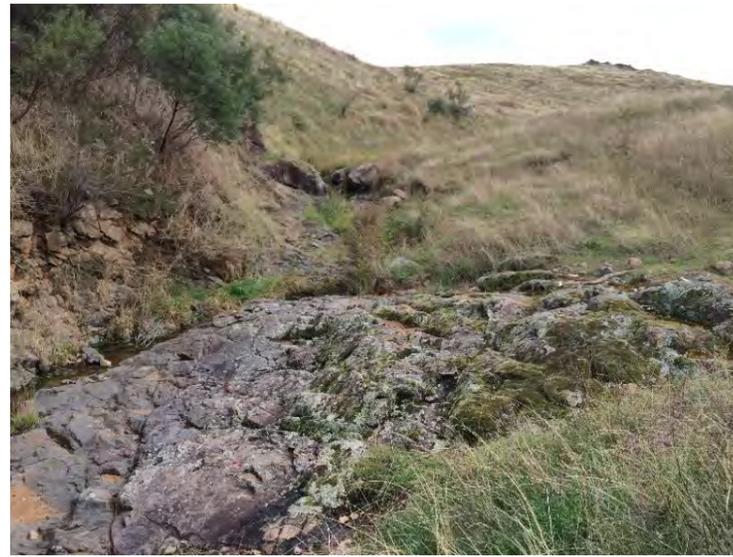
Photo 0238 – Existing rock ramp

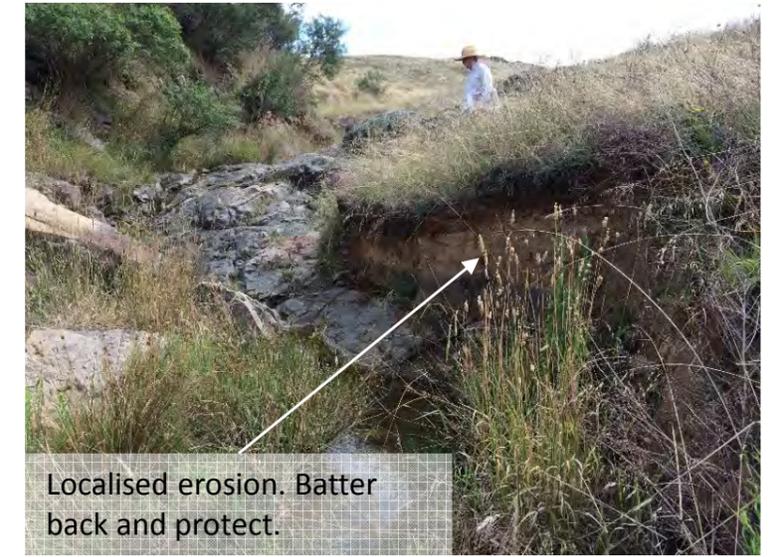
Photo 0241 – Existing rock ramp

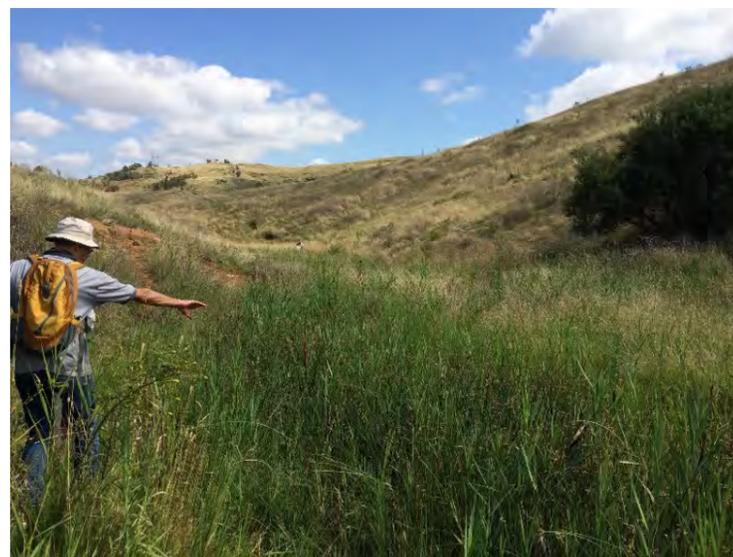
Photo 0252 – Stable gully with phragmites

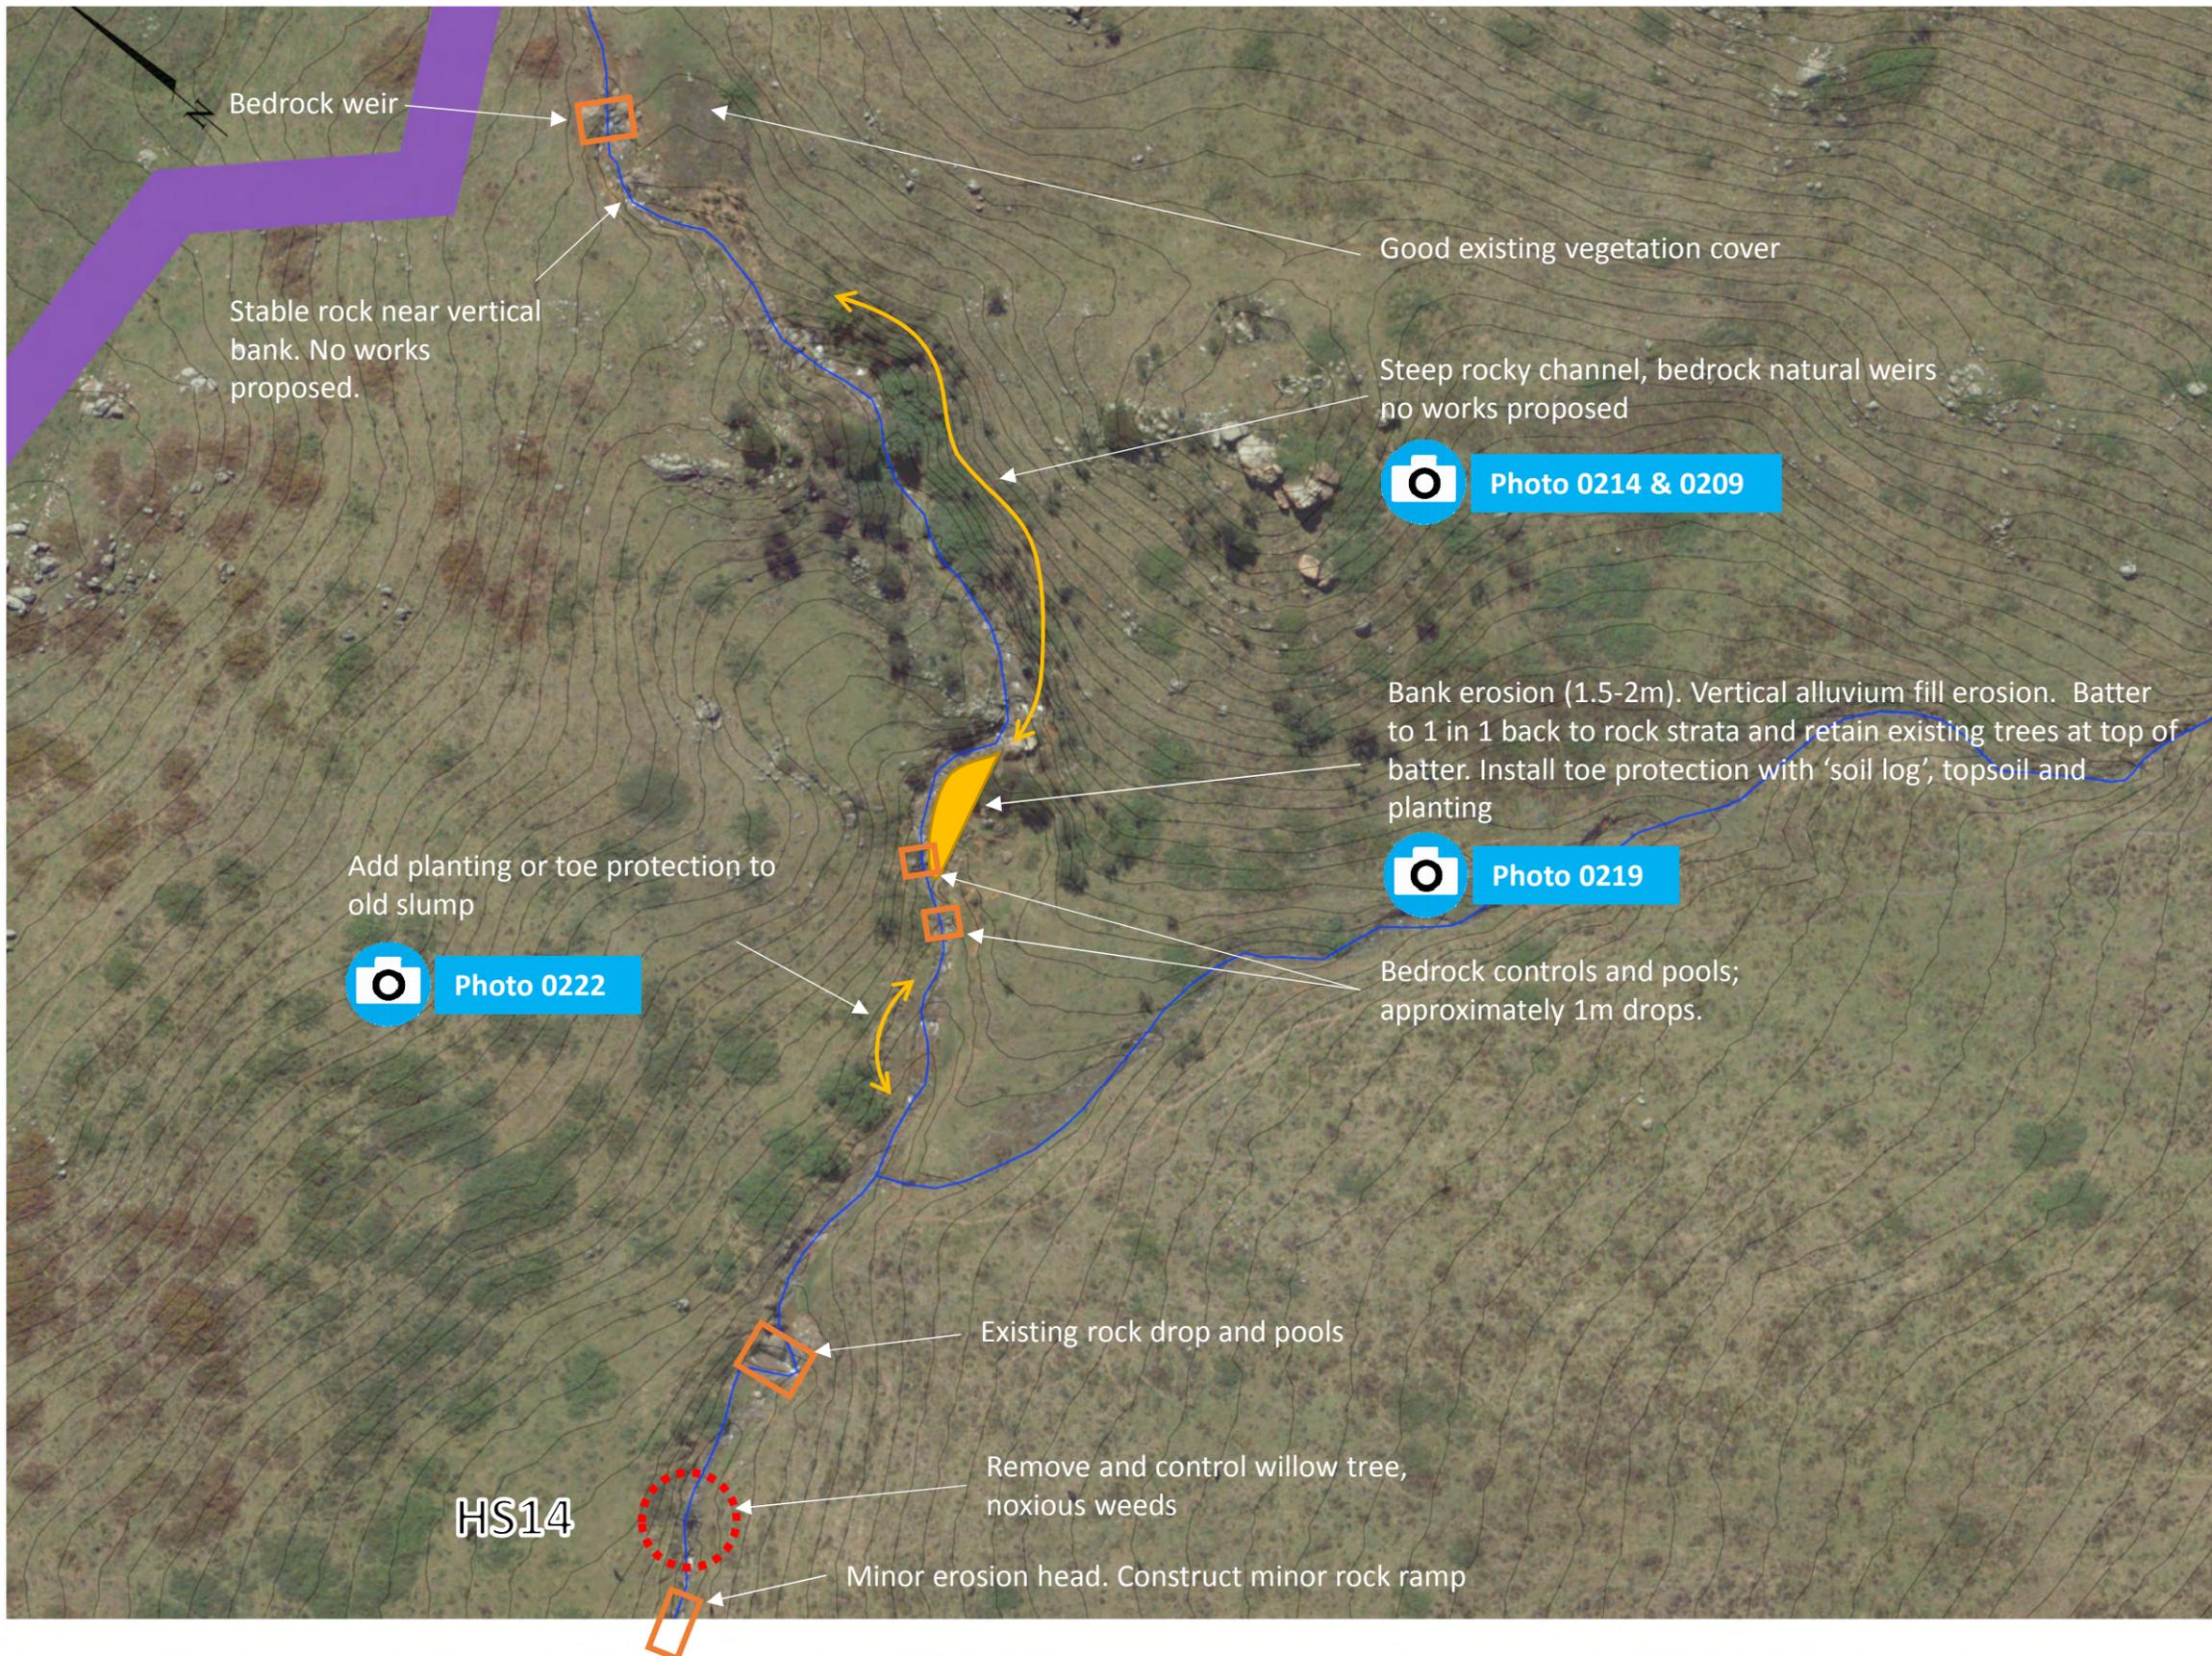
- General Notes for Sheet 7 Gully Area:**
1. Lower half of creek is flatter, consisting of natural rock drops and pools with stable grassed batters except where indicated.
 2. No works proposed except where indicated.
 3. Upper half of sheet is steep bed rock controlled channel with no works proposed.
 4. Non dispersive soil.
 5. Any earthworks to be re-topsoiled and revegetated.
 6. All works proposed subject to survey and detailed design.
