PREPARED FOR RIVERVIEW GROUP
MAY 2015
C13080-01D
ORIGINAL
CIVILWATER&ENVIRONMENT

WEST BELCONNEN DEVELOPMENT Phase 2 – Stream Strategies

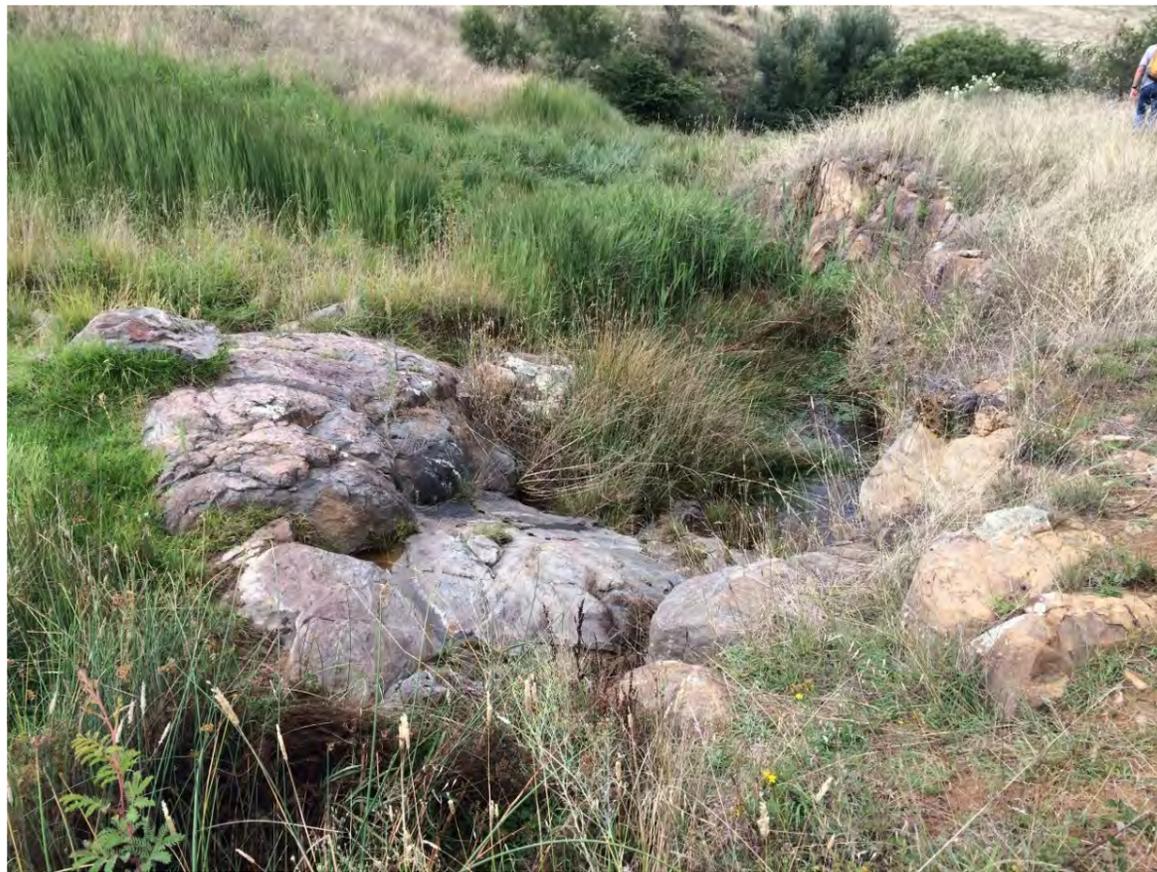
Photo 0209 – Bedrock controlled gully

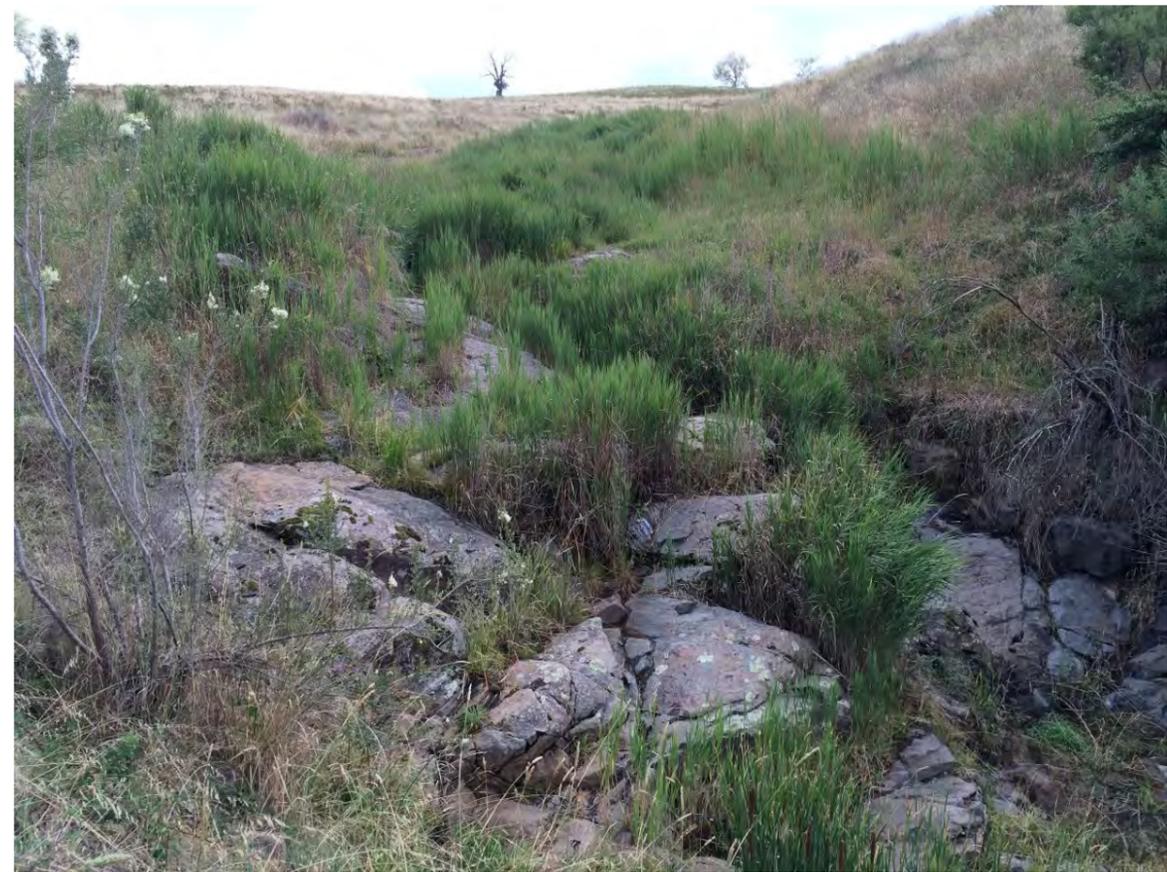
Photo 0214 – Bedrock controlled gully

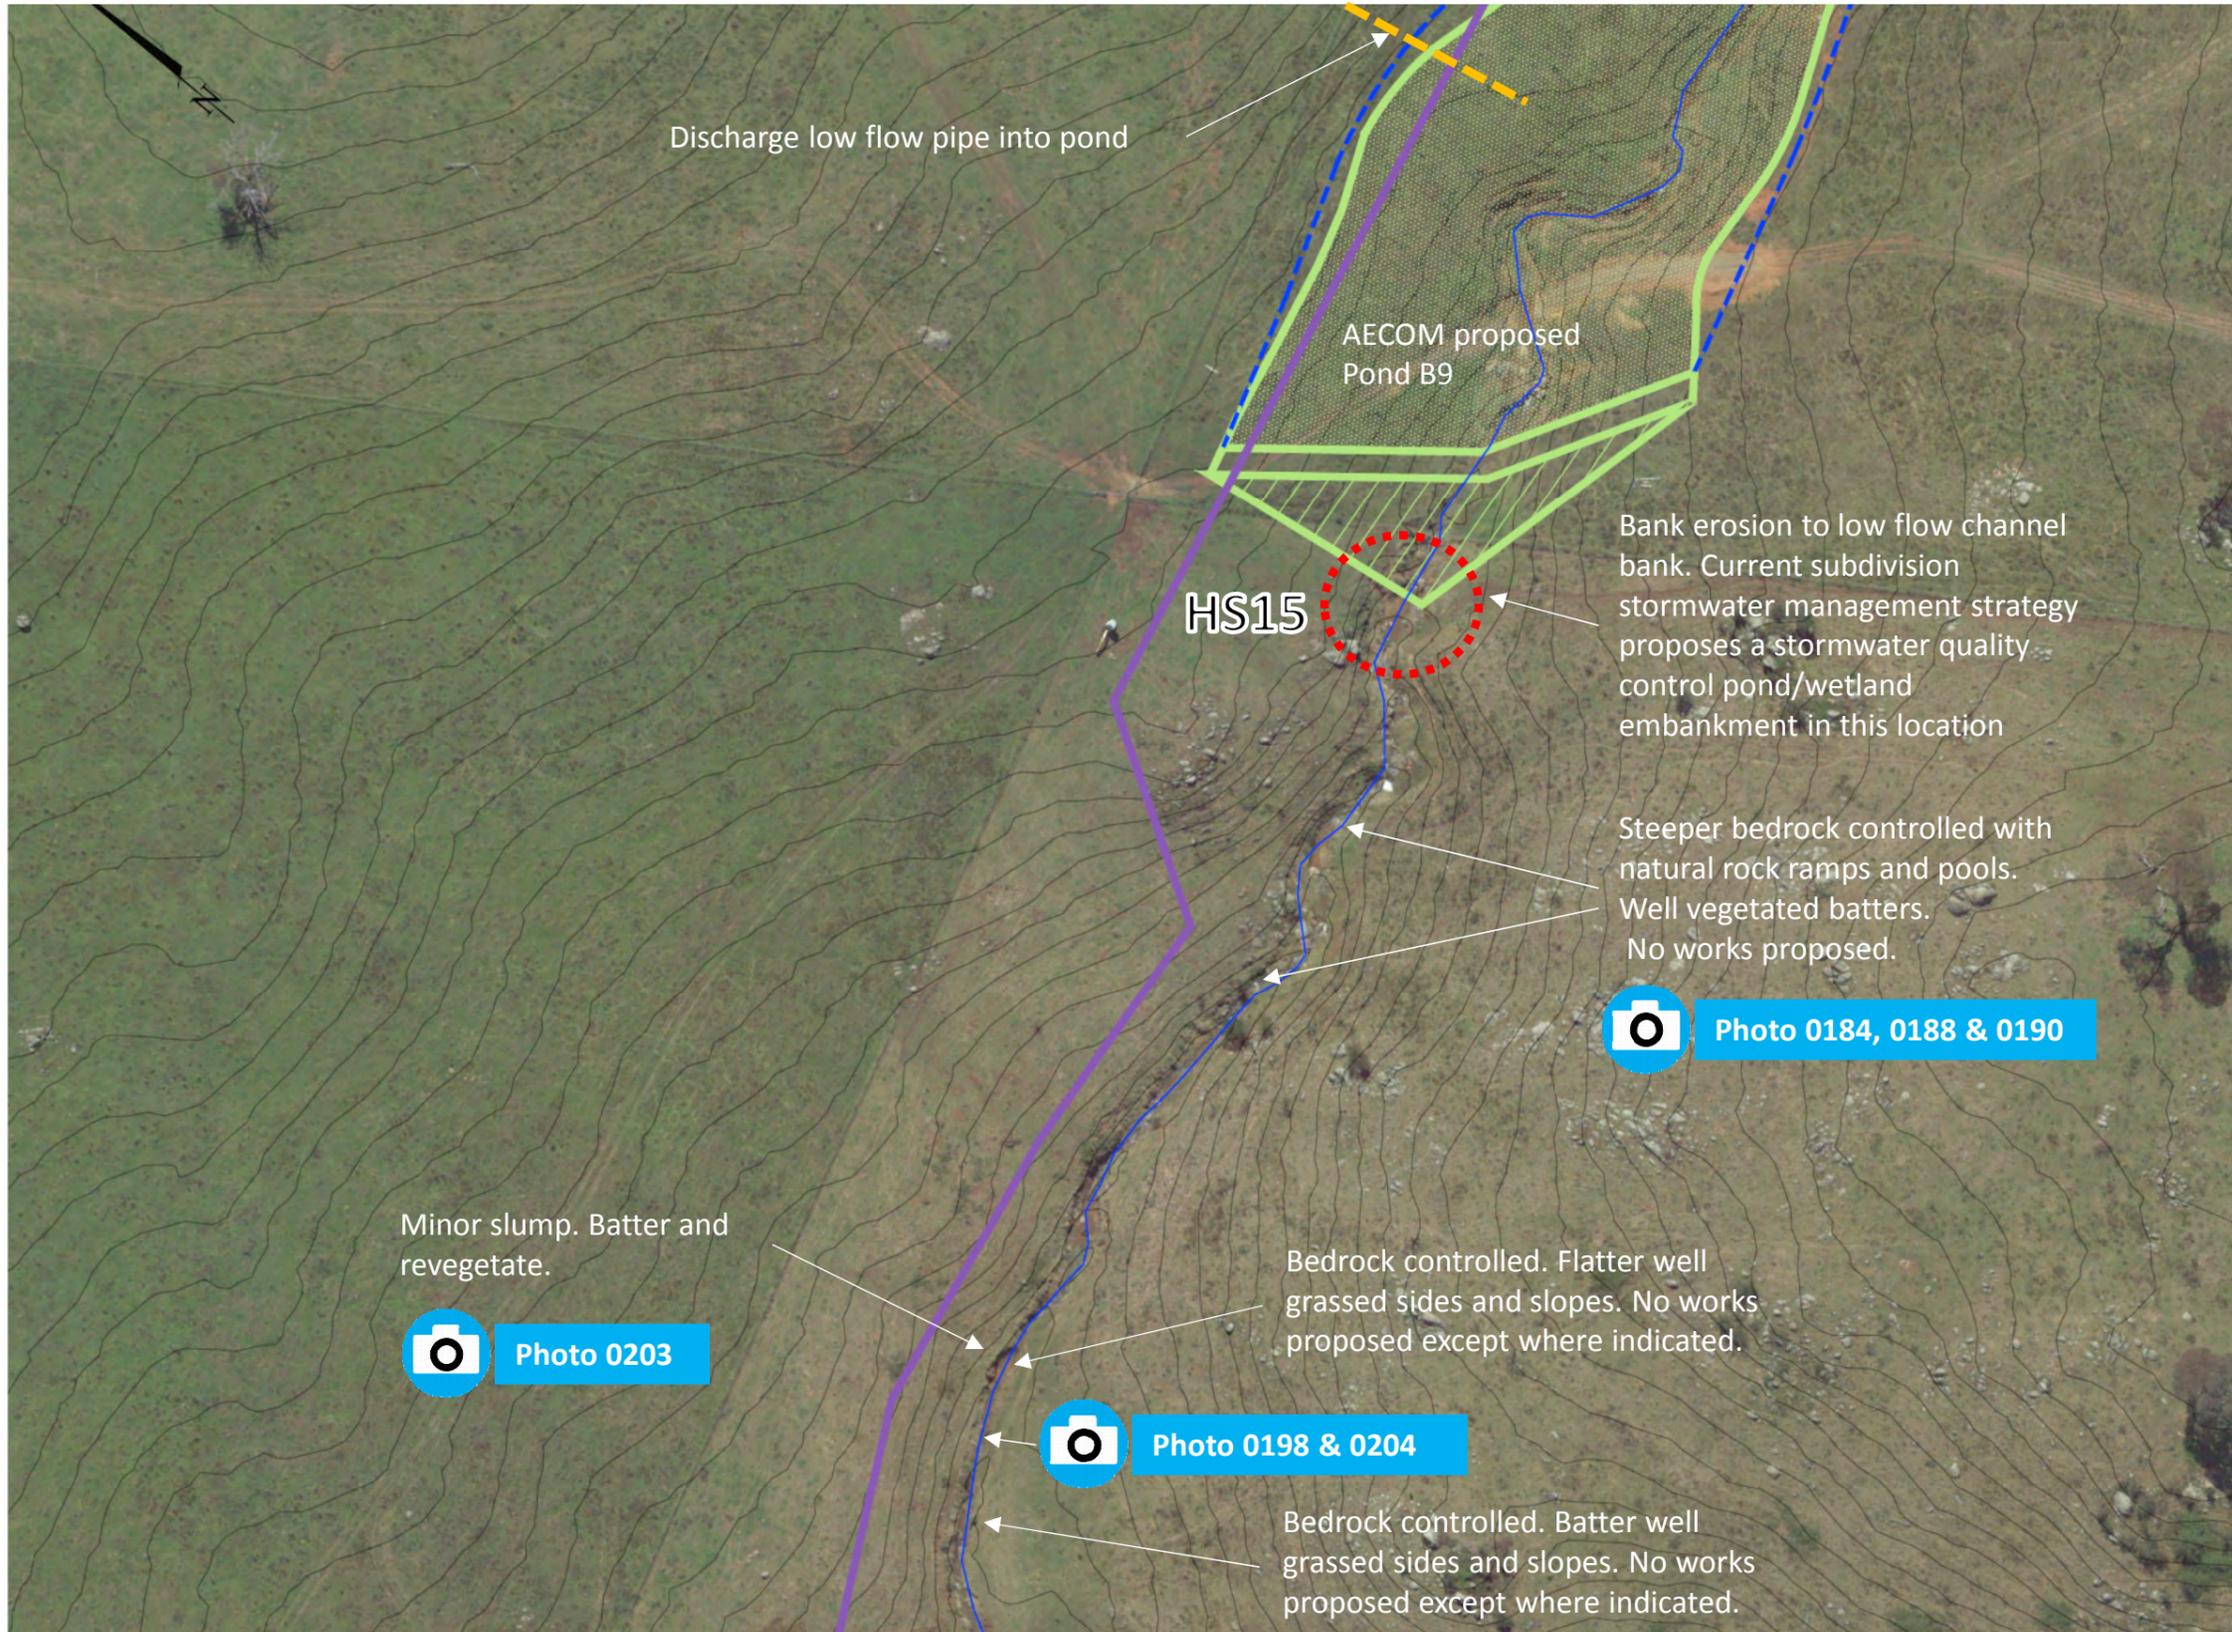
- General Notes for Sheet 9 Gully Area:**
1. Channel typically bedrock controlled with well grassed banks with little erosion. No works proposed except where indicated.
 2. Weeding to be undertaken progressively to ensure vegetation cover remains.
 3. Non dispersive soil.
 4. All works proposed subject to survey and detailed design.

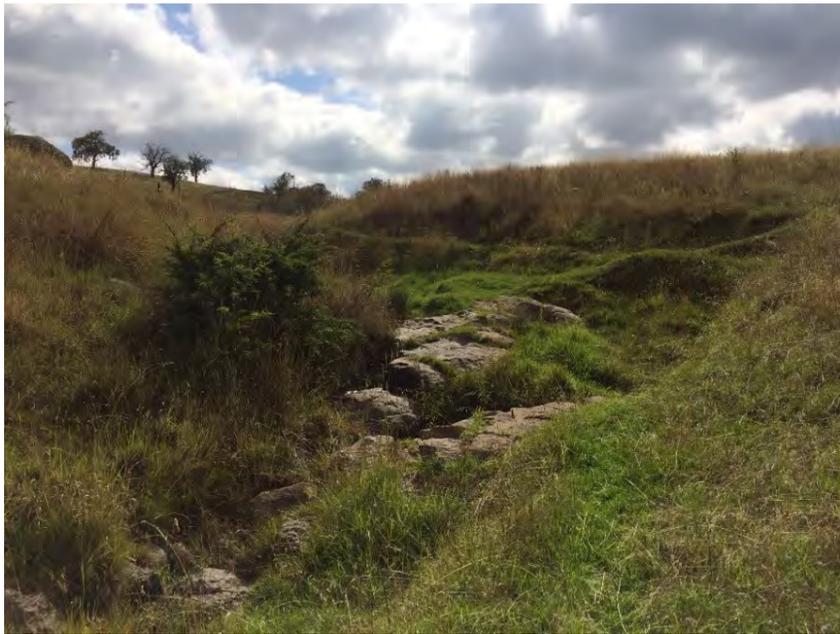
Photo 0184 – Bedrock controlled gully

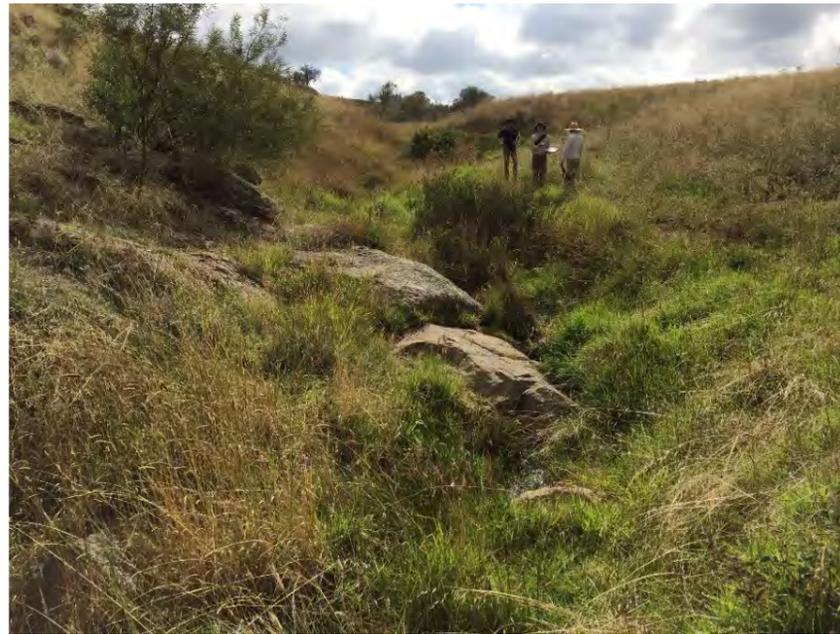
Photo 0188– Bedrock controlled gully

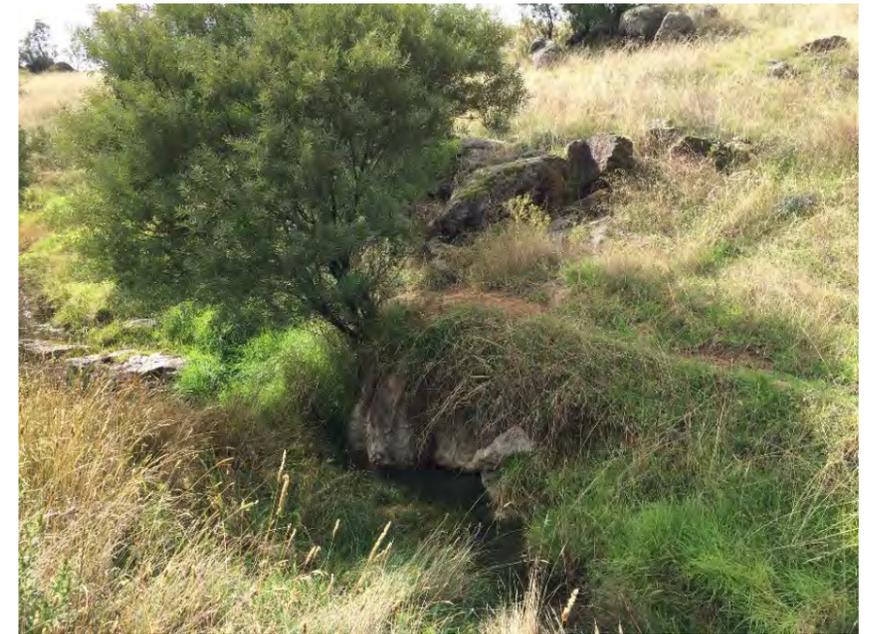
Photo 0190 – Bedrock controlled gully

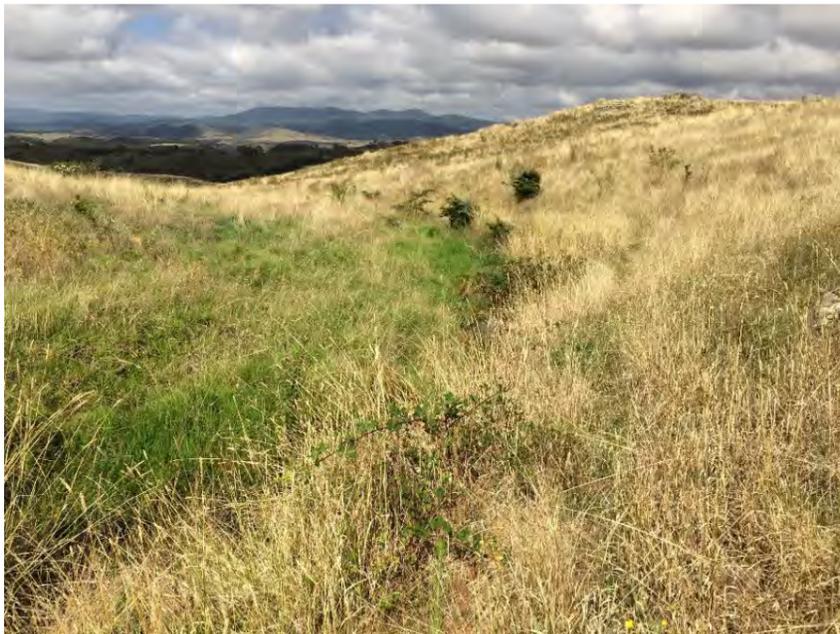
Photo 0198 – Stable vegetated gully

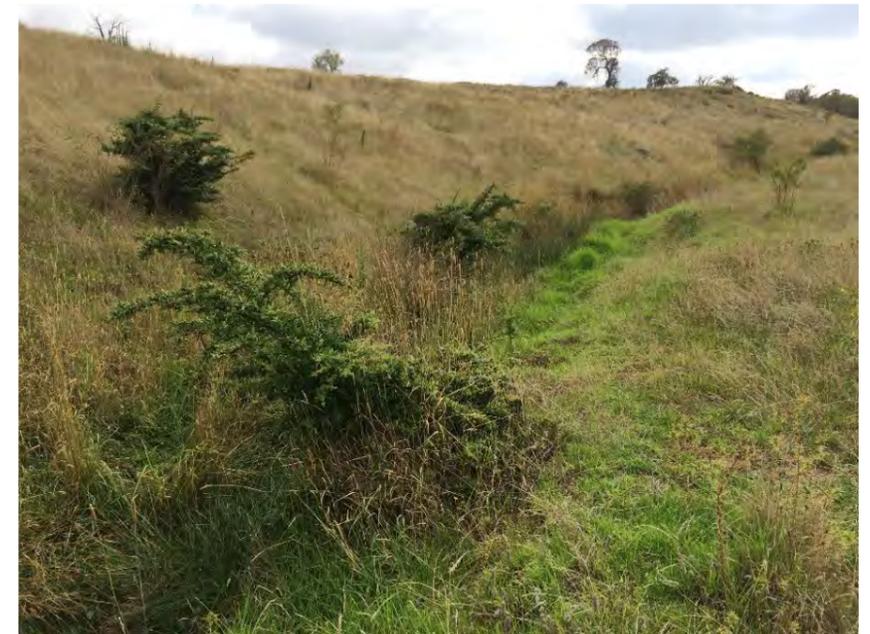
Photo 0204 – Stable vegetated gully

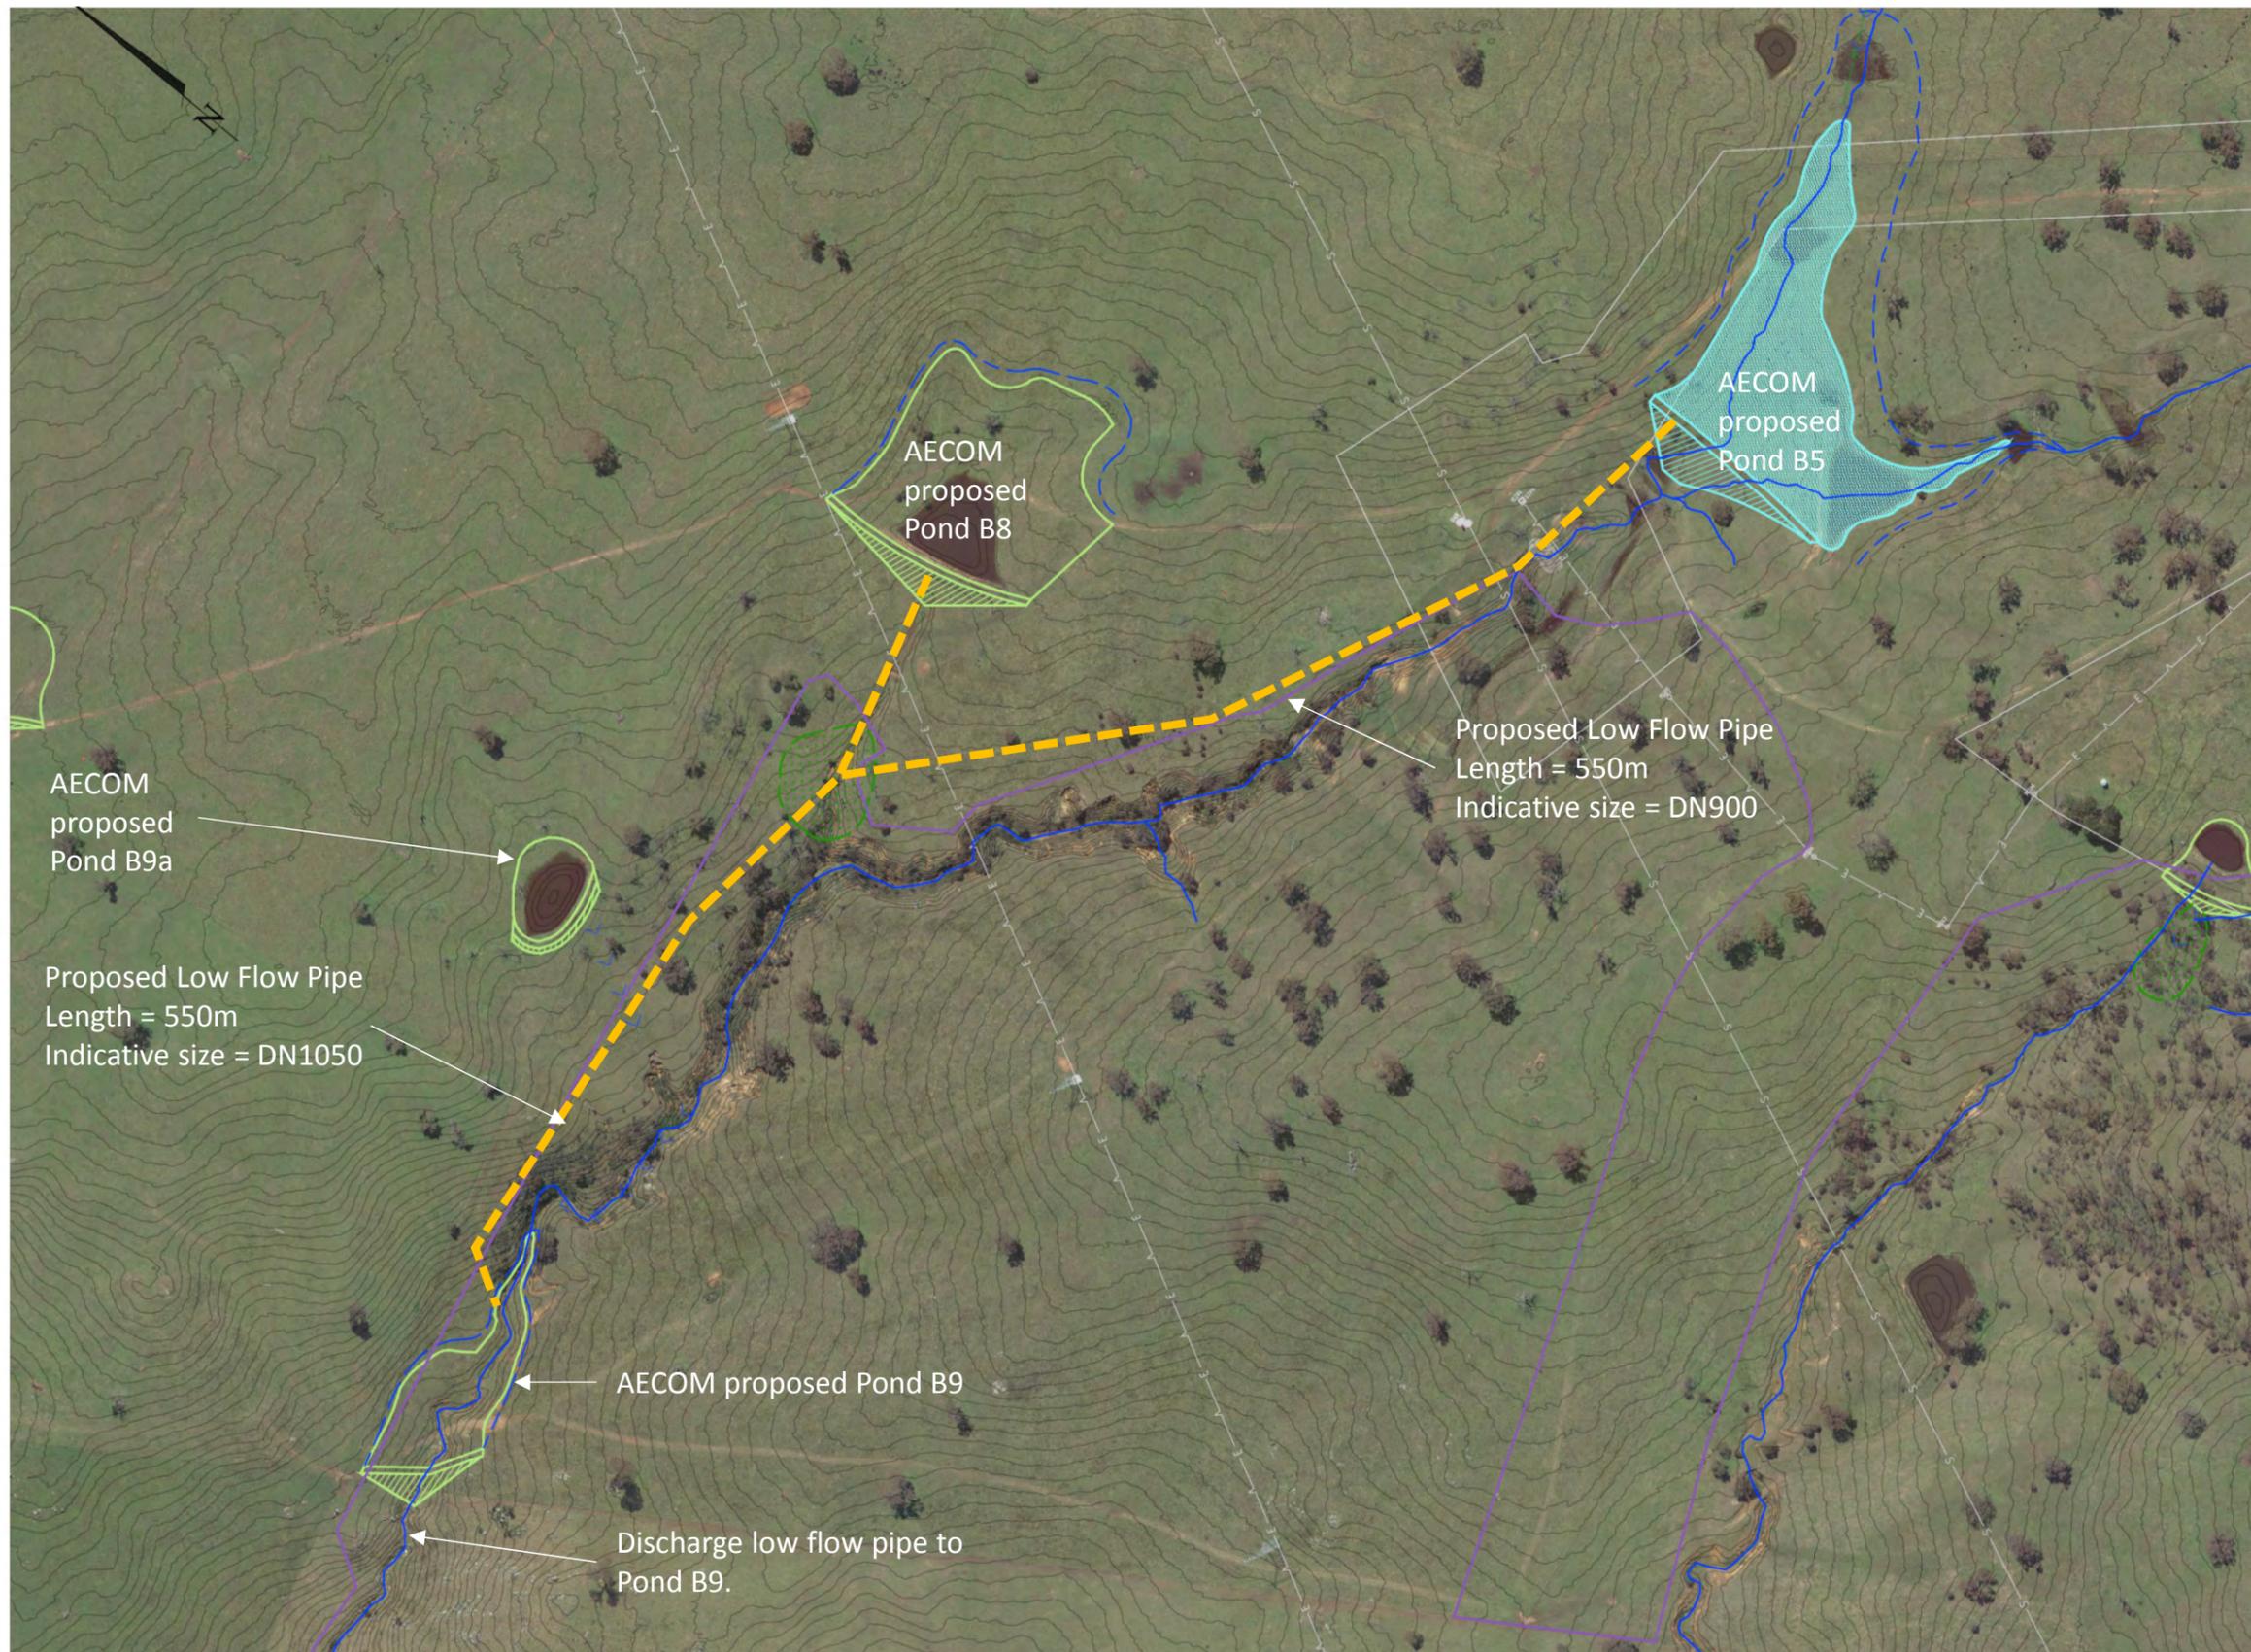
General Notes for Sheet 17

1. No protection works proposed with gully due to limited access.
2. Hotspot remediation works proposed along gully. Refer Brown Consulting report dated September 2014 for details.
3. Construct pipe to bypass frequent urbanised runoff around incised gully to maintain closer to natural flow frequent through gully.
4. Allow large less frequent flows to be conveyed through gully as currently occurs.
5. Discharge low flows at spillway outlet of Pond B9 into bedrock controlled creek section.
6. Possible relocation of ponds subject to final design.
7. All works proposed subject to survey and detailed design.

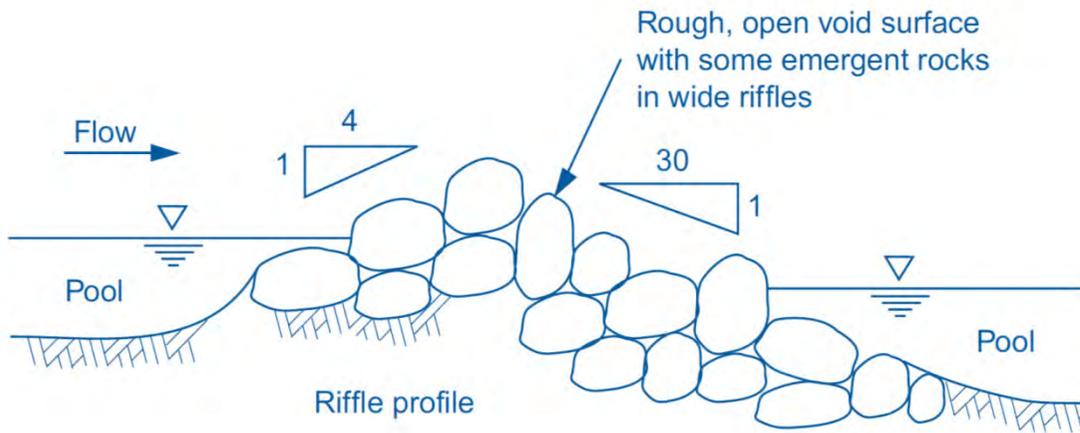
Image sourced from Natural Channel Design Guidelines
Figure A.14 Typical Riffle Profiles

Both Type 1 and 2 measures have pervious or leaky weirs. Often designed and constructed with no fines rock work to enable some infiltration through the structure but siltation will occur upstream of the bed controls. The crest of the ramp is typically designed to be higher than upstream channel invert. Subject to site survey and design integration into existing topography Rock Berms or Rock Rib could be used across the overbank flow area, perpendicular to flow, to minimise scour potential in the overbank areas.

Ramps can also be called riffles, rock weirs, Schauberger Boulder Bed Control or Schauberger Ramp. Subject to design and flow conditions a plunge pool or pond can be formed at the end of downstream ramp.

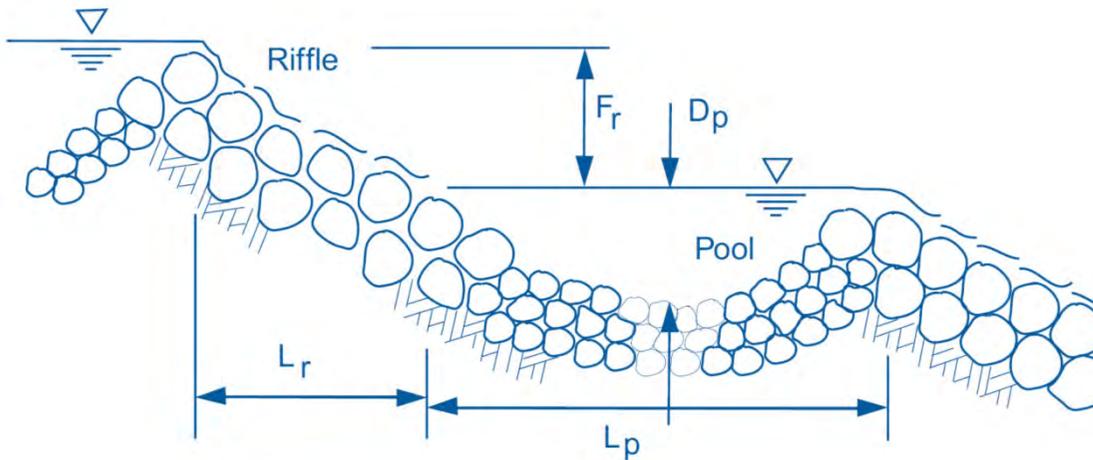
Image sourced from Natural Channel Design Guidelines
Figure 3.10 Pool-riffle System

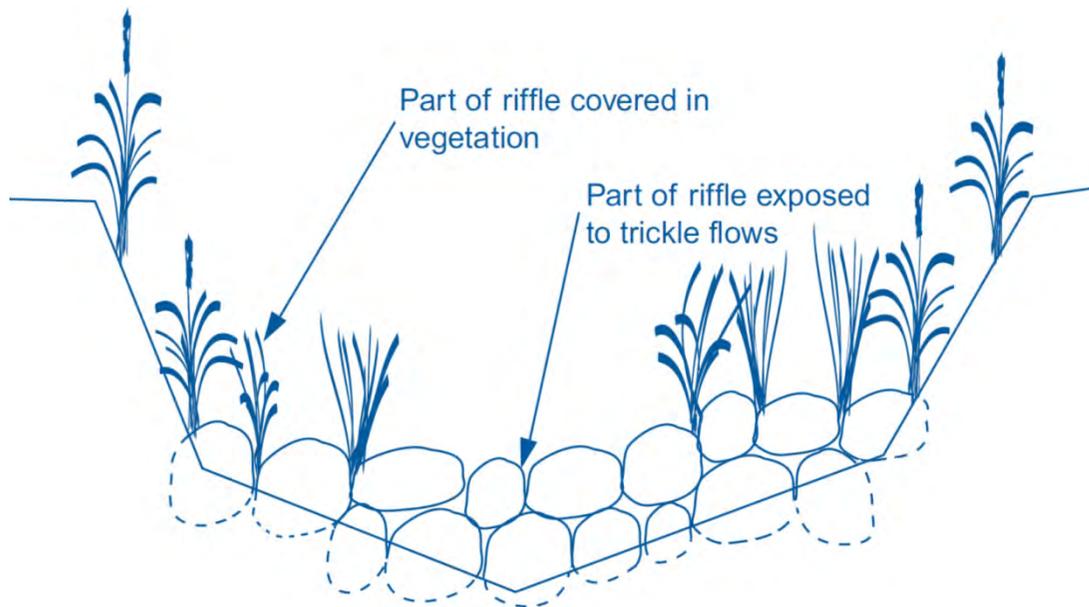
Image sourced from Natural Channel Design Guidelines
 Figure A.14 Typical Riffle Profiles

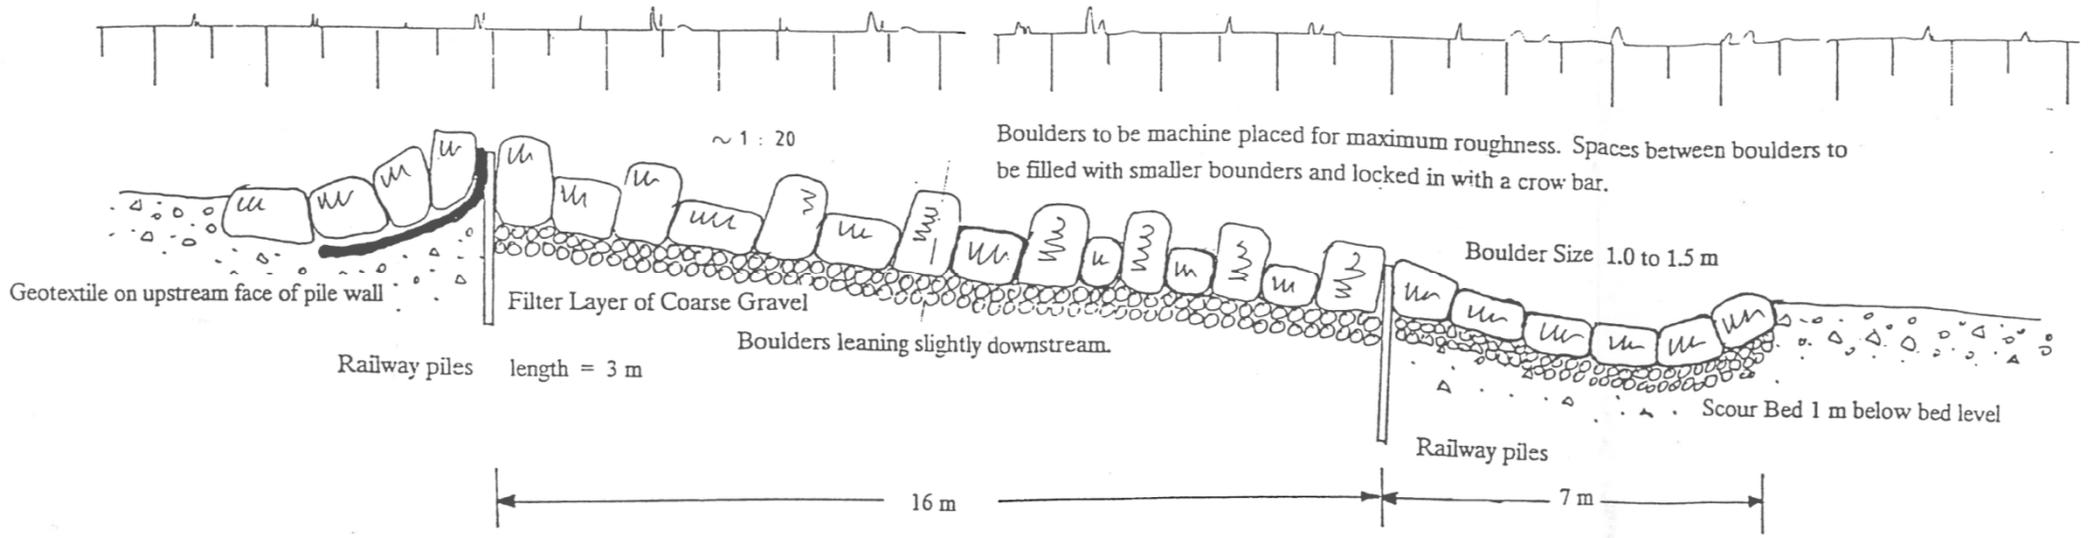
Image sourced from New South Wales Department of Water Resources
 Figure A2.4 Schauberger Ramp
