Report on
Geotechnical Assessment – Urban Capability

Proposed Subdivision
Blocks 1605 – 1607, West Belconnen, ACT

Prepared for
The Riverview Group

Project 77356
February 2014

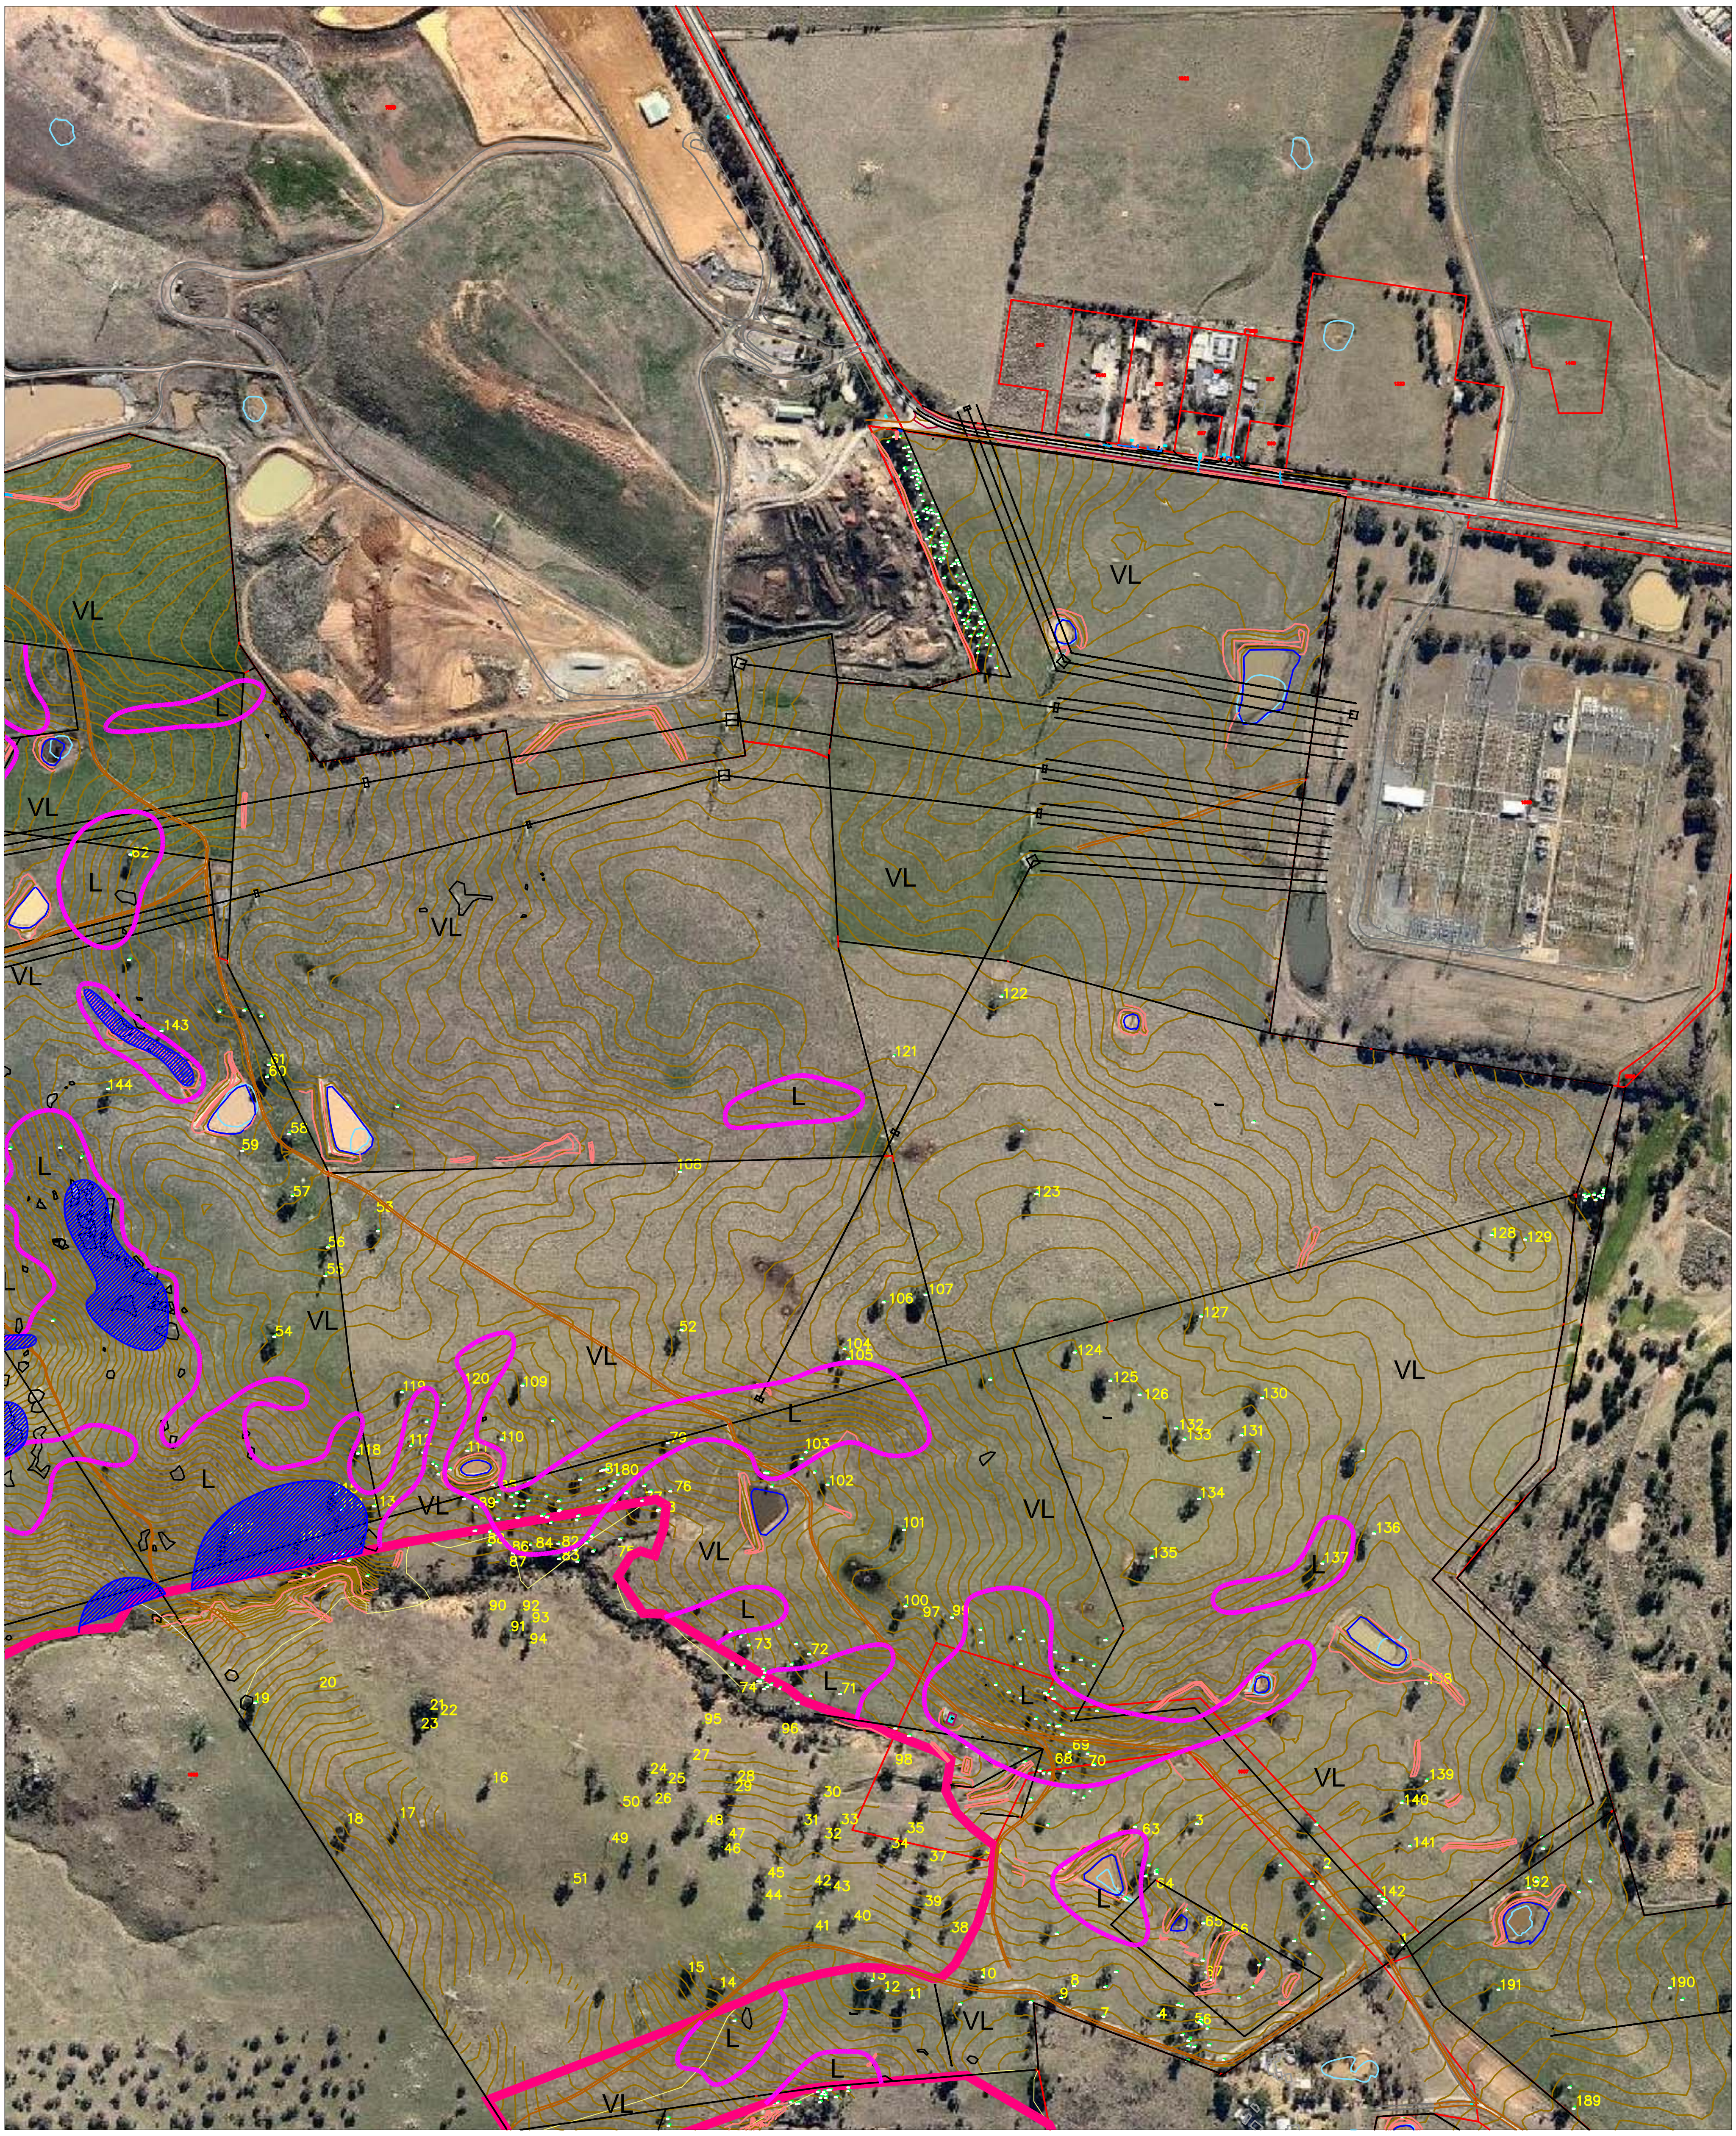
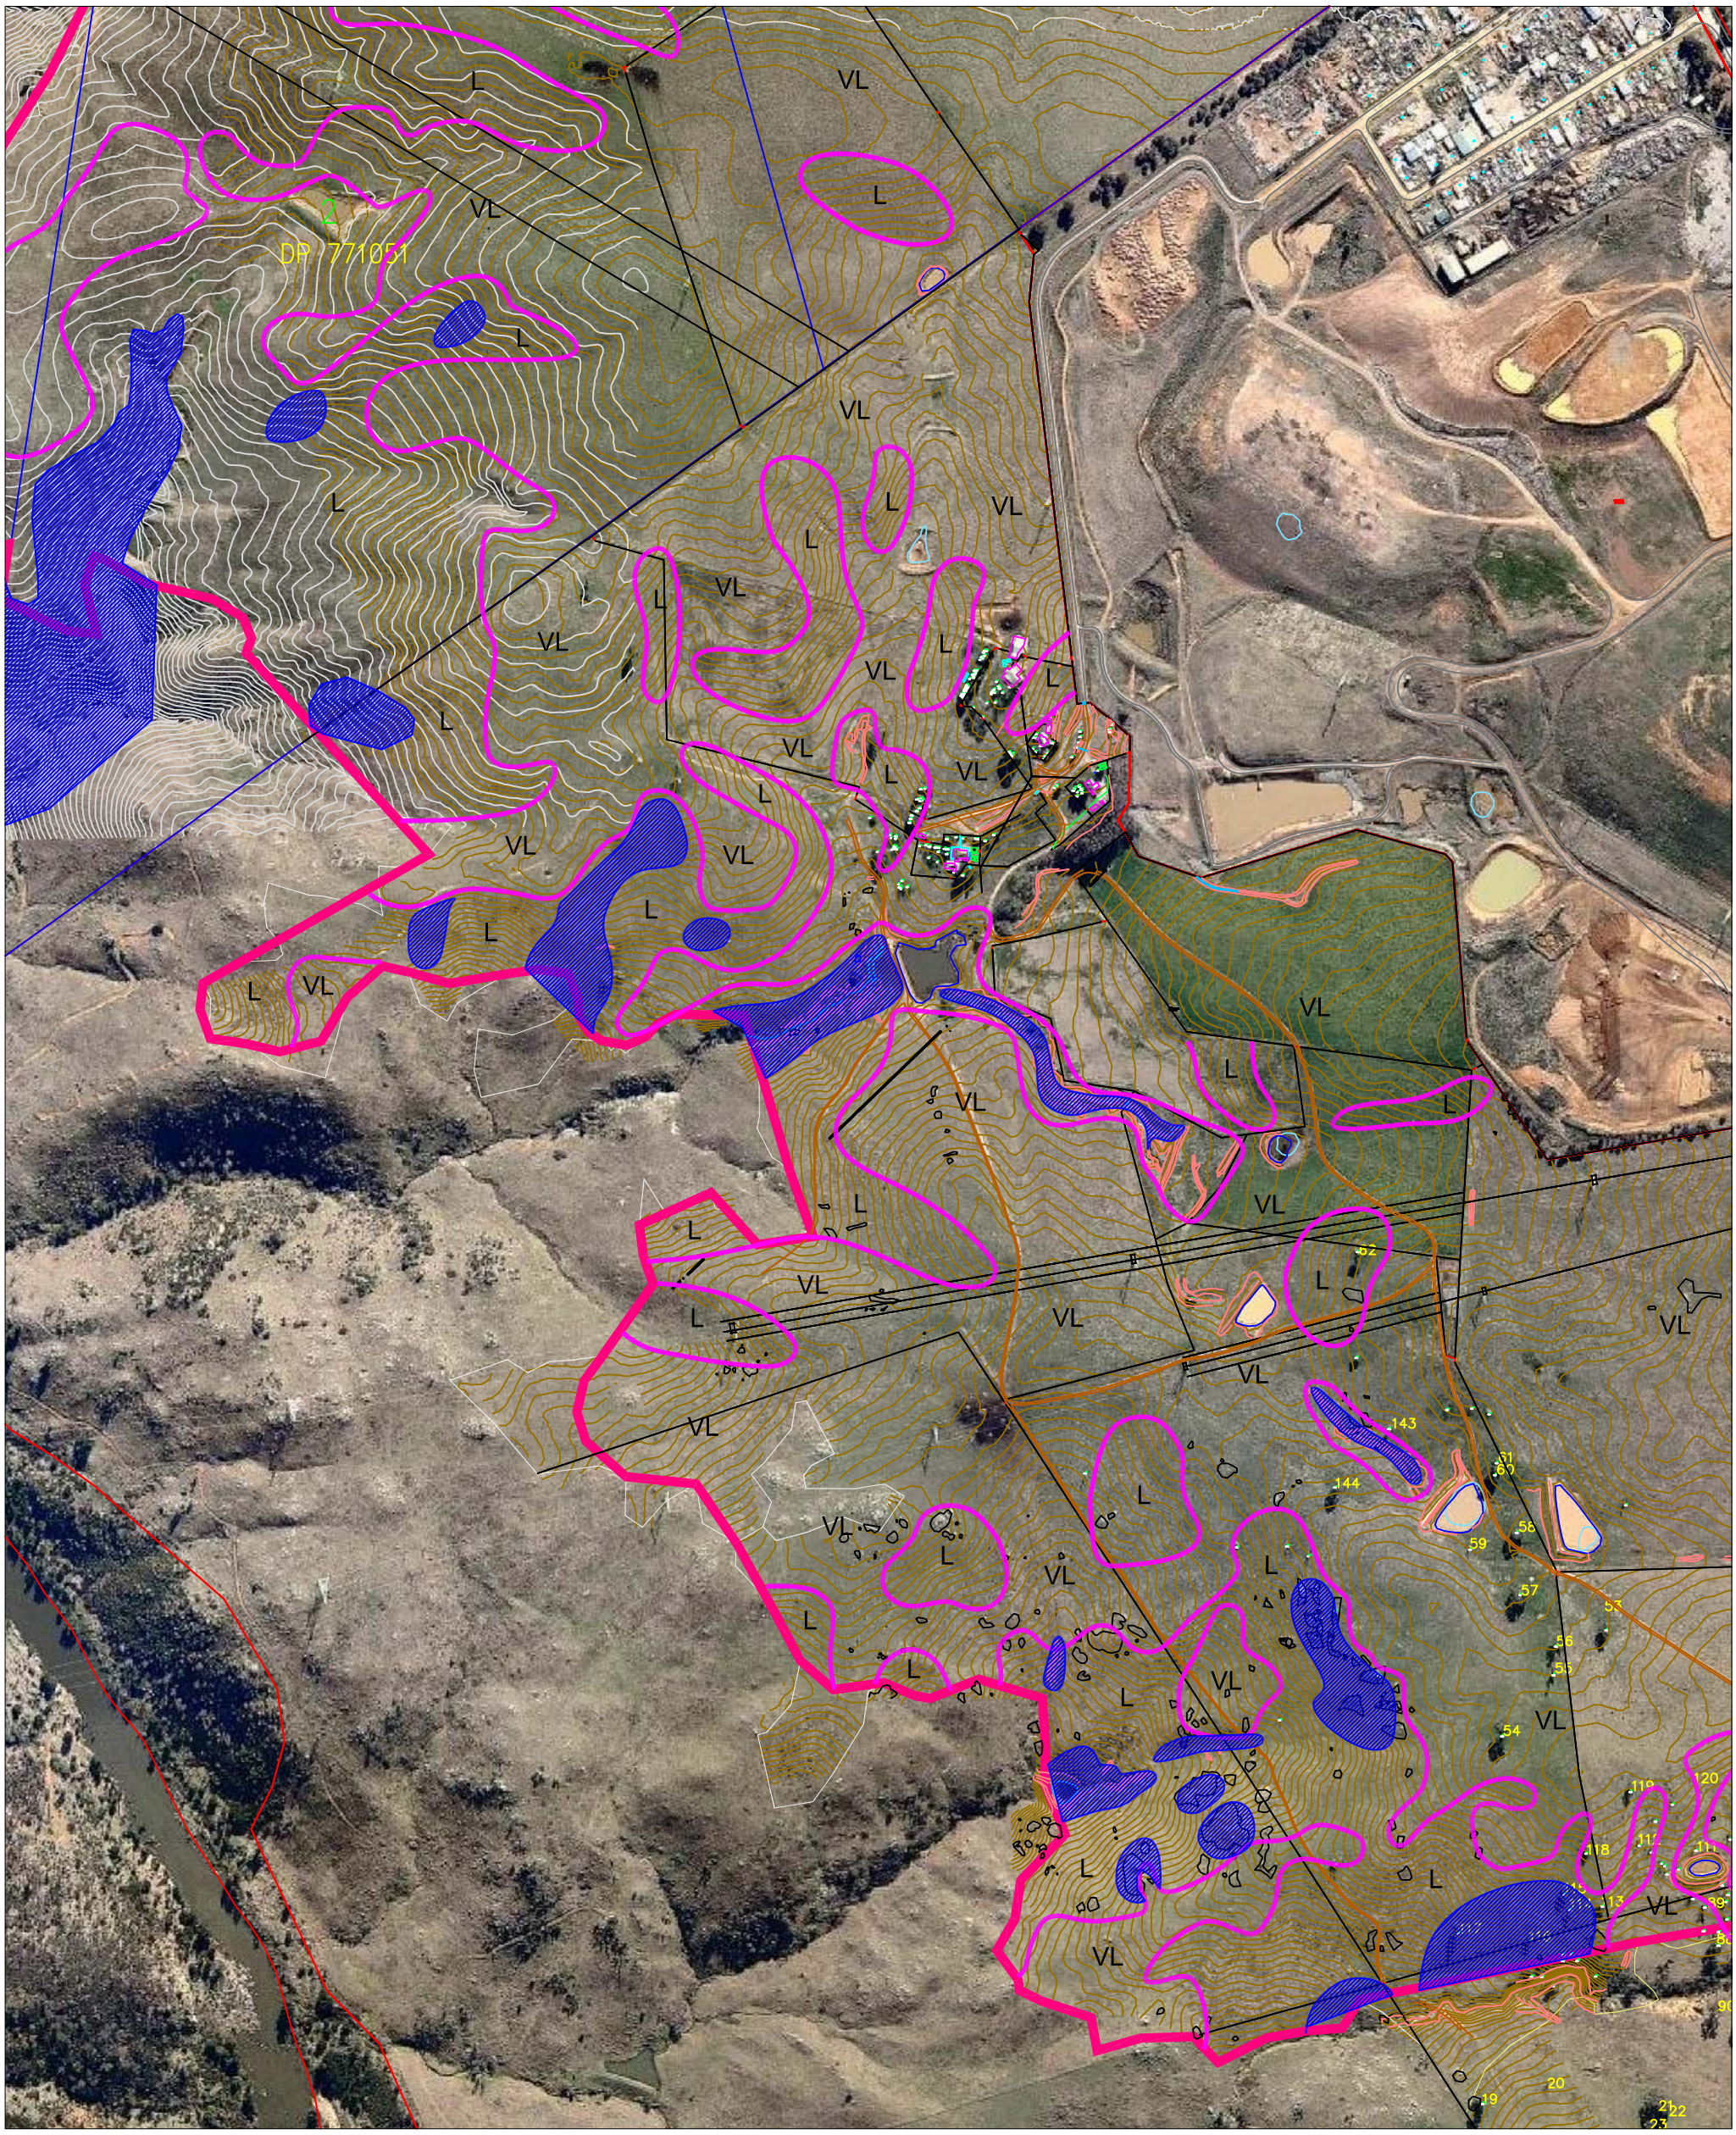
| Douglas Partners — Geotechnics / Environment / Groundwater | TITLE: **Approximate Locations of Potential Instability Risk** **Proposed Subdivision** **ACT Blocks 1605 - 1607, West Belconnen** | | | OFFICE: Canberra<br>DRAWN BY: MJJ<br>DATE: 5.11.2013 |

In summary, it is considered that most of the site is classified as very low or low risk of damage to property occurring as a result of slope instability. Several areas are considered of moderate or high risk (refer Drawings 6 – 8) of causing property damage due to the steep ground slopes and possible unsuitable design and construction practice.

***Stability:*** Several areas (refer Drawings 6 – 8) have been assessed as having a potential moderate to high risk of damage to property.

Areas of steeply sloping land (moderately and high risk) are not recommended for residential development at this stage. A detailed site stability assessment including subsurface investigations must be undertaken in these areas to establish an appropriate site model for analysis purposes to assess whether development is feasible in the high risk zones.

At this stage without subsurface investigations, development within the high risk areas are not recommended. A comprehensive site stability assessment will be required if development in those areas are proposed.
