Report on  
Geotechnical Assessment – Urban Capability

Proposed Subdivision  
Lots 1 – 5 and 7 DP771051, Parkwood, NSW

Prepared for  
The Riverview Group

Project 77356  
February 2014

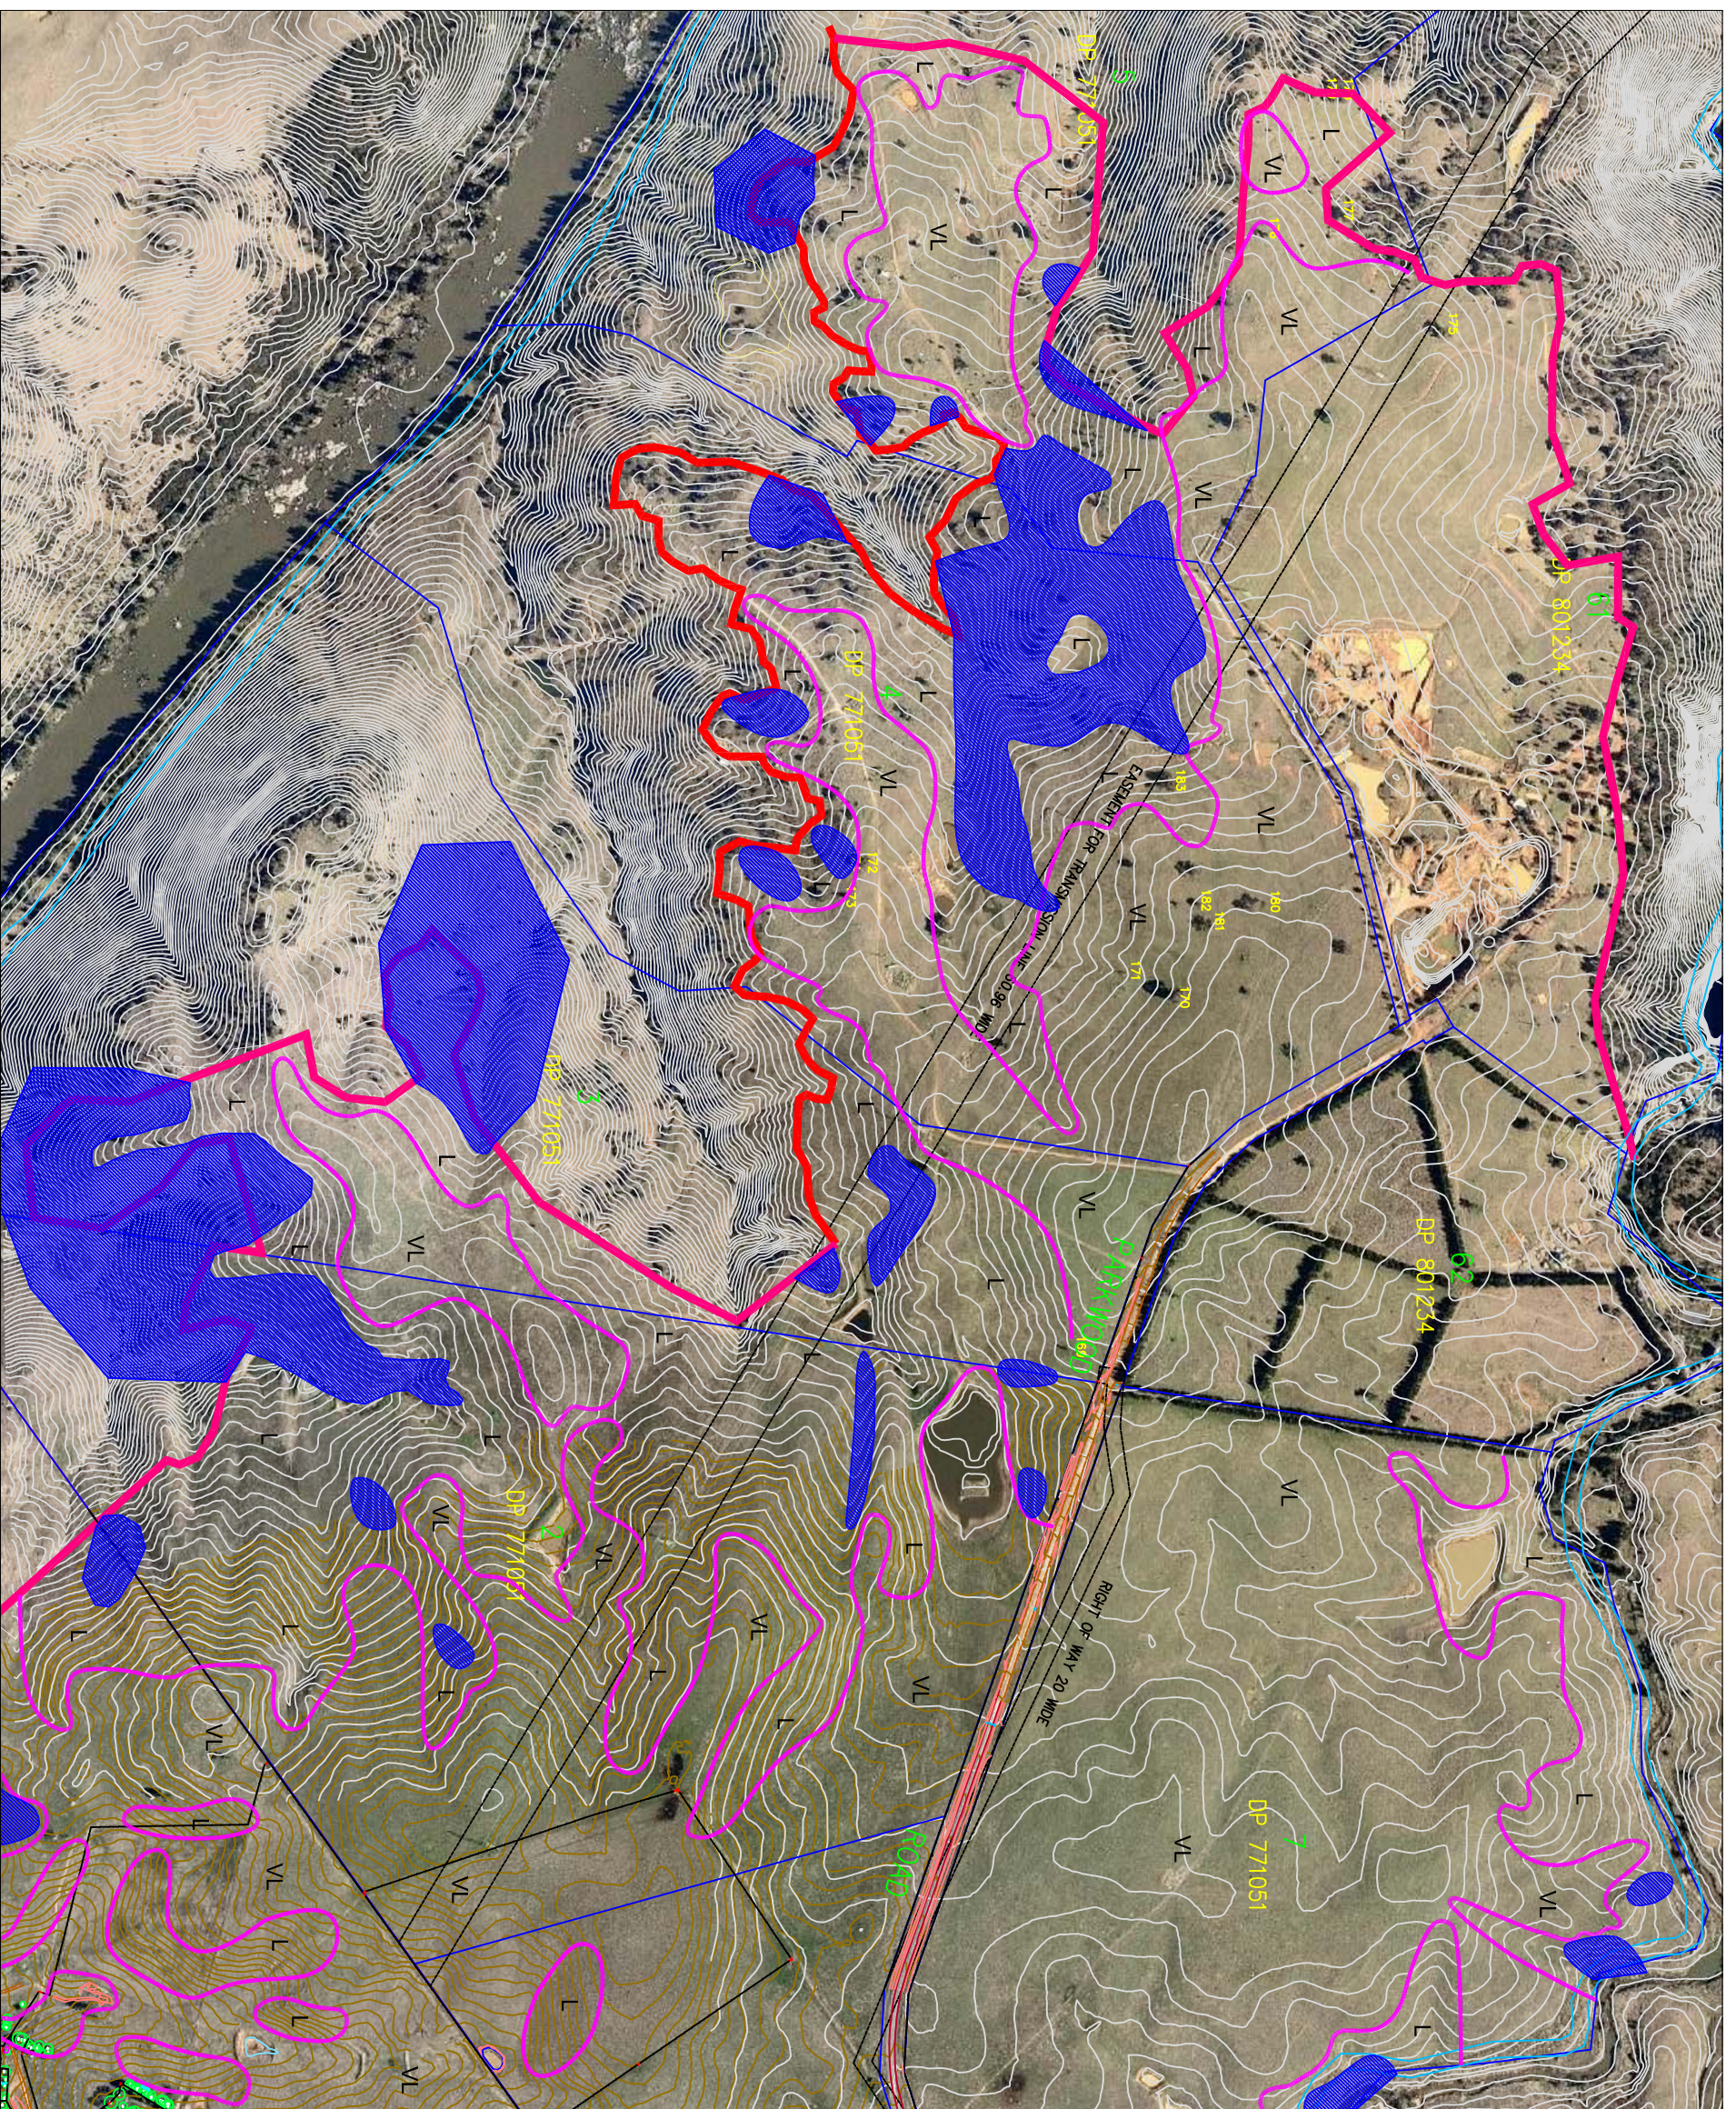
In summary, it is considered that most of the site is classified as very low or low risk of damage to property occurring as a result of slope instability. Several areas are considered of moderate or high risk (refer Drawings 5 and 6) of causing property damage due to the steep ground slopes and possible unsuitable design and construction practice.

Areas of steeply sloping land (moderate and high risk) are not recommended for residential development at this stage. A detailed site stability assessment including subsurface investigations must be undertaken in these areas to establish an appropriate site model for analysis purposes to assess whether development is feasible in the high risk zones.

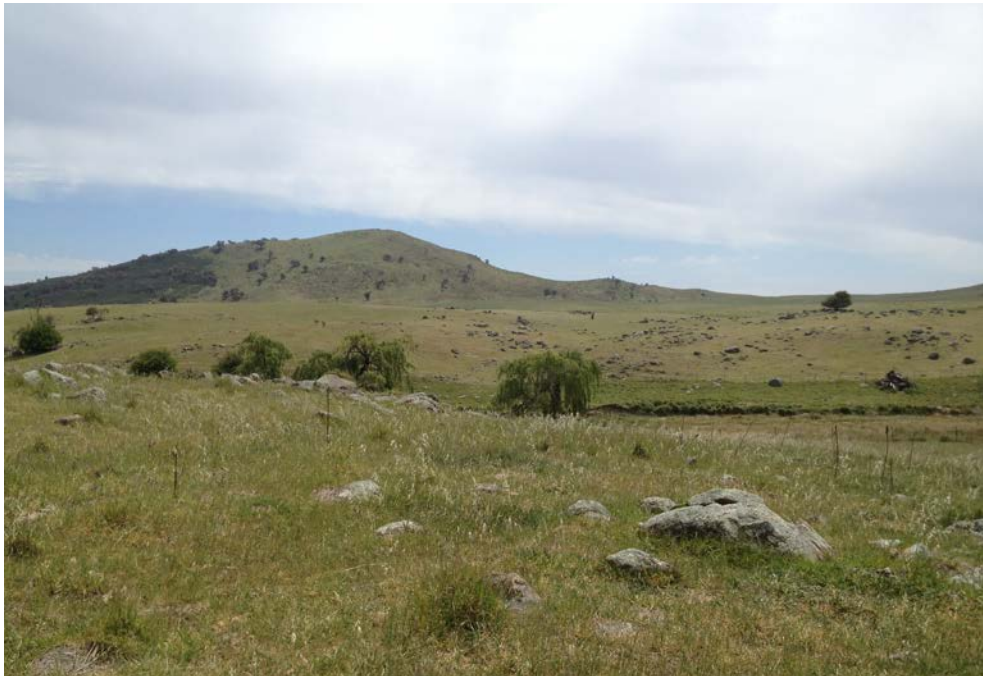
Photo N20 – Rock outcropping. Refer Drawing 3 for locality and direction
