# SITE CLASSIFICATION REPORT SUMMARY

<b>BLOCK:</b>	23(d)	<b>SECTION:</b>	19(AK)	<b>SUBURB:</b>	Strathnairn
<b>JOB No:</b>	77356.22	<b>DATE:</b>	March 2019		
<b>CLIENT:</b>	Calibre Consulting (ACT) Pty Ltd				
<b>CLASSIFICATION PROCEDURES:</b>					
<b>Existing Subsurface Conditions:</b> Refer attached test pit log(s) – Pit(s) 69,70 and Drawing 11.					
<b>Bulk Earthworks:</b> Filling within the block placed under Level 1 control as defined in AS 3798 – 2007 (Ref 1).					
<b>Laboratory Results:</b> Previous laboratory testing results indicated liquid limit ranging from 52-81%, plasticity index ranging from 39-68% and linear shrinkage ranging from 13.5-22.5%.					
<b>Site Classification:</b> High range Class M* (moderately reactive/filled) based on the worst case soil profile and on limited subsurface information and determined in general accordance with the requirements of AS2870-2011 (Ref 2). It must be noted that part of the block would be equivalent to Class S conditions due to shallow rock, therefore the classification must be reassessed should the soil profile change either by adding fill or removing soil from the block and/or if the presence of service trenches or retaining wa

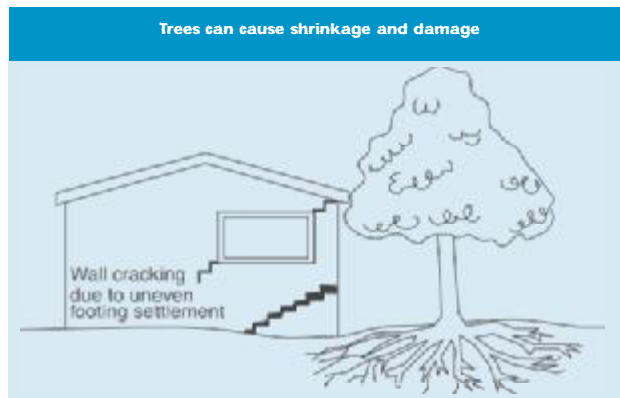
As the moisture absorption process completes its journey to the innermost areas of the building, the internal footings will rise. If the spread of moisture is roughly even, it may be that the symptoms will temporarily disappear, but it is more likely that swelling will be uneven, creating a difference rather than a disappearance in symptoms. In buildings with timber flooring supported by bearers and joists, the isolated piers will rise more easily than the strip footings or piers under walls, creating noticeable doming of flooring.

As the weather pattern changes and the soil begins to dry out, the external footings will be first affected, beginning with the locations where the sun's effect is strongest. This has the effect of lowering the external footings. The doming is accentuated and cracking reduces or disappears where it occurred because of dishing, but other cracks open up. The roof lines may become convex.

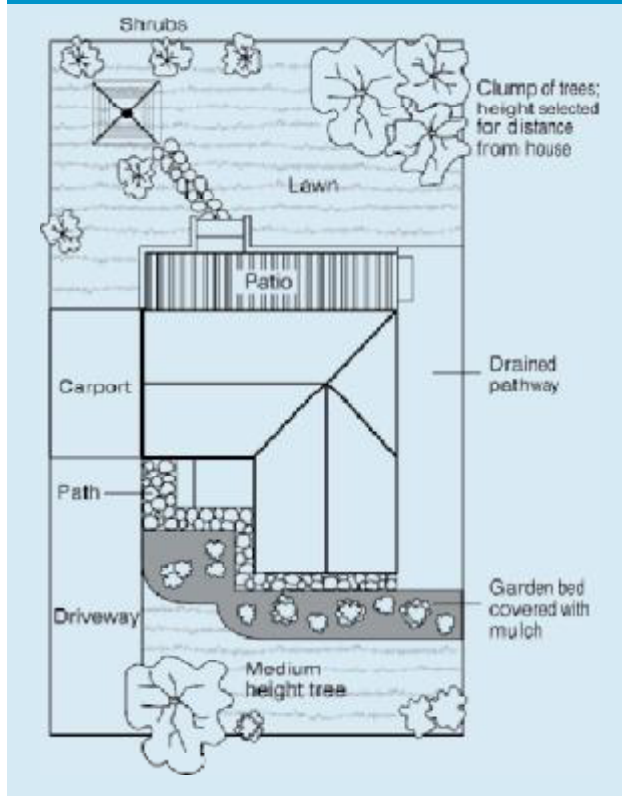
### Gardens for a reactive site

For this reason, particularly where problems exist or are likely to occur, it is recommended that an apron of paving be installed around as much of the building perimeter as necessary. This paving

should extend outwards a minimum of 900 mm (more in highly reactive soil) and should have a minimum fall away from the building of 1:60. The finished paving should be no less than 100 mm below brick vent bases.

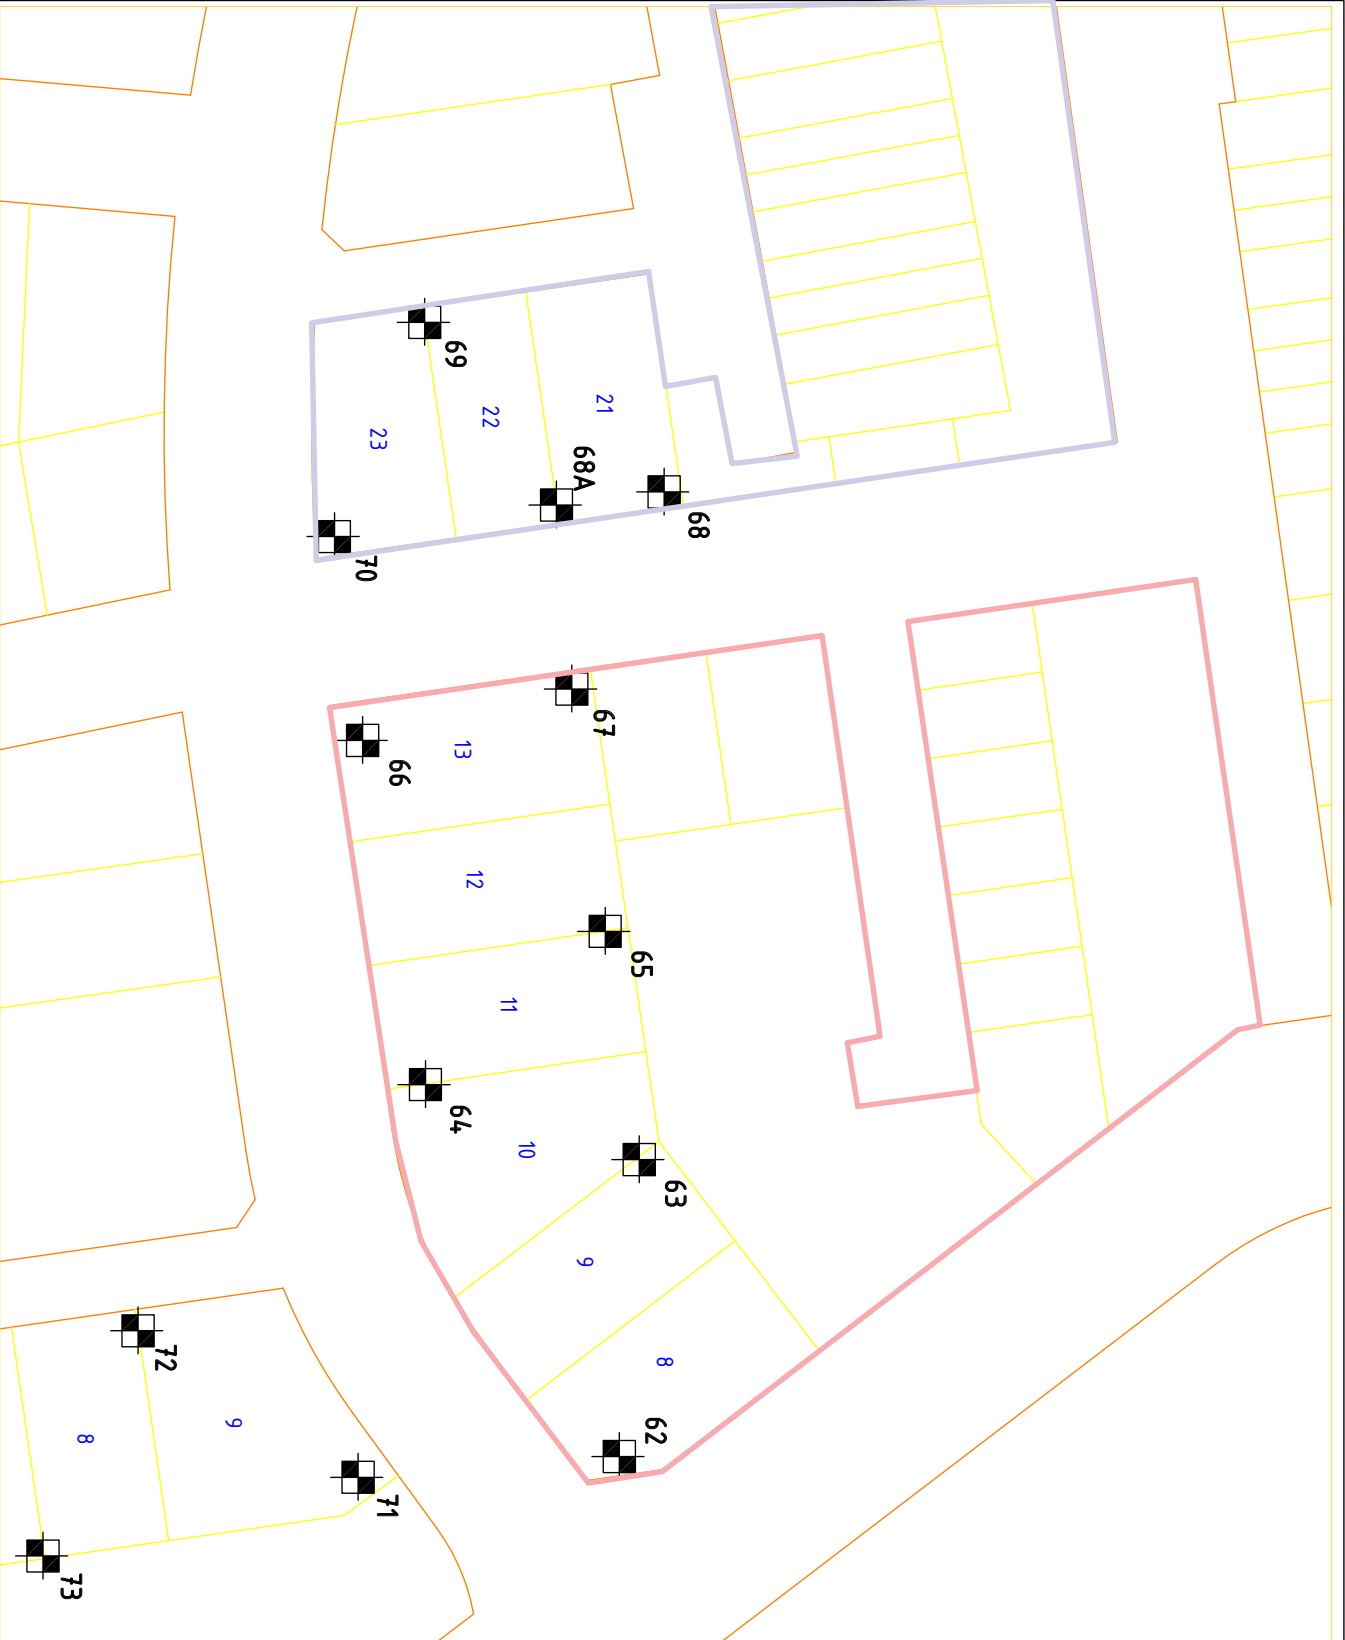
- LEGEND**
- ⊞ Test Pit Location
  - 6 Block Number
  - Block Boundary
  - Section 17 Boundary
  - Section 19 Boundary
