# SITE CLASSIFICATION REPORT SUMMARY

<b>BLOCK:</b>	31(ae)	<b>SECTION:</b>	20(AO)	<b>SUBURB:</b>	Strathnairn
<b>JOB No:</b>	77356.22	<b>DATE:</b>	May 2019		
<b>CLIENT:</b>	Calibre Consulting (ACT) Pty Ltd				
<b>Classification Procedures:</b>					
<b>Existing Subsurface Conditions:</b> Refer attached test pit log(s) – Pit(s) 137,139 and Drawing 3.					
<b>Laboratory Results:</b> Previous laboratory testing results indicated liquid limit ranging from 52-81%, plasticity index ranging from 39-68% and linear shrinkage ranging from 13.5-22%.					
<b>Site Classification:</b> Site classification in accordance with AS2870 - 2011 (Ref 1) provides guidance on the patterns and magnitude of moisture related seasonal ground movements that must be considered in design. Based on the current soil profile / state, on limited subsurface information, soil reactivity and allowing for variation in the subsoil profile, the overall site would be equivalent to worst case Class M (moderately reactive) conditions. It must be noted that parts of the site would be equivalent to Class S (slightly reactive) conditions. Therefore the site classification must be reassessed should the subsurface profile change by

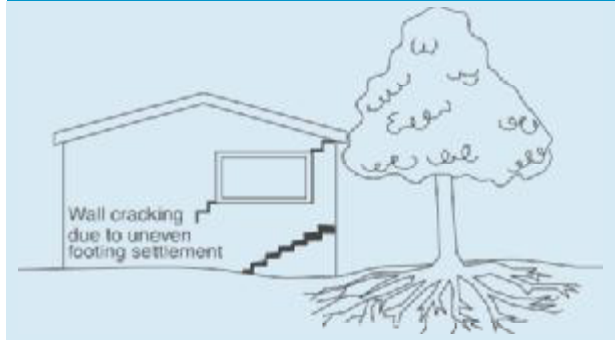
### Trees can cause shrinkage and damage

As the weather pattern changes and the soil begins to dry out, the external footings will be first affected, beginning with the locations where the sun's effect is strongest. This has the effect of lowering the external footings. The doming is accentuated and cracking reduces or disappears where it occurred because of dishing, but other cracks open up. The roof lines may become convex.

#### Movement caused by tree roots

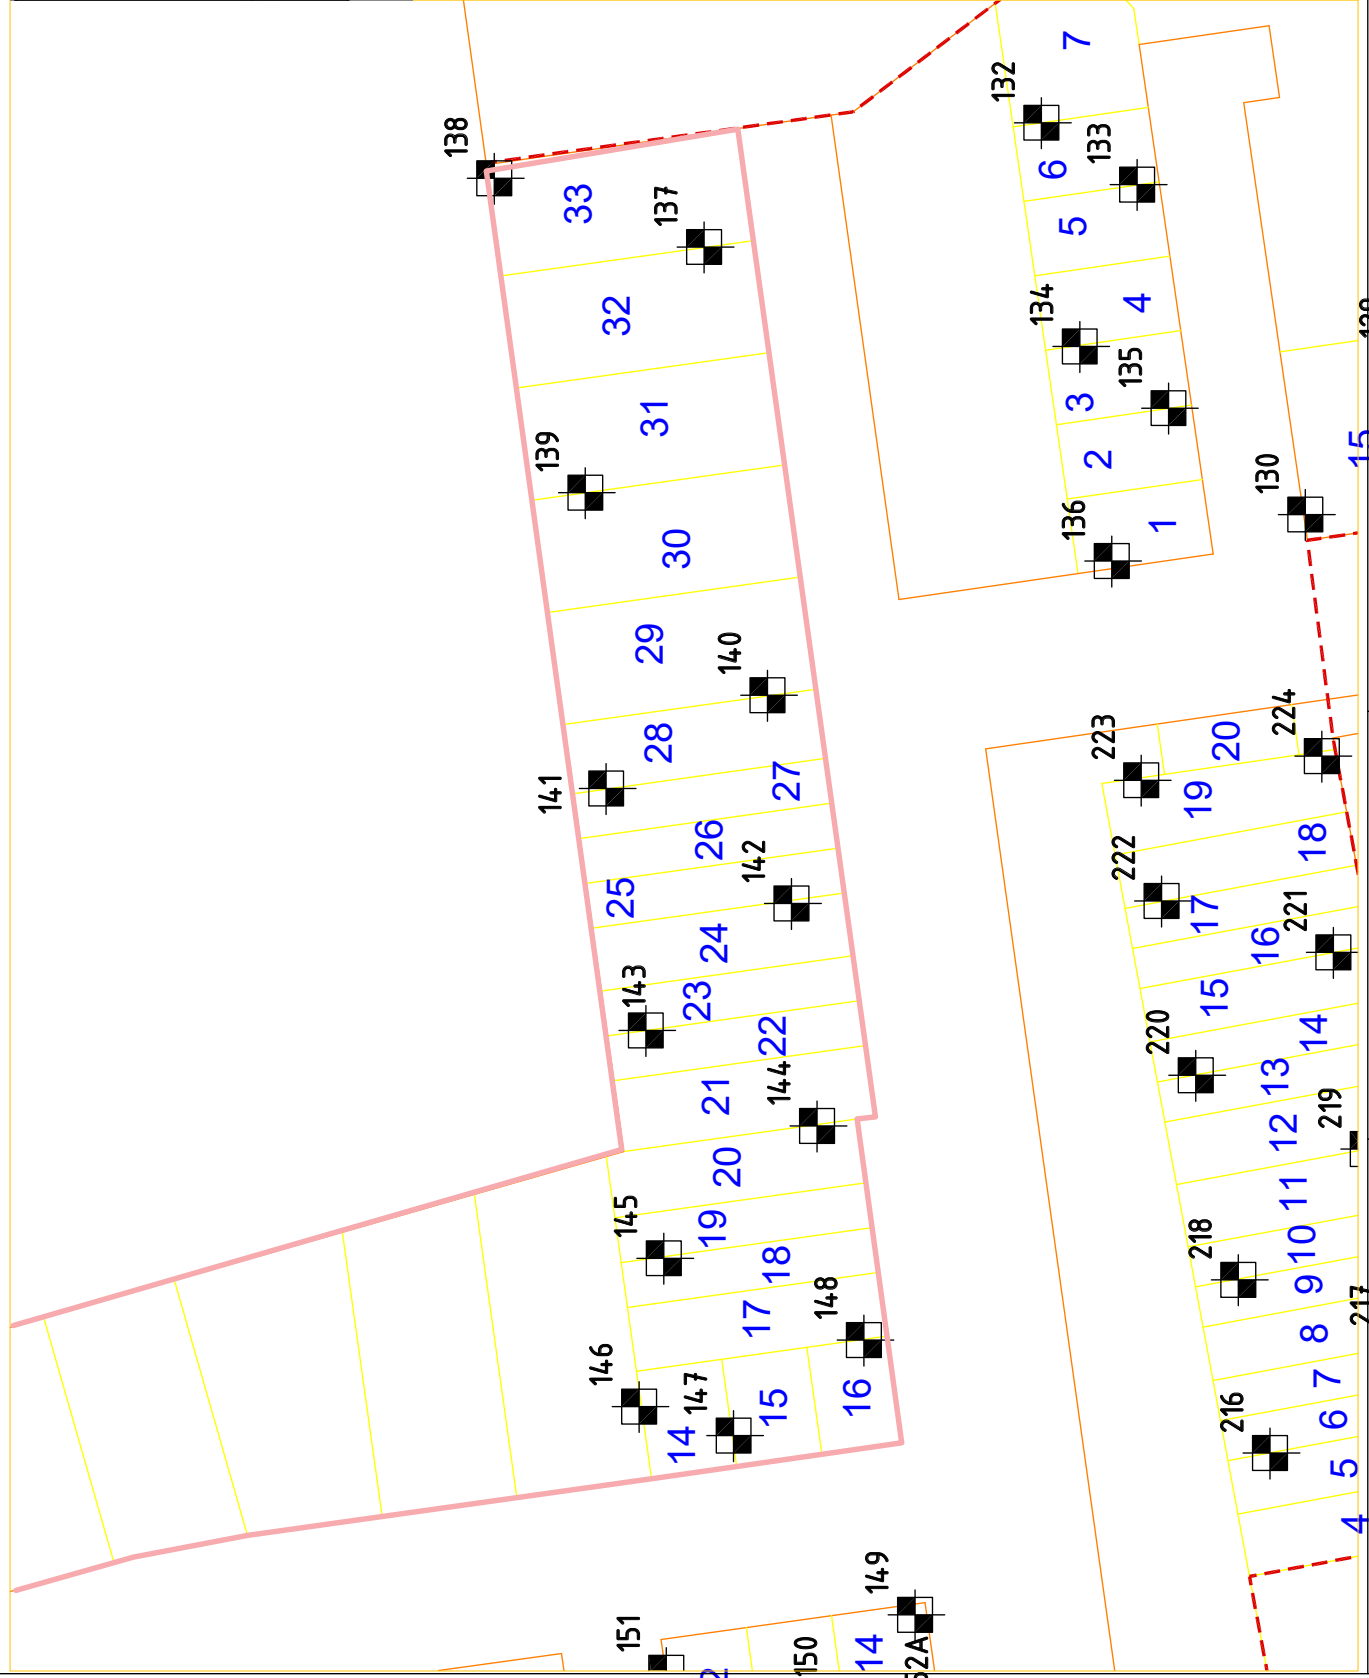
- ⊕ Test Pit Location
- 6 Block Number
- Block Boundary
- Section Boundary
- Stage Boundary
