SITE CLASSIFICATION REPORT SUMMARY

BLOCK: 24(x)	SECTION: 20(AO)	SUBURB: Strathnairn
JOB No: 77356.22		DATE: May 2019
CLIENT: Calibre Consulting (ACT) Pty Ltd

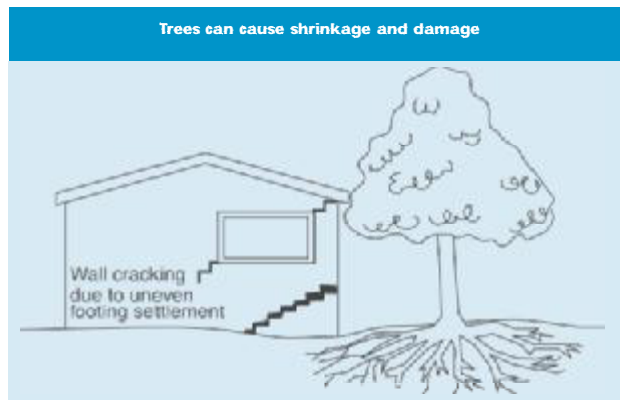
As the moisture absorption process completes its journey to the innermost areas of the building, the internal footings will rise. If the spread of moisture is roughly even, it may be that the symptoms will temporarily disappear, but it is more likely that swelling will be uneven, creating a difference rather than a disappearance in symptoms. In buildings with timber flooring supported by bearers and joists, the isolated piers will rise more easily than the strip footings or piers under walls, creating noticeable doming of flooring.

Swelling foundation soil due to rainy periods first lifts the most exposed extremities of the footing system, then the remainder of the perimeter footings while gradually permeating inside the building footprint to lift internal footings. This swelling first tends to create a dish effect, because the external footings are pushed higher than the internal ones.

The first noticeable symptom may be that the floor appears slightly dished. This is often accompanied by some doors binding on the floor or the door head, together with some cracking of cornice mitres. In buildings with timber flooring supported by bearers and joists, the floor can be bouncy. Externally there may be visible dishing of the hip or ridge lines.

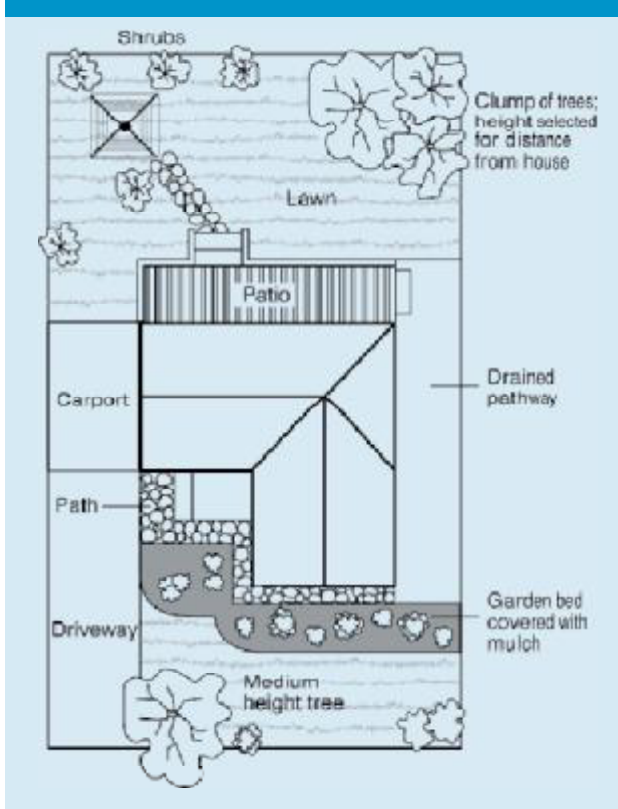
Gardens for a reactive site

should extend outwards a minimum of 900 mm (more in highly reactive soil) and should have a minimum fall away from the building of 1:60. The finished paving should be no less than 100 mm below brick vent bases.

It is prudent to relocate drainage pipes away from this paving, if possible, to avoid complications from future leakage. If this is not practical, earthenware pipes should be replaced by PVC and backfilling should be of the same soil type as the surrounding soil and compacted to the same density.

It is essential to remember that the soil that affects footings extends well beyond the actual building line. Watering of garden plants, shrubs and trees causes some of the most serious water problems.

For this reason, particularly where problems exist or are likely to occur, it is recommended that an apron of paving be installed around as much of the building perimeter as necessary. This paving
