SITE CLASSIFICATION REPORT SUMMARY

BLOCK: 26(z)	SECTION: 20(AO)	SUBURB: Strathnairn
JOB No: 77356.22		DATE: May 2019
CLIENT: Calibre Consulting (ACT) Pty Ltd

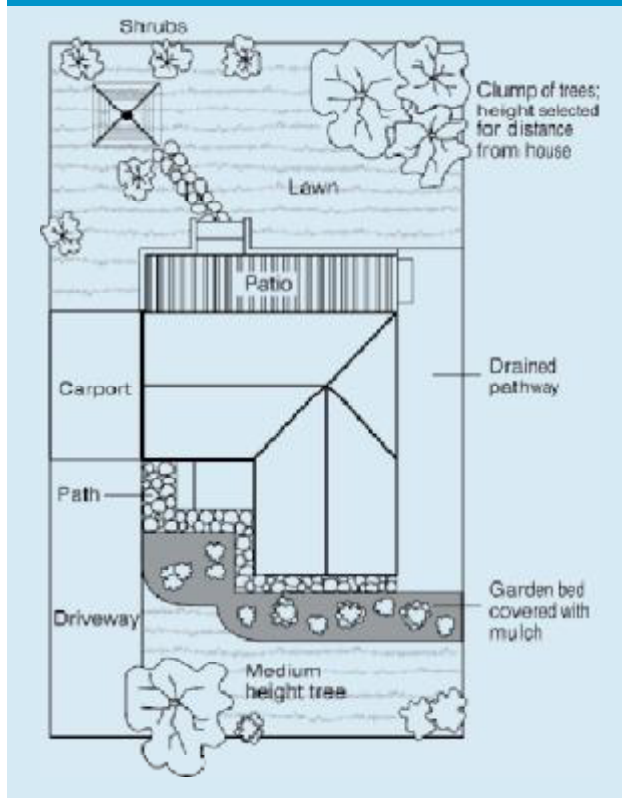
Gardens for a reactive site

should extend outwards a minimum of 900 mm (more in highly reactive soil) and should have a minimum fall away from the building of 1:60. The finished paving should be no less than 100 mm below brick vent bases.

It is prudent to relocate drainage pipes away from this paving, if possible, to avoid complications from future leakage. If this is not practical, earthenware pipes should be replaced by PVC and backfilling should be of the same soil type as the surrounding soil and compacted to the same density.

For this reason, particularly where problems exist or are likely to occur, it is recommended that an apron of paving be installed around as much of the building perimeter as necessary. This paving
