SITE CLASSIFICATION REPORT SUMMARY

BLOCK:	3(c)	SECTION:	26(AV)	SUBURB:	Strathnairn
JOB No:	77356.22	DATE:			May 2019
CLIENT:	Calibre Consulting (ACT) Pty Ltd				
Classification Procedures:					
Existing Subsurface Conditions: Refer attached test pit log(s) – Pit(s) 190,191 and Drawing 9.					
Bulk Earthworks: Filling within the block placed under Level 1 control as defined in AS 3798 – 2007 (Ref 1).					
Laboratory Results: Previous laboratory testing results indicated liquid limit ranging from 52-81%, plasticity index ranging from 39-68% and linear shrinkage ranging from 13.5-22%.					
Site Classification: Site classification in accordance with AS2870 - 2011 (Ref 2) provides guidance on the patterns and magnitude of moisture related seasonal ground movements that must be considered in design. Based on the current soil profile / state, on limited subsurface information, soil reactivity and allowing for variation in the subsoil profile, the overall site would be equivalent to low range Class H1* (highly reactive/filled) conditions. The site classification must be reassessed should the subsurface profile change by either cutting or filling and/or if the presence of service trenches,

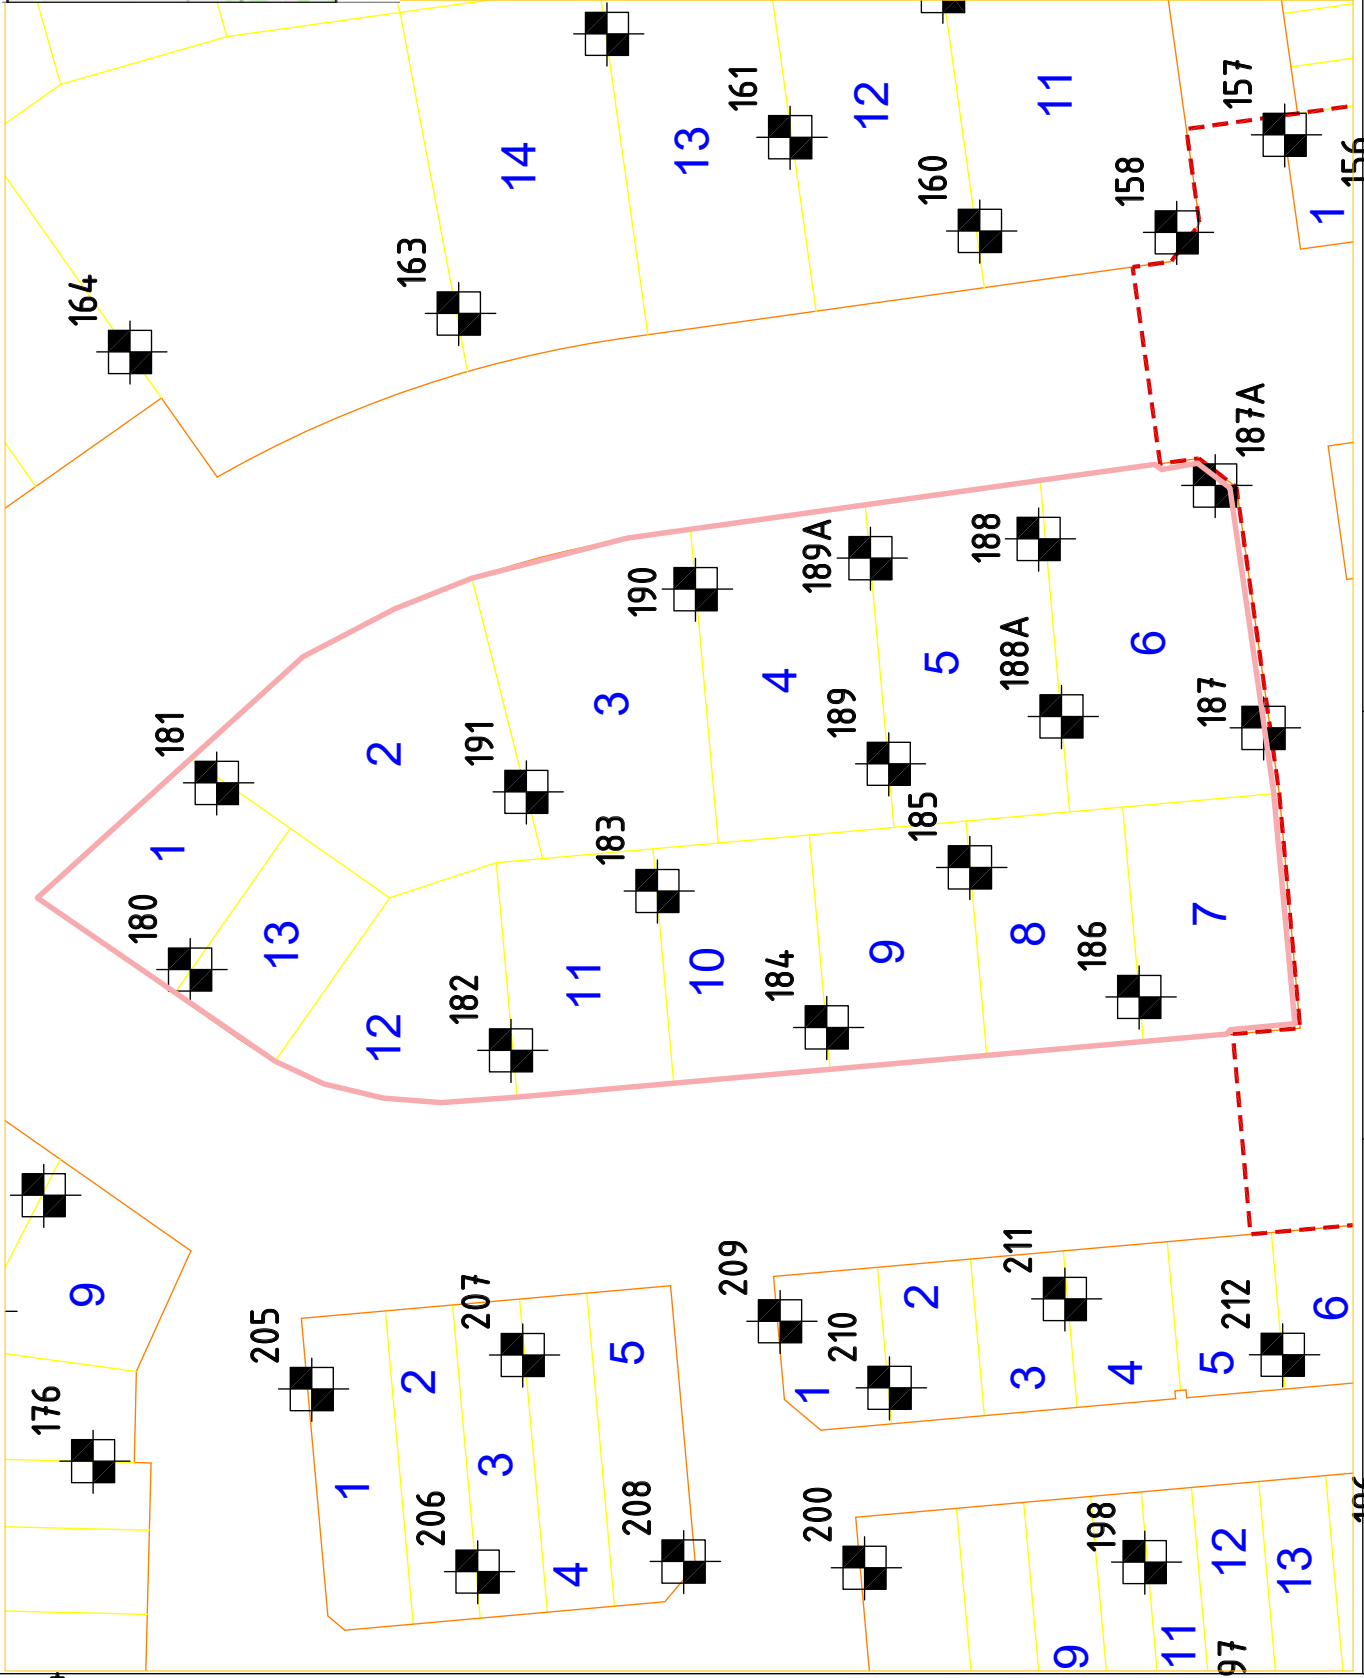
- ⊕ Test Pit Location
- 6 Block Number
- Block Boundary
- Section Boundary
- Stage Boundary
