# SITE CLASSIFICATION REPORT SUMMARY

<b>BLOCK:</b>	6(f)	<b>SECTION:</b>	26(AV)	<b>SUBURB:</b>	Strathnairn
<b>JOB No:</b>	77356.22	<b>DATE:</b>	June 2019		
<b>CLIENT:</b>	Calibre Consulting (ACT) Pty Ltd				
<b>Classification Procedures:</b>					
<b>Existing Subsurface Conditions:</b> Refer attached test pit log(s) – Pit(s) 187,187A,188,188A and Drawing 9.					
<b>Bulk Earthworks:</b> Filling within the block placed under Level 1 control as defined in AS 3798 – 2007 (Ref 1).					
<b>Laboratory Results:</b> Previous laboratory testing results indicated liquid limit ranging from 52-81%, plasticity index ranging from 39-68% and linear shrinkage ranging from 13.5-22%.					
<b>Site Classification:</b> Site classification in accordance with AS2870 - 2011 (Ref 2) provides guidance on the patterns and magnitude of moisture related seasonal ground movements that must be considered in design. Based on the current soil profile / state, on limited subsurface information, soil reactivity and allowing for variation in the subsoil profile, the overall site would be equivalent to Class H1* (highly reactive/filled) conditions. The site classification must be reassessed should the subsurface profile

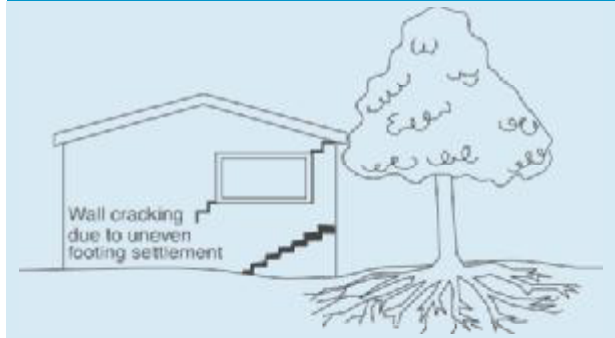
### Trees can cause shrinkage and damage

As the weather pattern changes and the soil begins to dry out, the external footings will be first affected, beginning with the locations where the sun's effect is strongest. This has the effect of lowering the external footings. The doming is accentuated and cracking reduces or disappears where it occurred because of dishing, but other cracks open up. The roof lines may become convex.

#### Movement caused by tree roots
