SITE CLASSIFICATION REPORT SUMMARY

BLOCK:	7(g)	SECTION:	26(AV)	SUBURB:	Strathnairn
JOB No:	77356.22	DATE:	June 2019		
CLIENT:	Calibre Consulting (ACT) Pty Ltd				
Classification Procedures:					
Existing Subsurface Conditions: Refer attached test pit log(s) – Pit(s) 186,187,188A and Drawing 9.					
Bulk Earthworks: Filling within the block placed under Level 1 control as defined in AS 3798 – 2007 (Ref 1).					
Laboratory Results: Previous laboratory testing results indicated liquid limit ranging from 52-81%, plasticity index ranging from 39-68% and linear shrinkage ranging from 13.5-22%.					
Site Classification: Site classification in accordance with AS2870 - 2011 (Ref 2) provides guidance on the patterns and magnitude of moisture related seasonal ground movements that must be considered in design. Based on the current soil profile / state, on limited subsurface information, soil reactivity and allowing for variation in the subsoil profile, the overall site would be equivalent to Class H1* (highly reactive/filled) conditions. The site classification must be reassessed should the subsurface profile change by either cutting or filling and/or if the presence of service trenches, ret

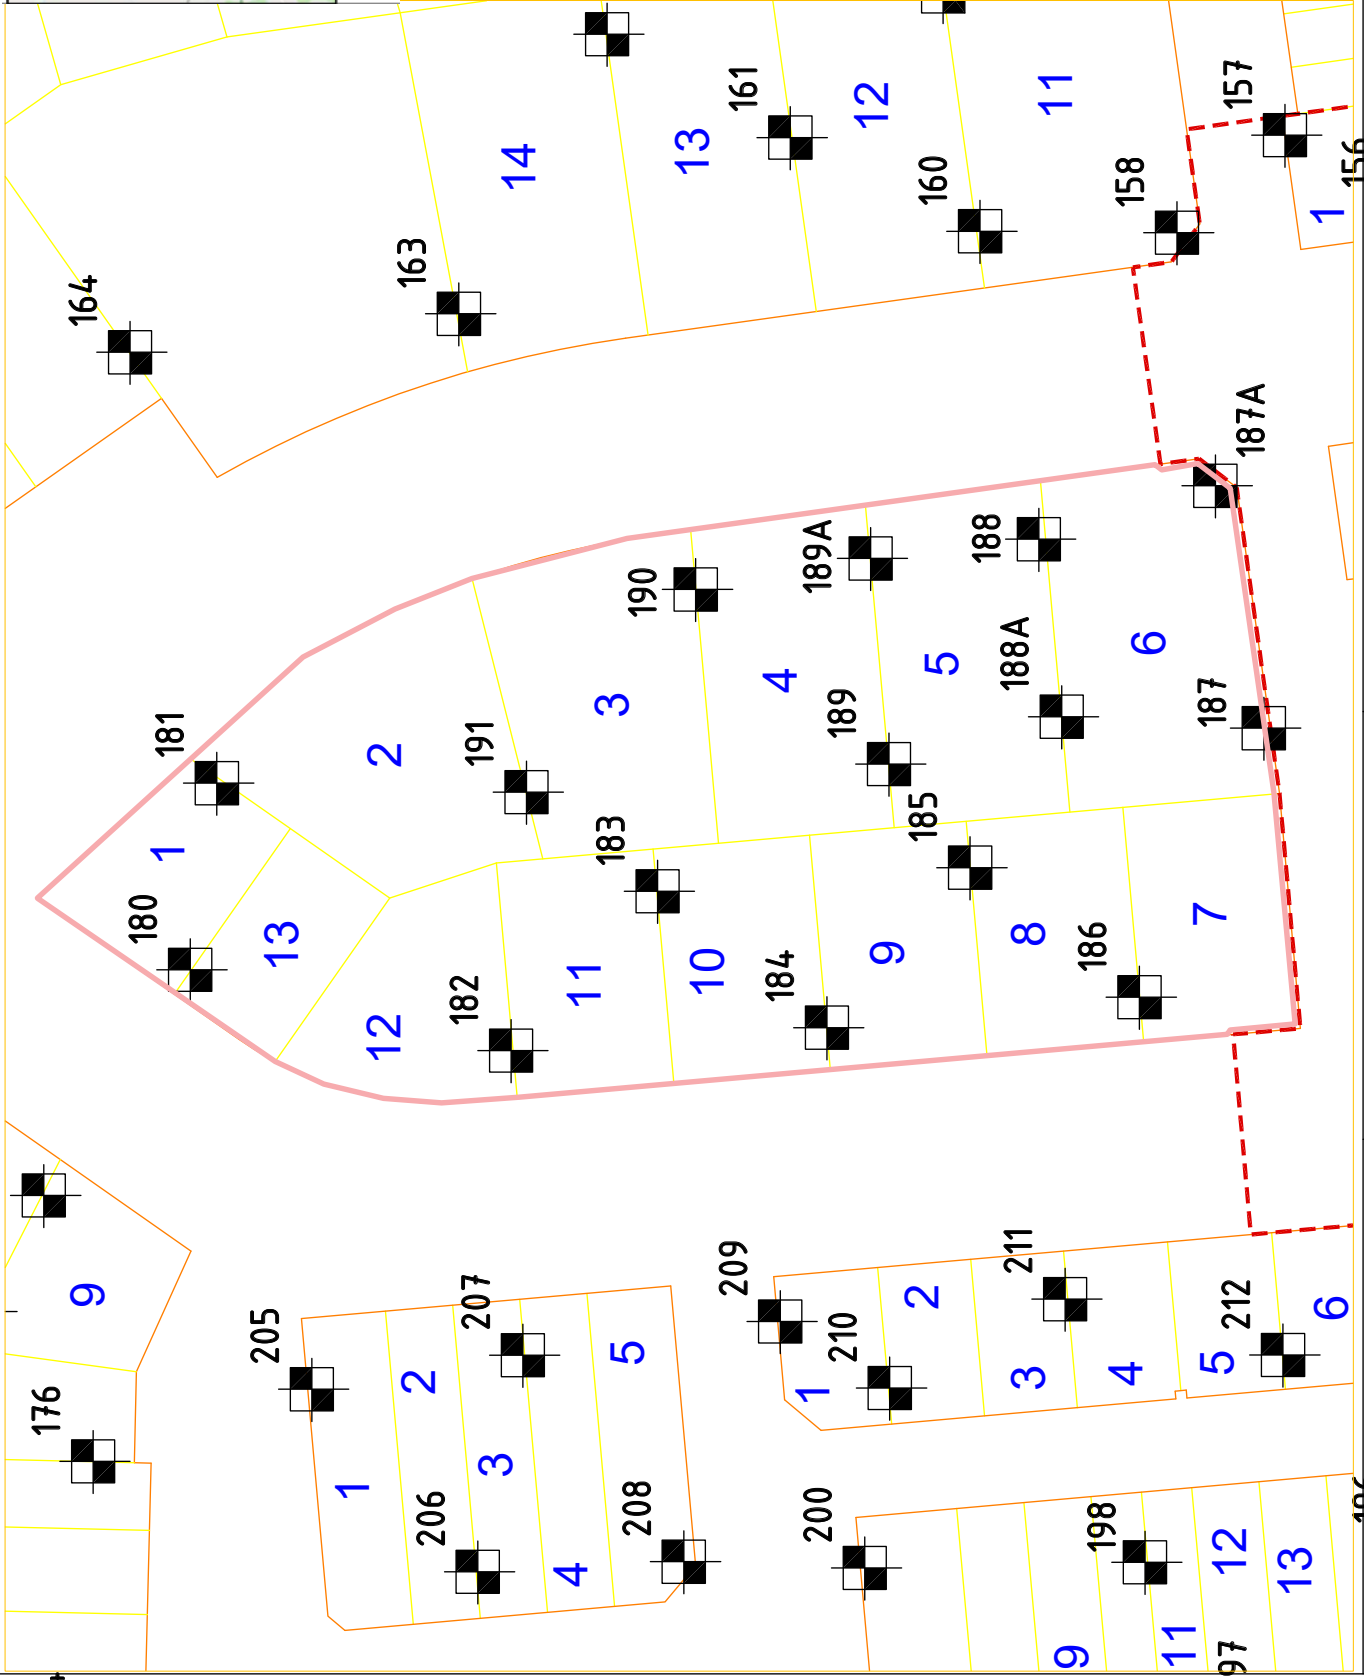
- LEGEND**
- ⊕ Test Pit Location
 - 6 Block Number
 - Block Boundary
 - Section Boundary
 - - - Stage Boundary
