# SITE CLASSIFICATION REPORT SUMMARY

**BLOCK:** 2 (d)      **SECTION:** 33 (AZ)      **SUBURB:** Strathnairn  
**JOB No:** 77356.27      **DATE:** August 2019  
**CLIENT:** Calibre Consulting (ACT) Pty Ltd

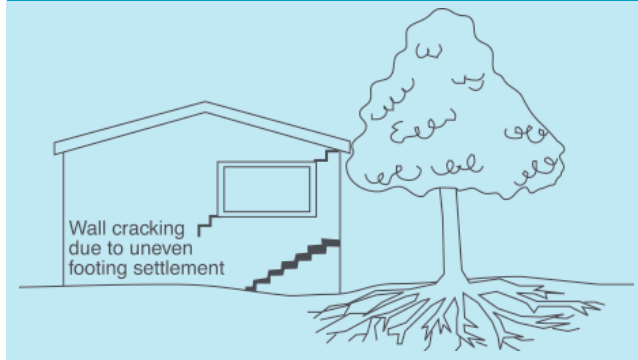
### Trees can cause shrinkage and damage

As the weather pattern changes and the soil begins to dry out, the external footings will be first affected, beginning with the locations where the sun's effect is strongest. This has the effect of lowering the external footings. The doming is accentuated and cracking reduces or disappears where it occurred because of dishing, but other cracks open up. The roof lines may become convex.

#### Movement caused by tree roots

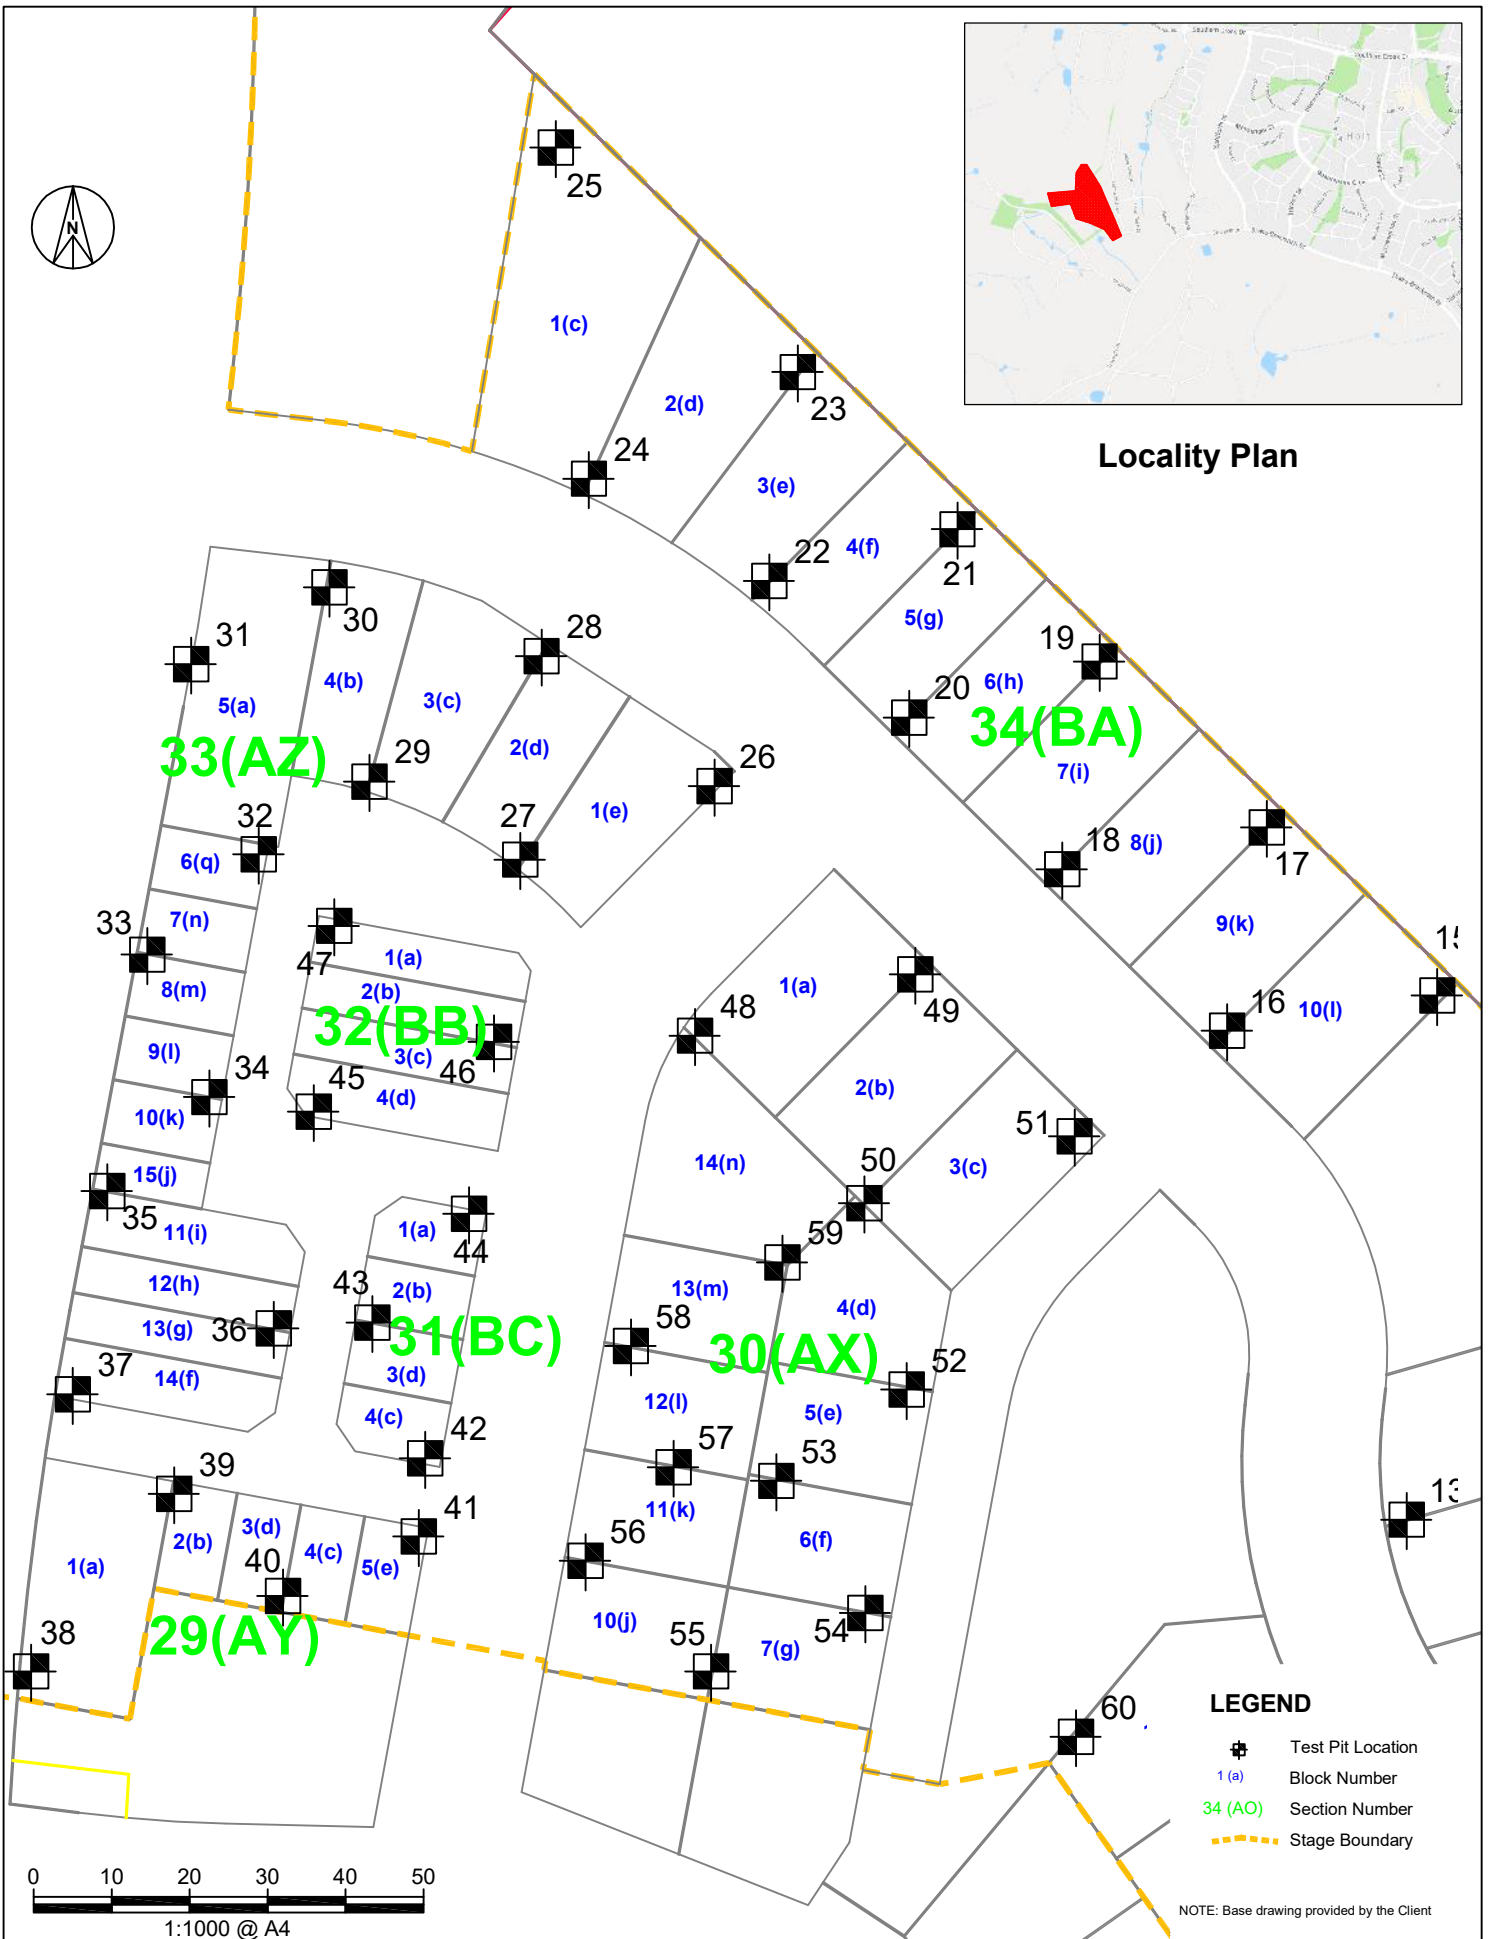
**LEGEND**

- Test Pit Location
- 1 (a) Block Number
- 34 (AO) Section Number
- Stage Boundary

**Existing Subsurface Conditions:** Refer attached test pit log(s) – Pit(s) 27,28 and Drawing 1.
