## Investigation Summary Report

| Project | Proposed Residential Subdivision | Date | 25 January 2024 |
| Address | Block 1 Section 9, Macnamara | Reference | R.079.Rev0 |

This report presents the factual results of a geotechnical investigation undertaken at Block 1 Section 9, Macnamara.

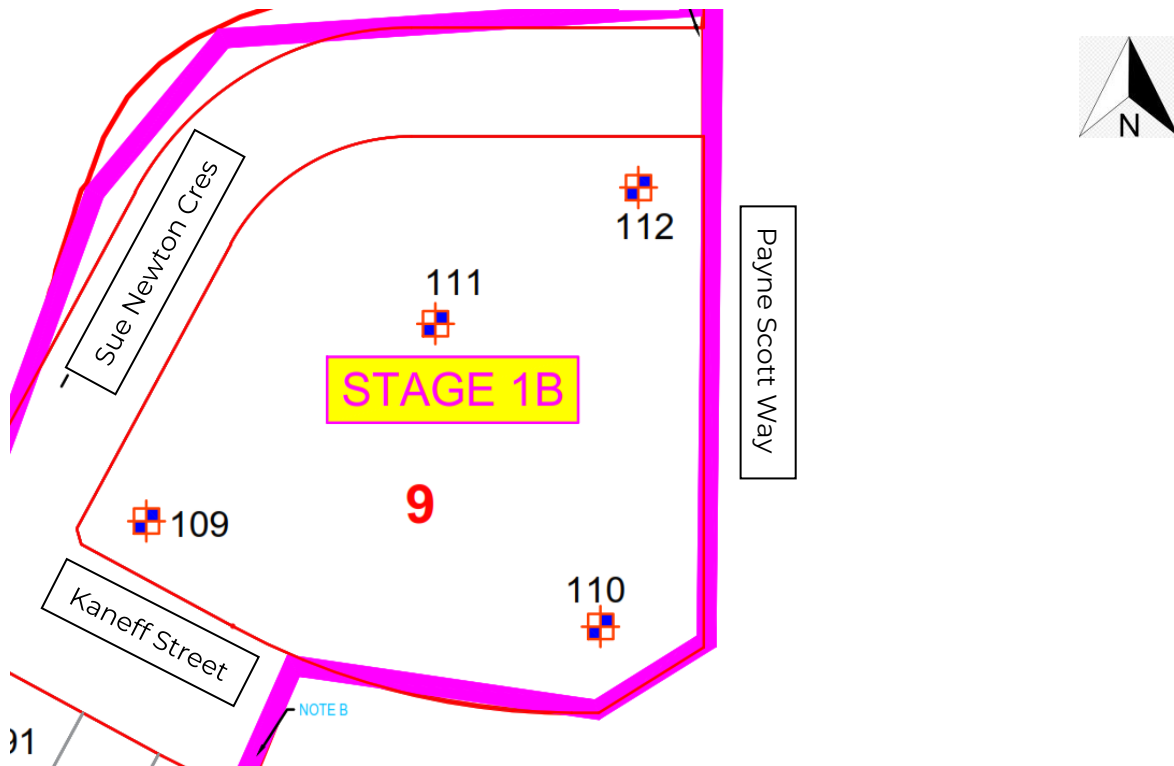
**Figure 1: Approximate locations of test pits.**

The field investigation applicable to Block 1 Section 9, comprised the excavation of four test pits (Pits 109 to 112) to depths of 1.5 – 1.9 m at the approximate locations shown in Figure 1 below. The test pits were excavated using a CAT 305E CR mini-excavator (~5 tonne) fitted with a 300 mm wide bucket working under the direction of a geotechnical engineer. Disturbed samples of the soils encountered in the test pits were collected for possible laboratory testing and to assist in strata identification.

The test pits were located on site using a hand-held GPS which is accurate only to about 3 – 5 m. Surface levels provided on the attached test pit logs were determined by interpolation of the finished surface level design drawings. Positions and levels must not be relied on.
